# **STRUCTURAL BARN EVALUATION**

**243 POST ROAD  
BOWDOINHAM, MAINE 04008**

Inspection Date: September 25, 2020

Project No. 20-0377-ME

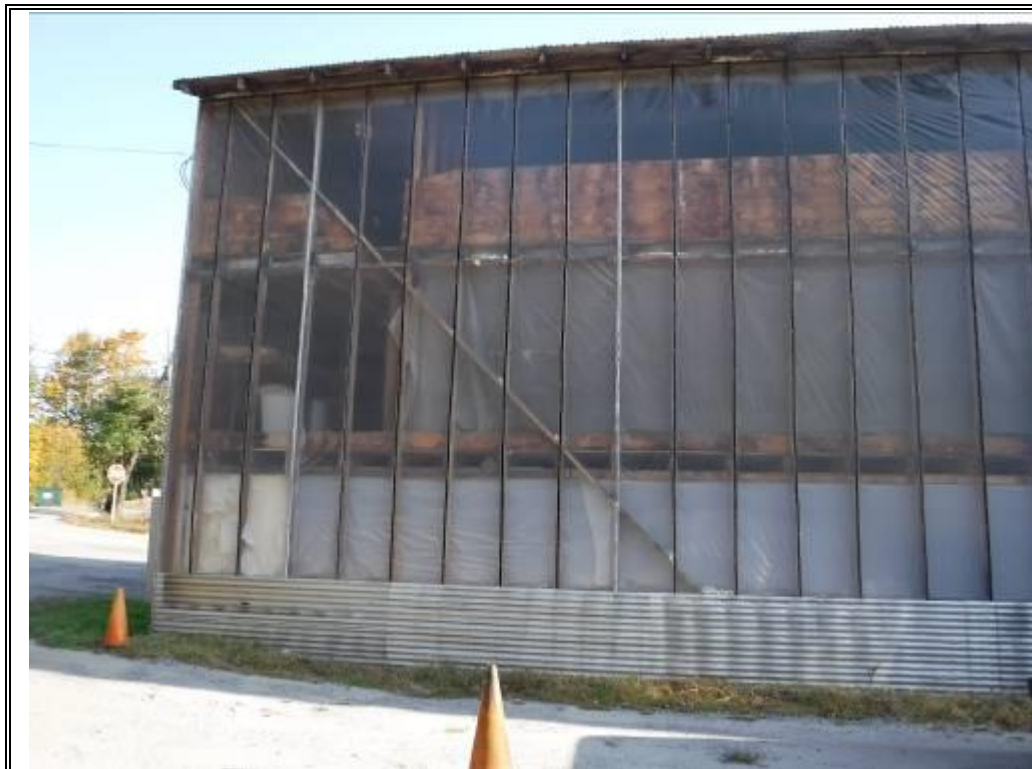
**Photo Number**  
**2**

The south wall of the building is sheathed with plastic sheeting stapled to the studs. Some limited diagonal braces have been let into the wall for the full height of the wall. I recommend that the building be fully evaluated and that parts of the wall be sheathed and fastened as needed per the evaluation. The sheathing would need to be fully attached to bring the shear loads from the roof framing down to the foundation. We discussed installing the sheathing on the inside; this would involve some complications to the wind design analysis. A better solution still allowing the solar gain may be to install the sheathing to the outside of the studs and then install a Trombe-wall type collector to the outside of the sheathing.

**Description:**  
West End of South  
Wall  
Note Let-in  
Bracing, Plastic  
Sheathing

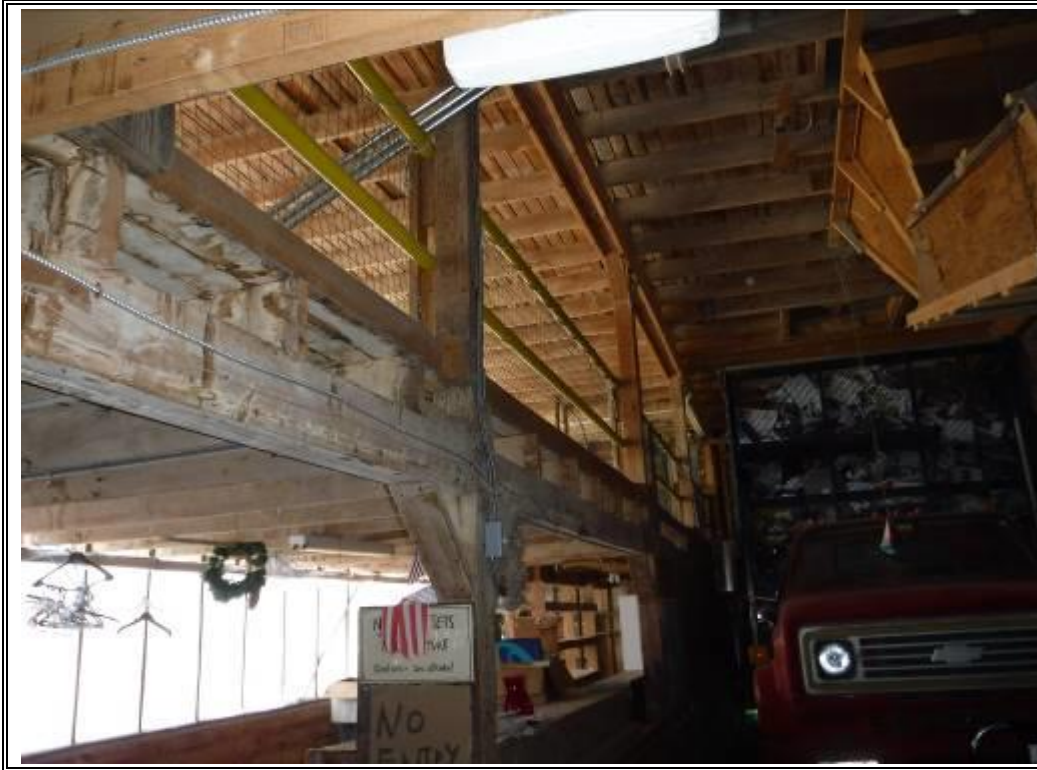
**Photo Number**

West end bays with third floor roof hatch for truck loading

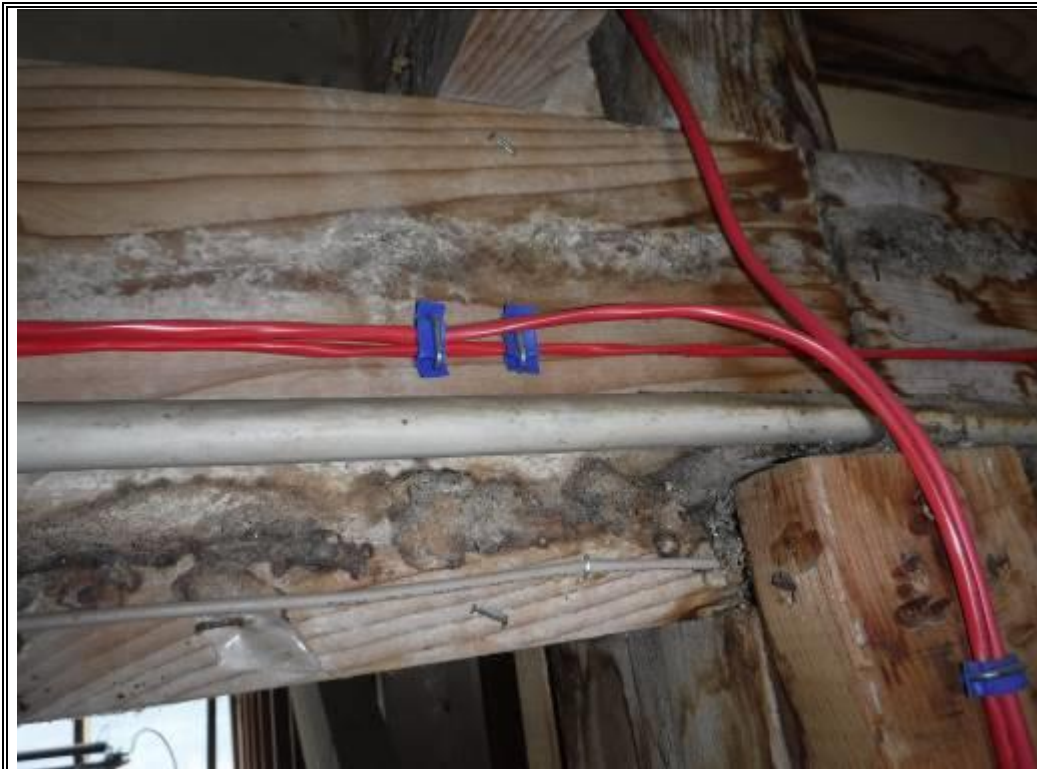
chicken pee debris on location of previous power lines

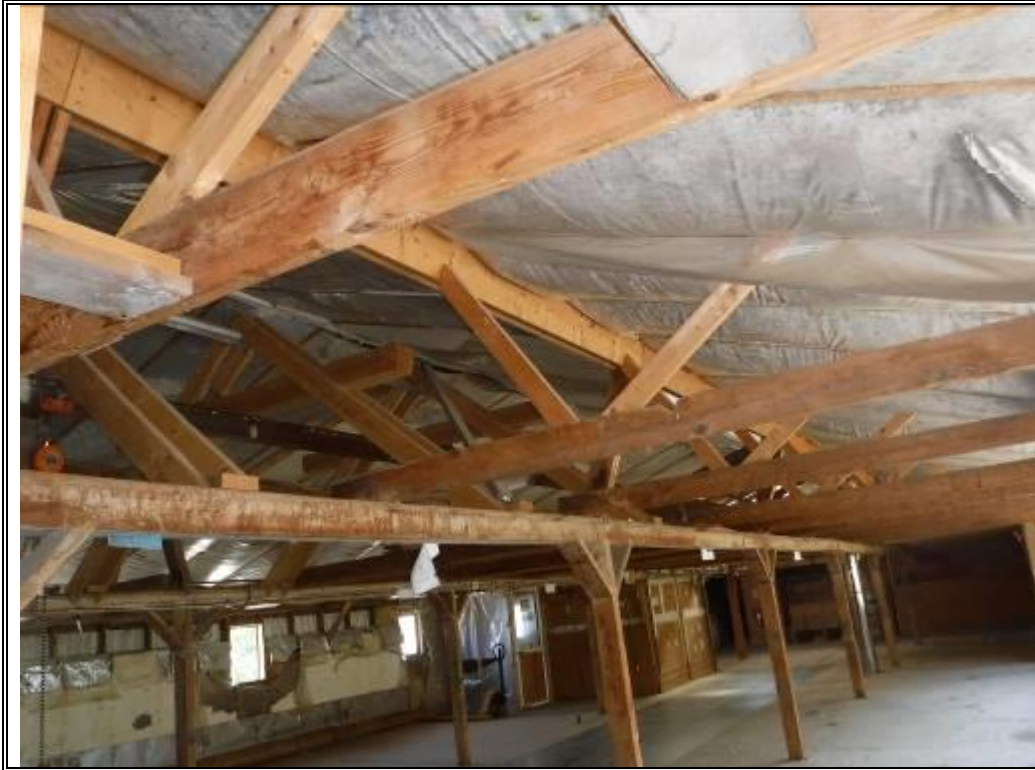
**Photo Number**  
**7**

If we assume that the area of the third floor used for the pallet jack is just used for the one pallet jack, and that the rest of the span in that area is unloaded except for dead load, then only that load is on the framing at one time – so the 4x4 area carries 1440 sf, and the rest of the structure supporting the rest of the floor in that bay is unloaded except for the dead load. This would require restricting the load to the one pallet jack. Note that this is the current loading condition in the third floor near the truck opening. This means that no material would be stored in the same bay as the pallet jack travel. The floor that has been enhanced should be painted, or curbed, so the pallet jack can't travel beyond the enhanced floor area, and placarded for only that use with no storage.

**Description:**  
southwest end 3rd  
with pallet jack,  
insulation at roof  
framing

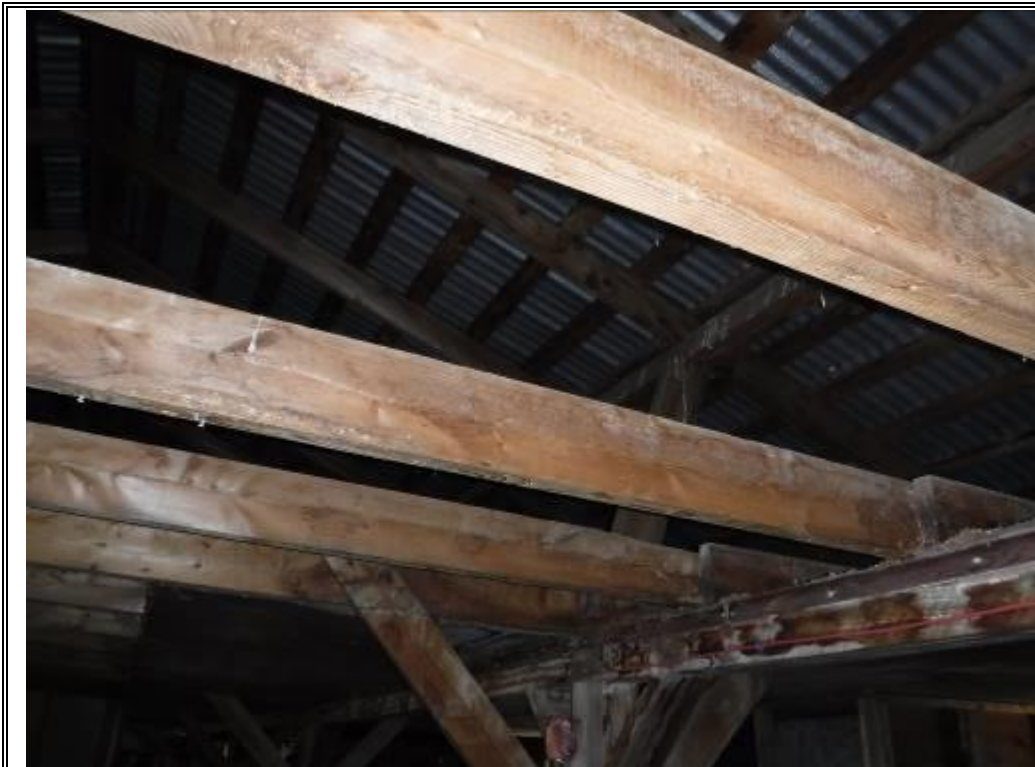
**Photo Number**  
**8**

**Description:**  
typical roof  
framing no  
insulation

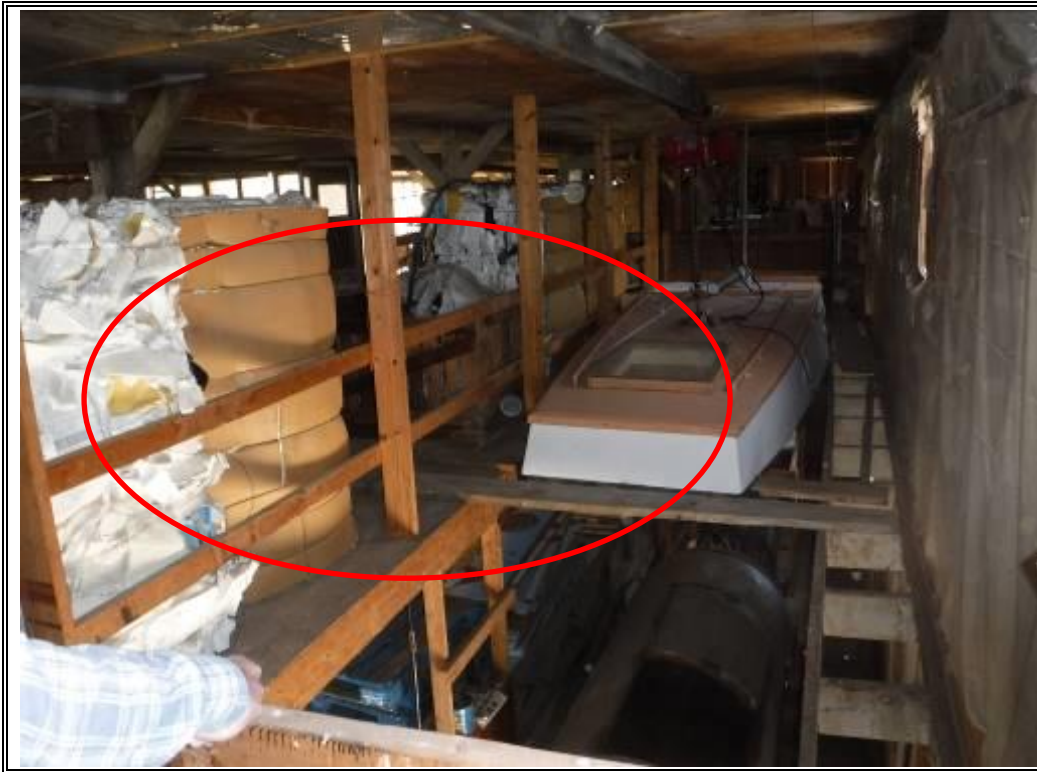
**Photo Number**  
**9**

When the building was repurposed into a new use as a recycling center, the barn was modified in some locations to make openings in the floors. Some of these modifications weren't engineered, and resulted in an inadequate structure.

**Description:**  
Inadequately supported floor area

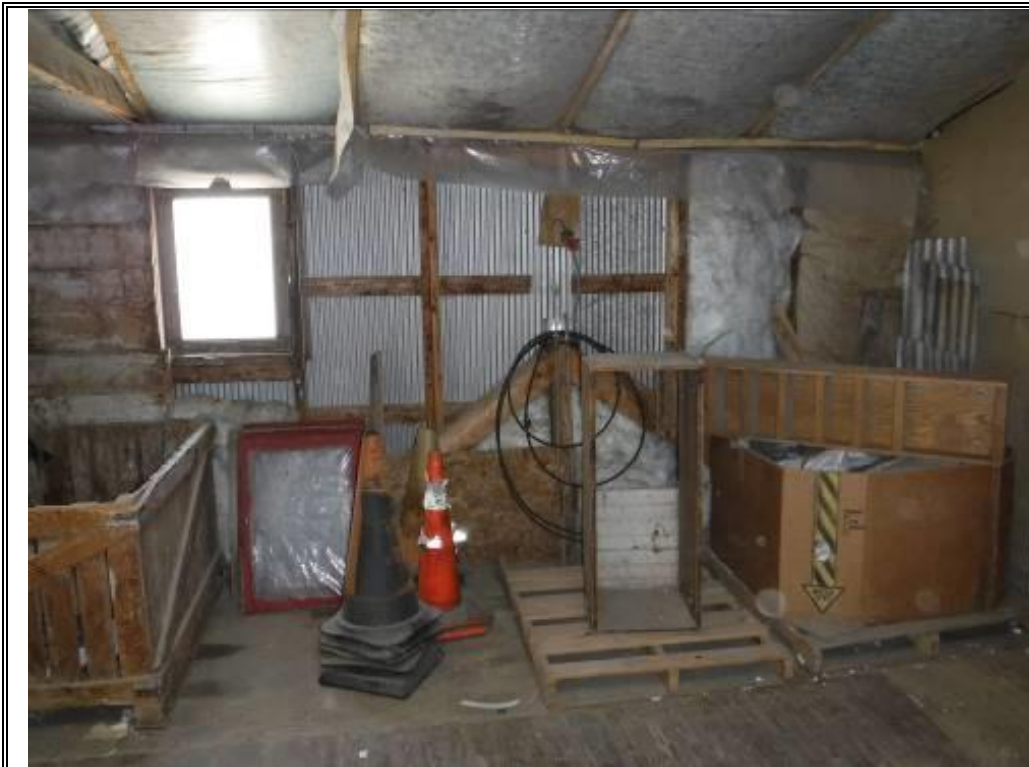
**Photo Number**  
**10**

**Description:**  
truss at north wall opening

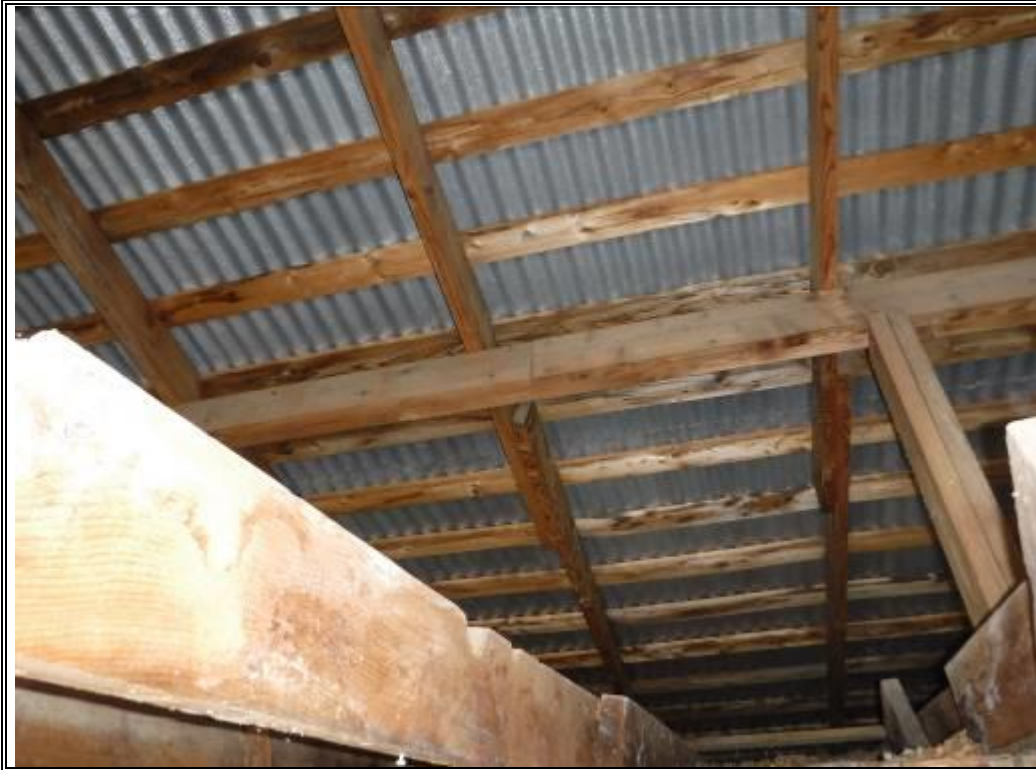
**Photo Number**  
**11**

**Description:**  
roof framing at  
north side, east  
end, typical

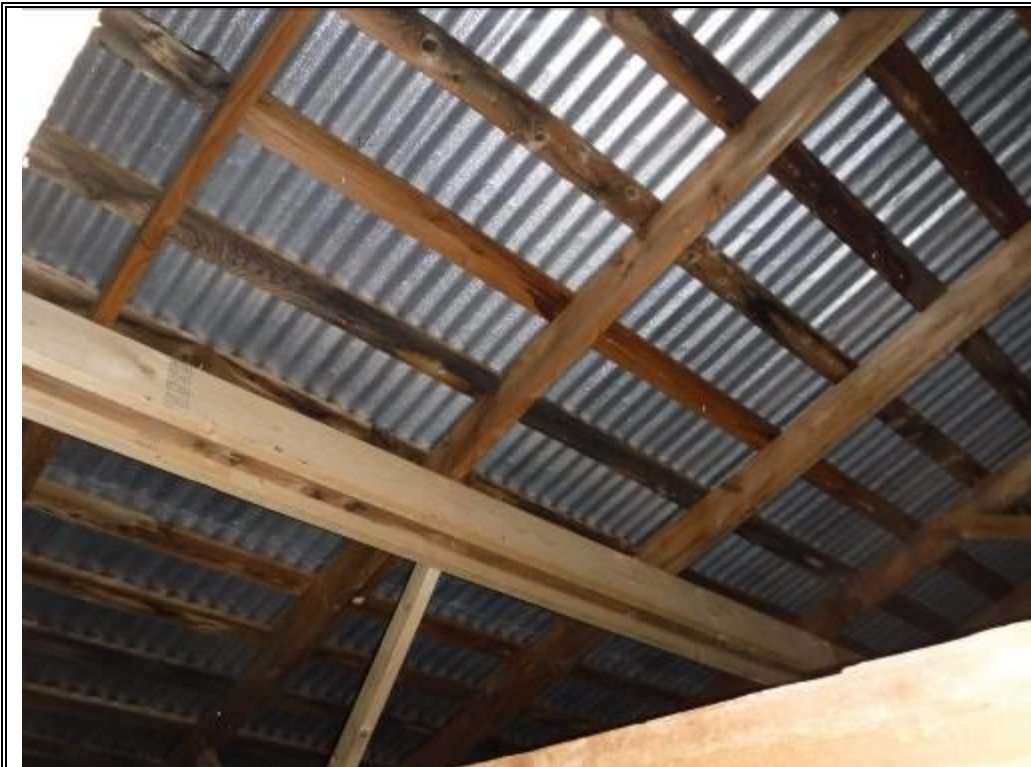
**Photo Number**  
**12**

**Description:**  
roof framing with  
beefed up roof  
purlin

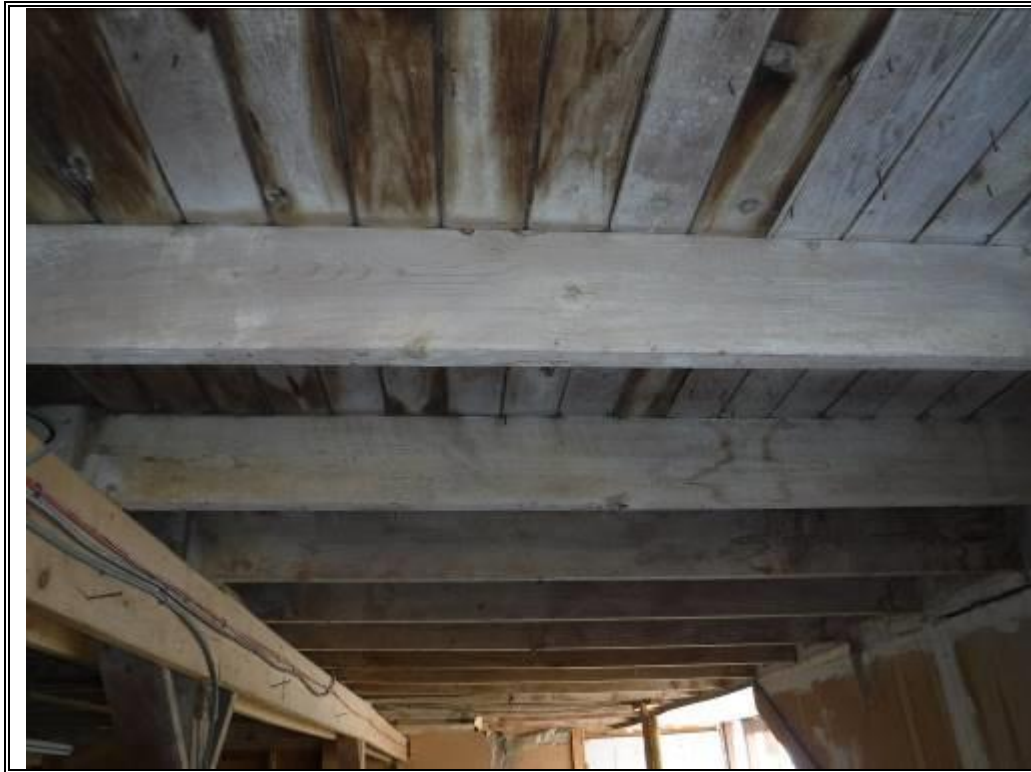
**Photo Number**  
**13**

**Description:**  
typical joist and  
floor sheathing  
condition

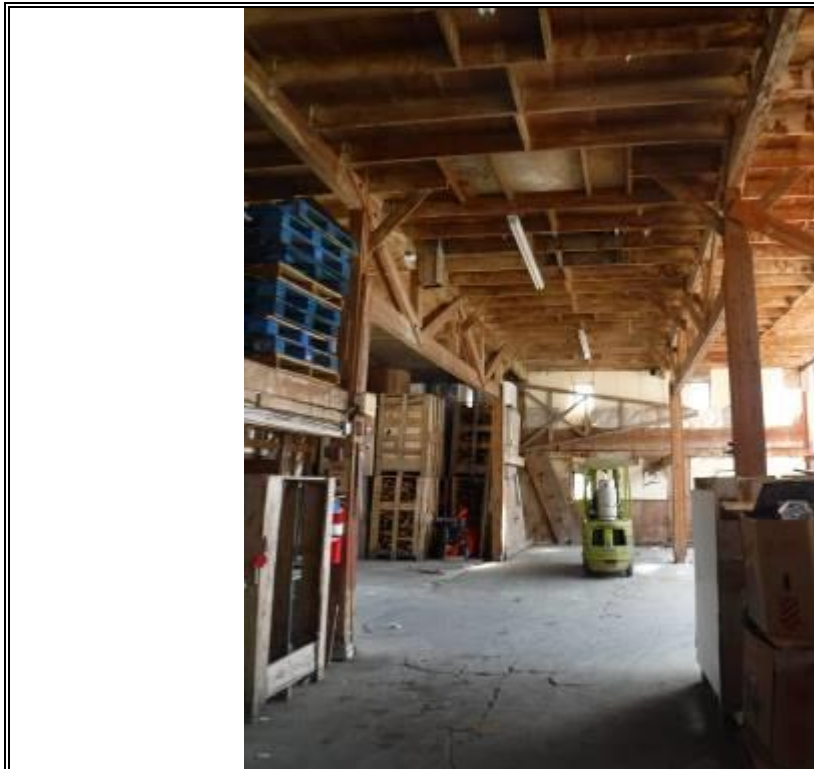
**Photo Number**  
**14**

7. Some floor areas have been removed, including the second floor framing at the front of the building in the center aisle, the second floor framing near the center of the building in the north aisle, and the second floor framing at the back end of the building. The removed post-and-beam framing has been replaced with wood trusses to replace the removed supports for the third floor.

**Description:**  
south bay with  
second floor  
removed and  
added trusses  
taking column  
loads

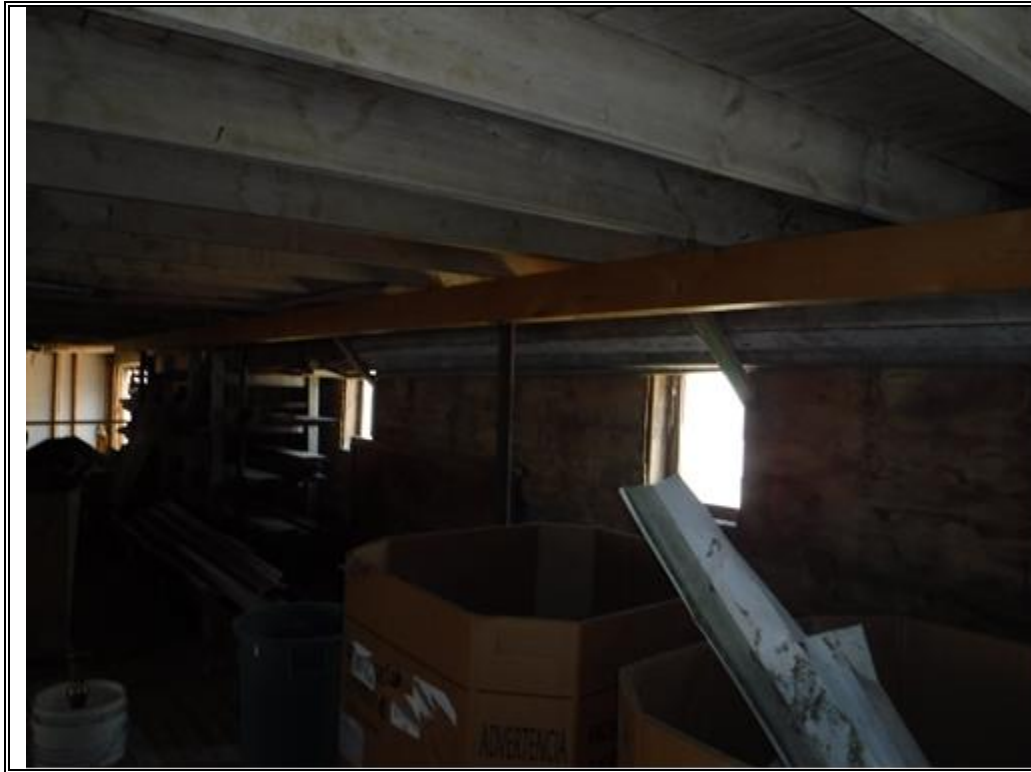
**Photo Number**  
**15**

**Description:**  
added beam to  
support third floor  
north bay

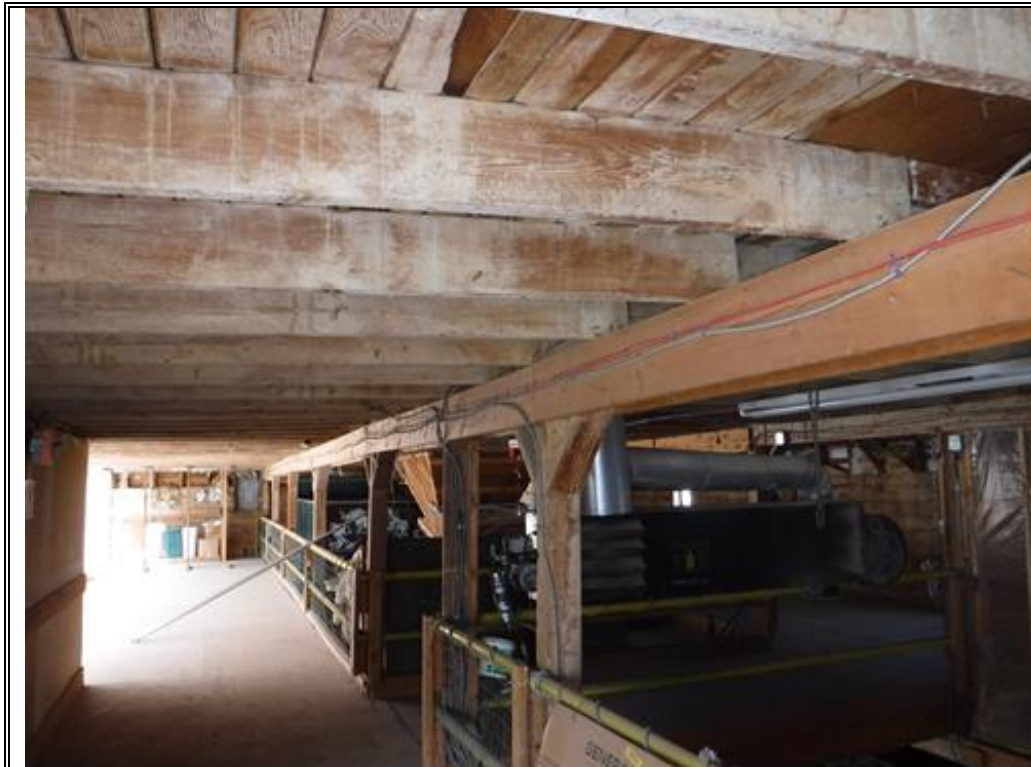
**Photo Number**  
**16**

3. The framing is in three bays of 2x8 joists at 24" on center, with 12' spans. The joists land on two interior wood beams running front-to-back, originally built with 3 – 2x8s, spanning 12' from post-to-post. The posts are 6x6 solid or built-up posts. There are 45 degree angle braces from the post to the beams, and in some locations there are angle braces north-to-south as well. The material appears to be hemlock or pine. The floor sheathing is wood boards. The joists are generally in good condition, though in some areas they are stained and have debris left over from the chicken barn use. The beams supporting the joists are generally deflected in the center.

**Description:**  
typical floor  
framing, with  
beam supporting  
joists strengthened

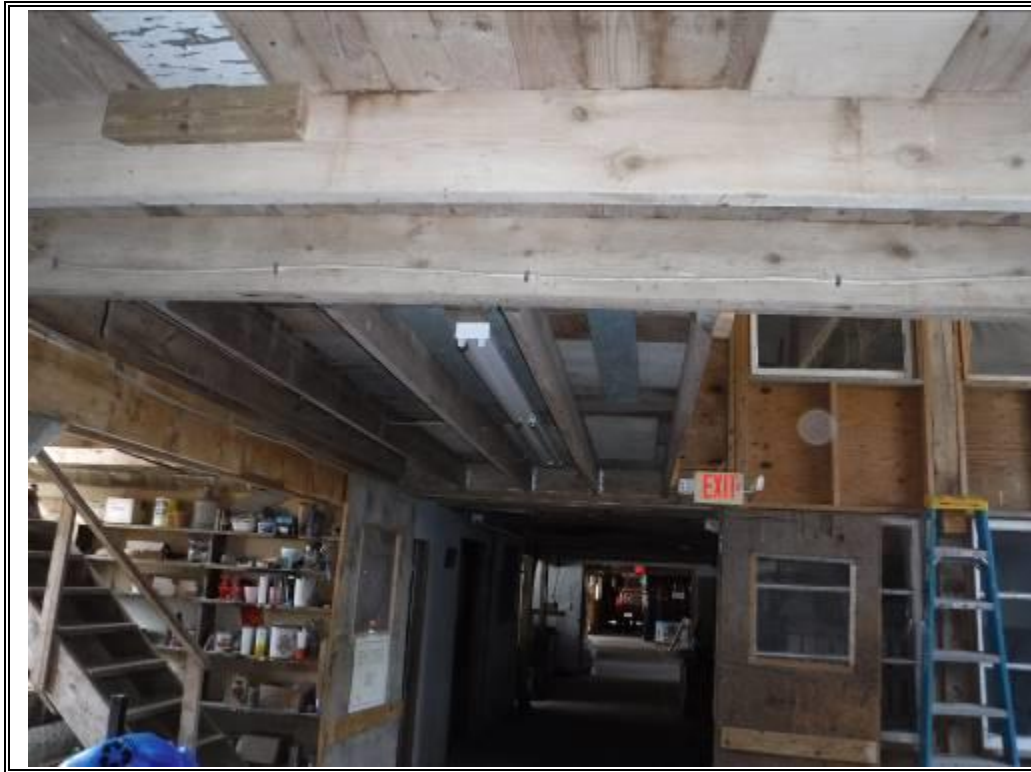
**Photo Number**  
**17**

**Description:**  
area of second  
floor should be  
checked

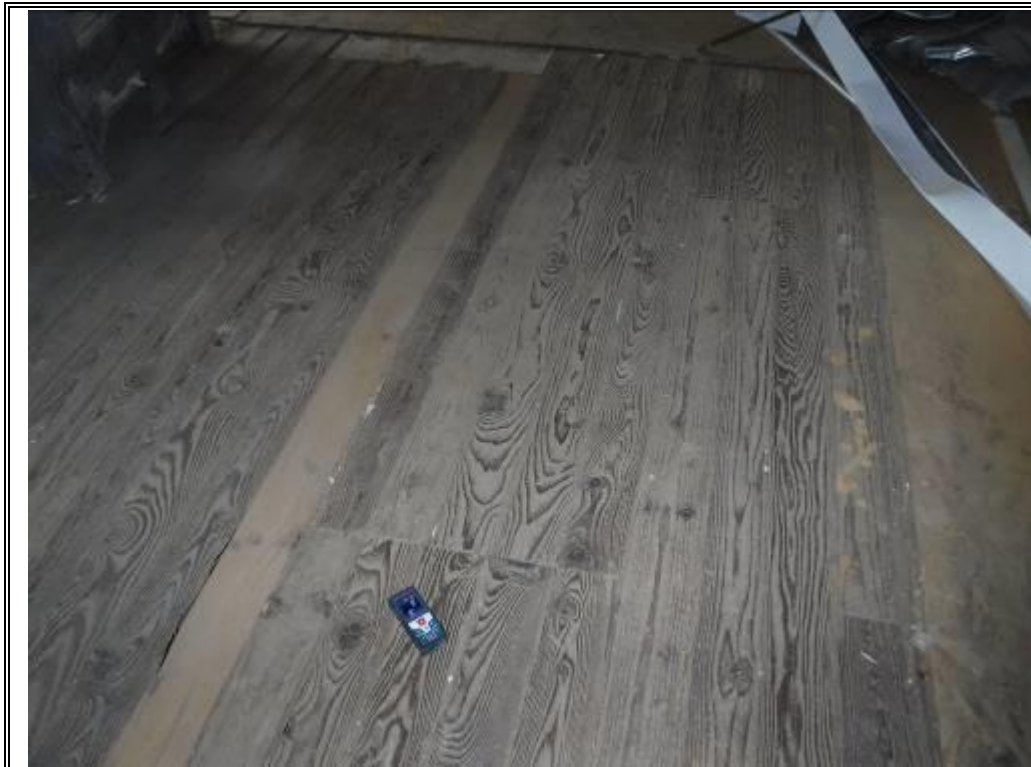
**Photo Number**  
**18**

**Description:**  
original floor  
sheathing

There are some areas with the original board floor sheathing. These areas should be inspected periodically, if kept in use, as the use for chickens may have deteriorated the strength properties over time. Most of the floors have been surfaced over with plywood, which is in good condition and adequately attached, where observed.

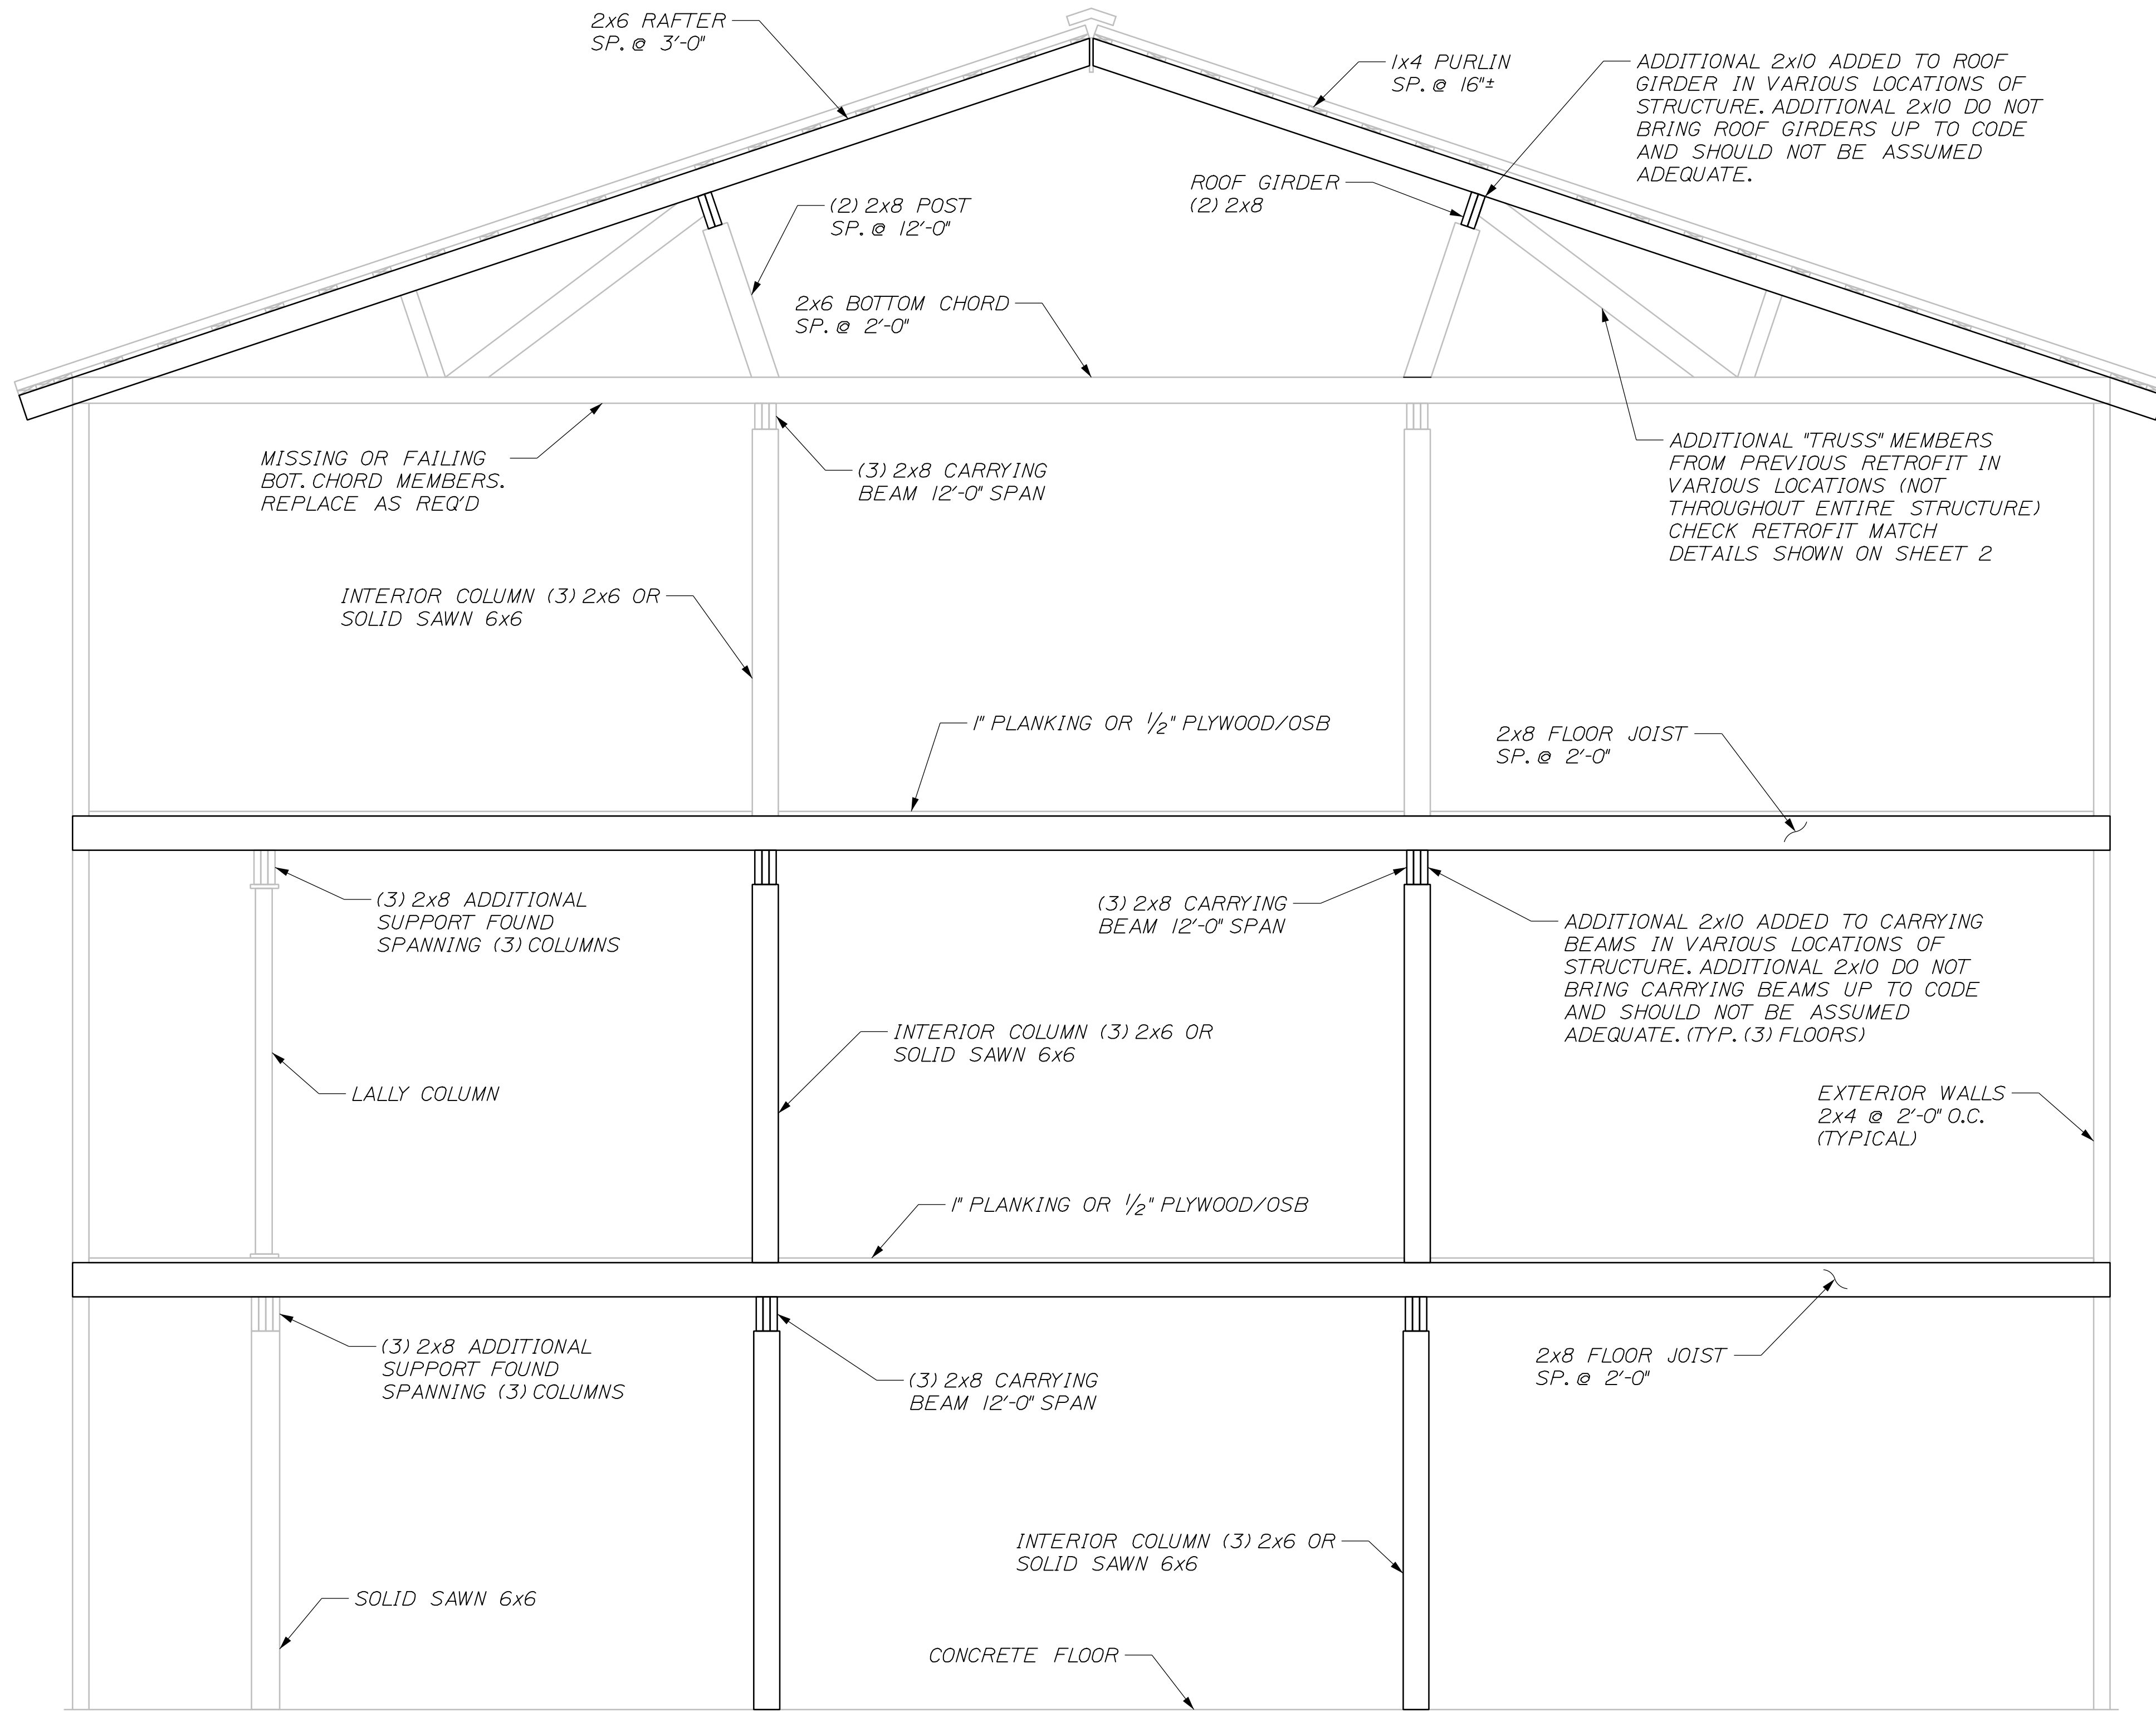
TYPICAL SECTION ~ LOOKING AWAY FROM THE ROAD  
 1/2" = 1'-0"  
 NOTE: MEMBERS IN BOLD ARE UNDERSIZED AND NEED RETROFIT TO BE ABLE TO SUPPORT DESIGN LOADS

EXISTING STRUCTURAL MEMBER	EXISTING ALLOWABLE LIVE LOAD
FLOOR JOIST ~ 2x8 @ 2'-0"	27.4psf
CARRYING BEAM ~ (3) 2x8 12' SPAN	10.3psf
2ND FLOOR COLUMNS ~ (3) 2x6 12' SPACING	61.1psf
1ST FLOOR COLUMNS ~ (3) 2x6 12' SPACING	56.1psf

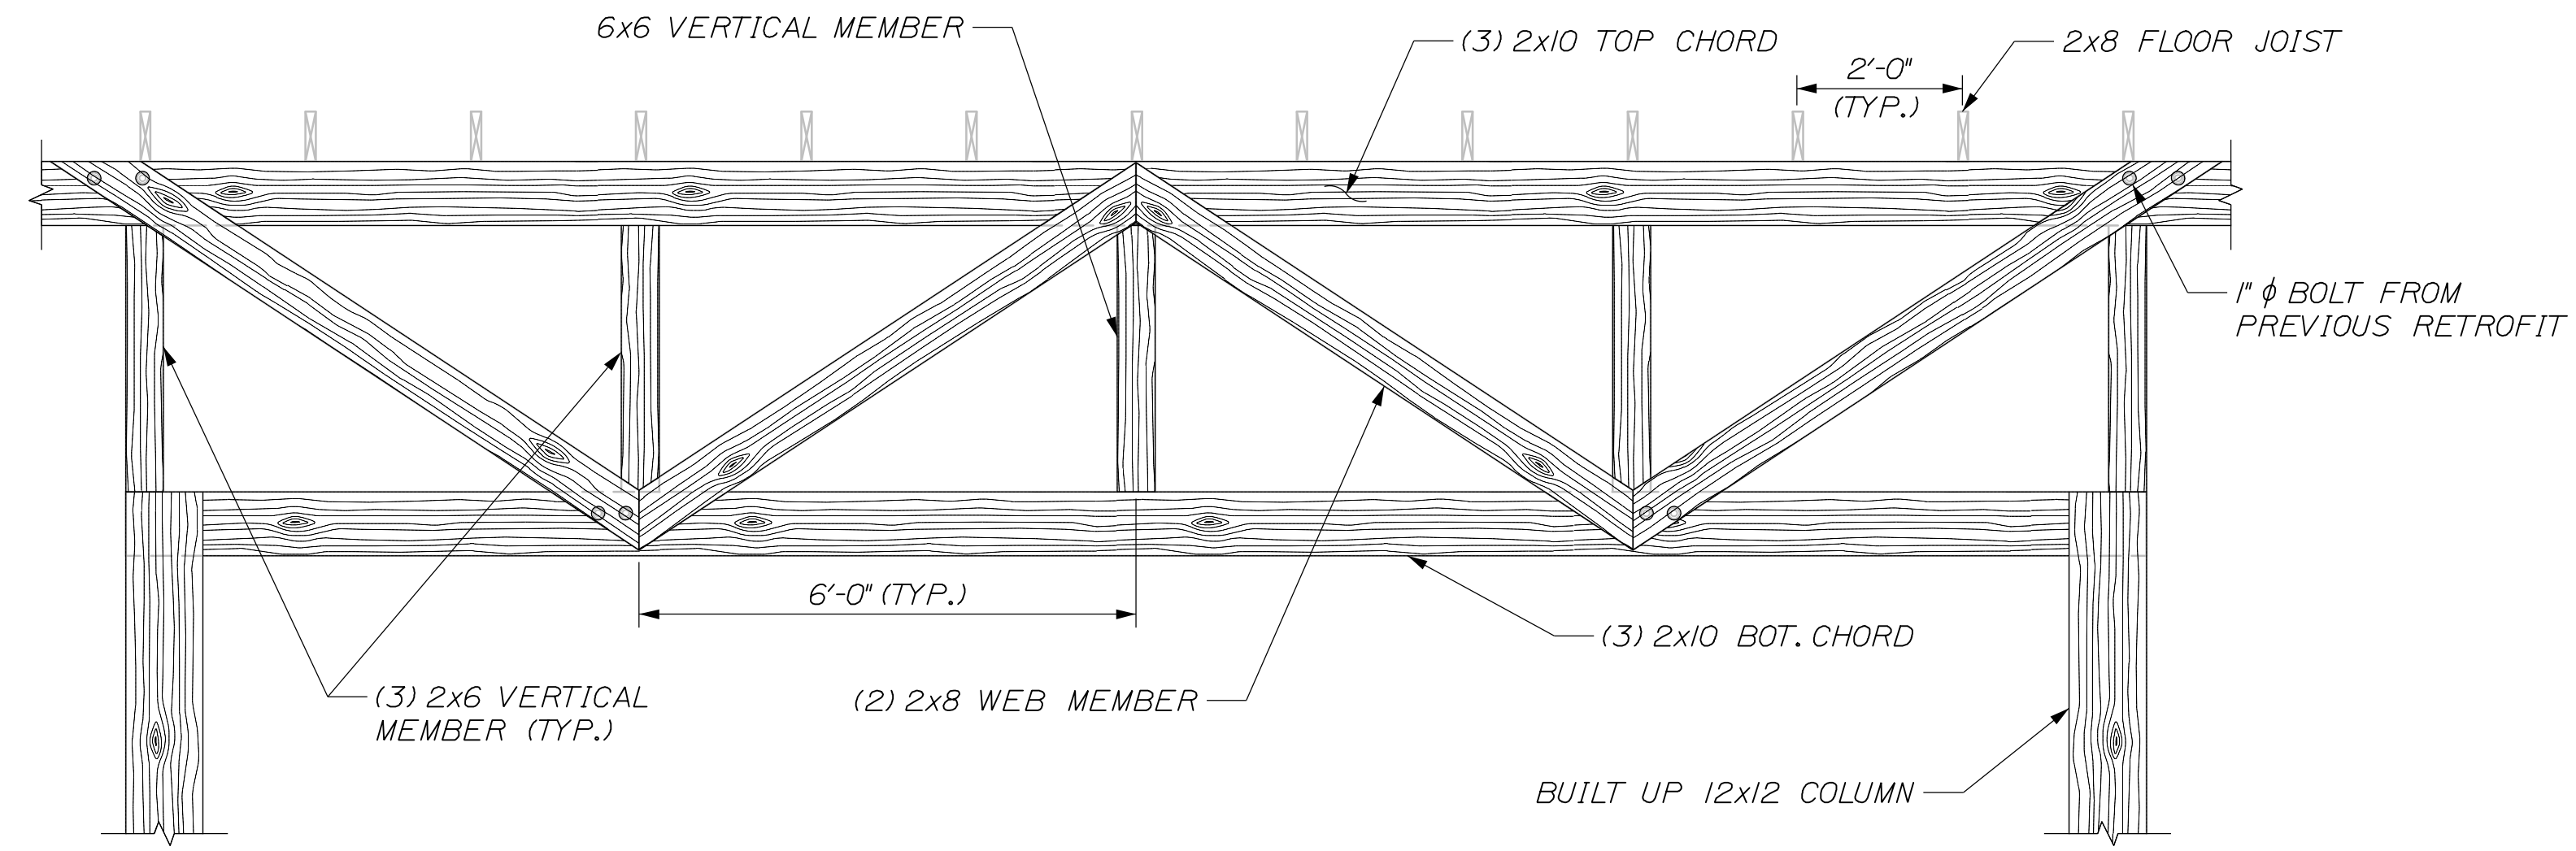
**EXISTING CEILING TRUSS**  
 $\frac{1}{2}'' = 1'-0''$   
 NOTE: EXISTING CEILING TRUSS FOUND IN REAR OF BUILDING
