Preservation Timber Framing, Inc.

4/10/2023 | 101 Photos

Bowdoinham Old Town Hall Photo Report

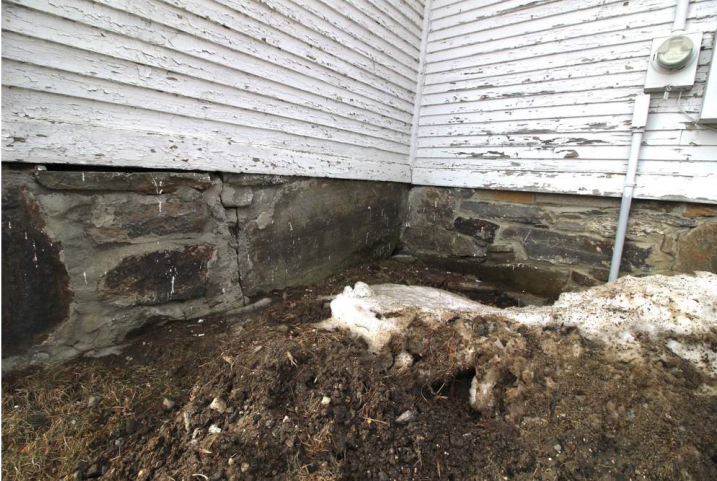
3

Recently, movement has been observed in the foundation. Here a long crack is visible in the mortar.

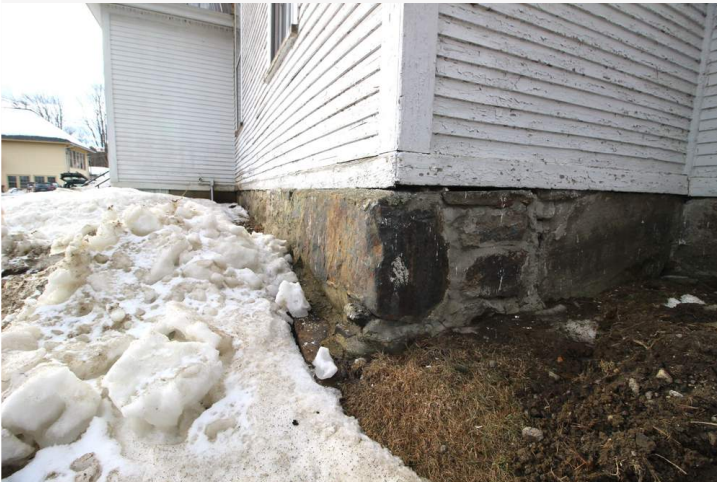
4

This capstone is proud of the wall plane. Water that lands on this corner can be redirected into the building, rotting the framing from the foundation up.

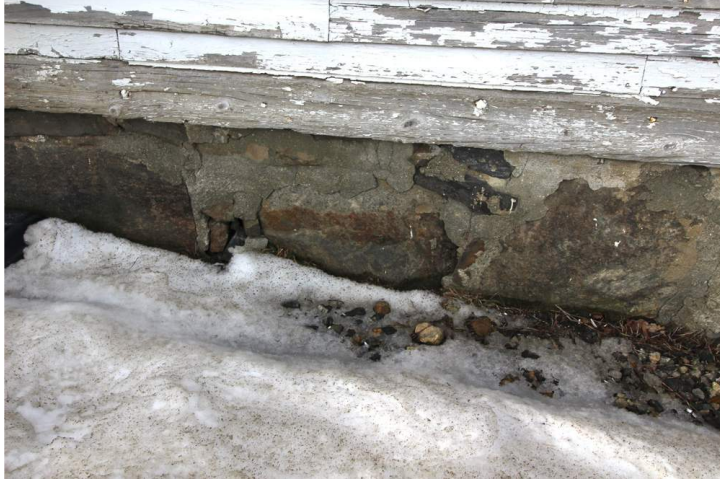
5

The infill mortar work varies in neatness and skill, and appears to have been applied in multiple generations.

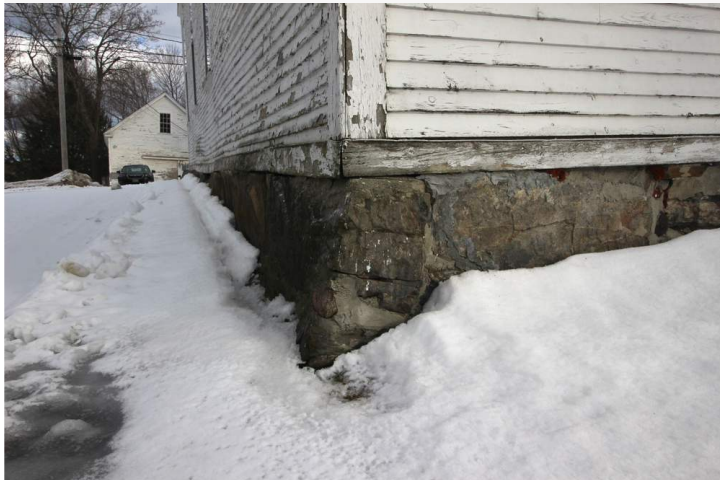
6

Northwest foundation corner. This section has moved dramatically, and shows multiple repair attempts. The footer is not adequate to withstand annual freeze-thaw cycling.

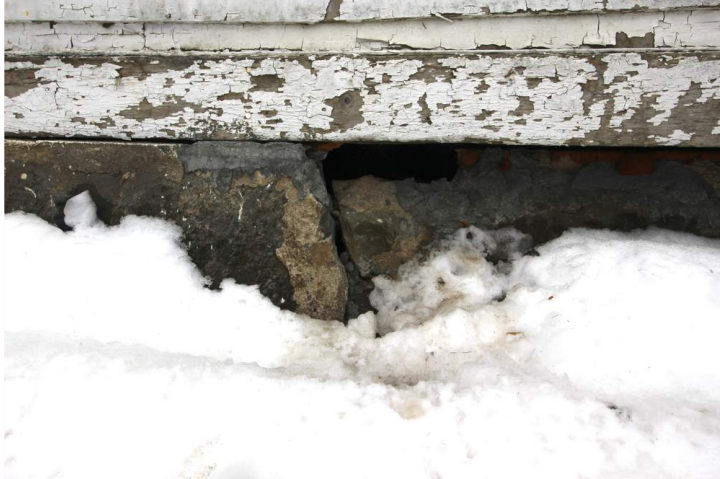
7

Despite mortaring attempts, this north eave foundation stone has tipped into the crawl space.

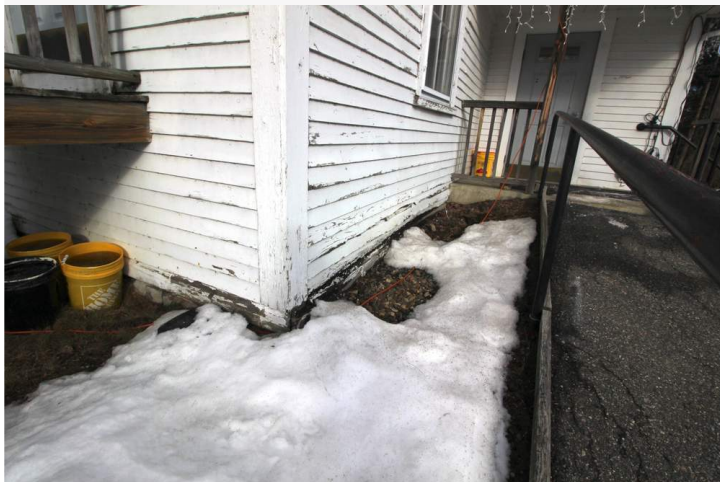
8

Behind the ramp, the grade pitches toward the building and directs rainwater under the building. Water and snow get trapped in the gully between the ramp and building.

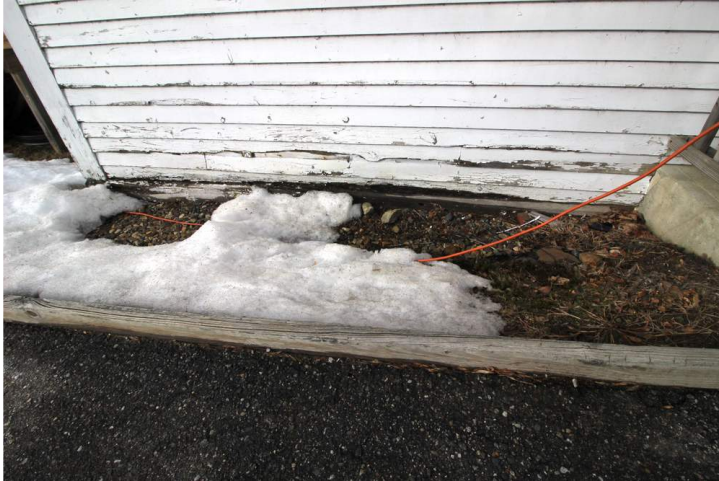
9

Consequently, the water table is showing signs of rot.

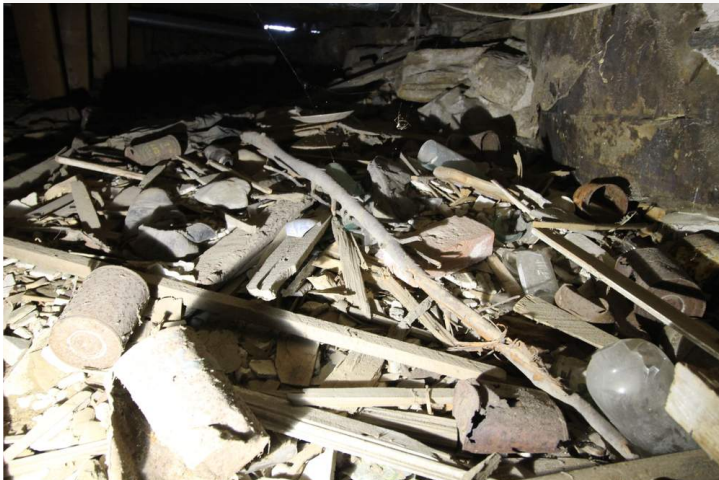
10

The crawl space is full of old bottles, debris, and broken glass. It will need to be removed, and some of the items may be of interest to a local antiquarian.

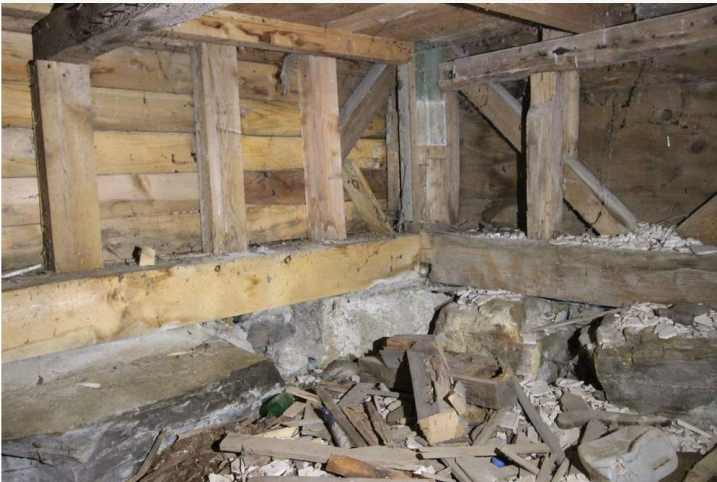
2

Southwest corner. A new south sill has been installed without engaging the undercarriage joinery. The new sill is about 3" narrower than the original sill.

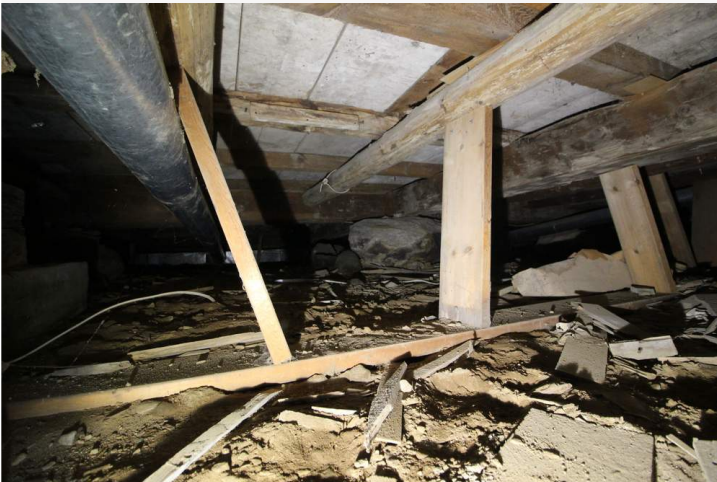
6

The log joists are supported at the midspan by little 2x8 kickstands. These stand on long 2x8s laid in the dirt, and are a temporary repair.

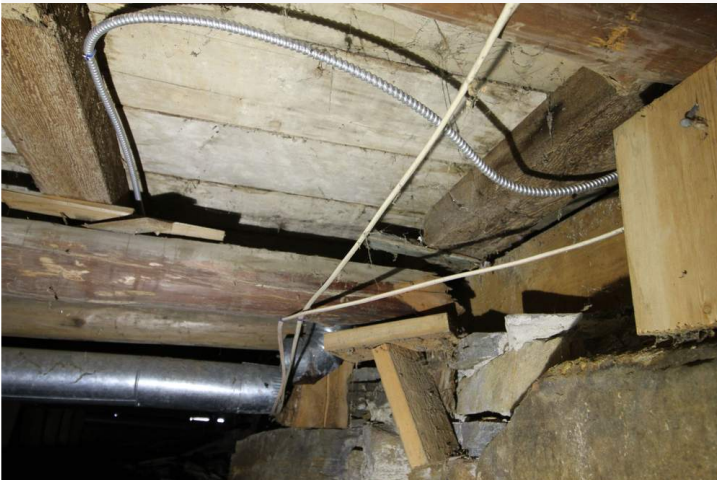
10

The ends of the log joists show signs of rot. They do not connect with the replacement sill.

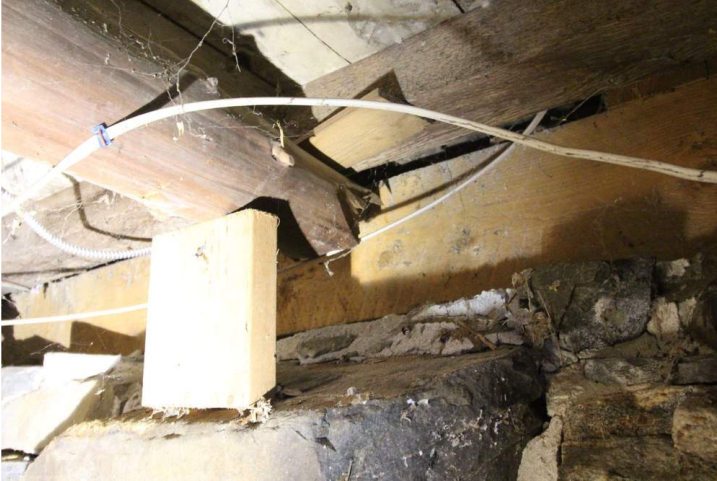
11

Another log joist end showing signs of rot, not connecting with the eave sill, and propped up on a rickety 2x8.

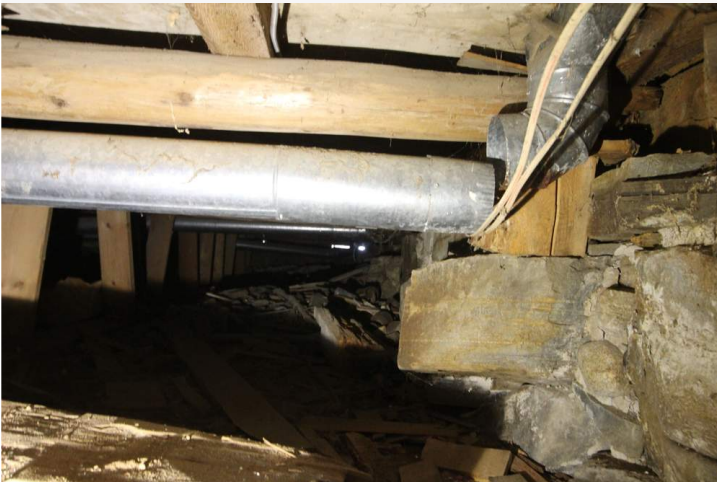
12

This duct work is disconnected. Ducts will need to be serviced.

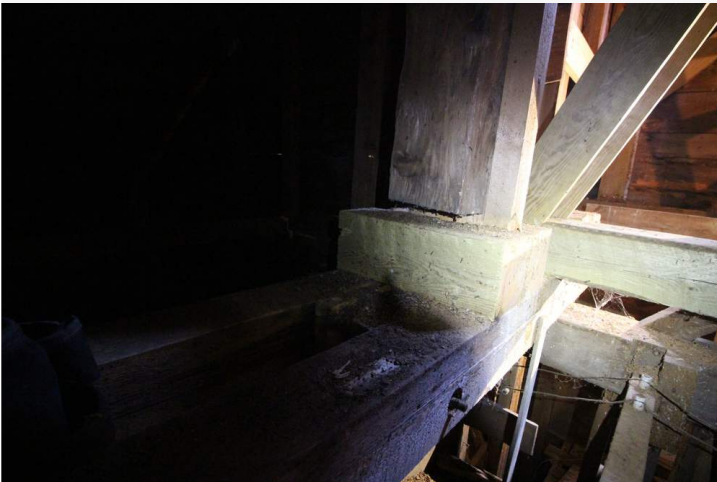
10

NW tower post, short blocks. The post is relieved on the rear face so that part of the bottom of the post foot is not in contact with the blocks.

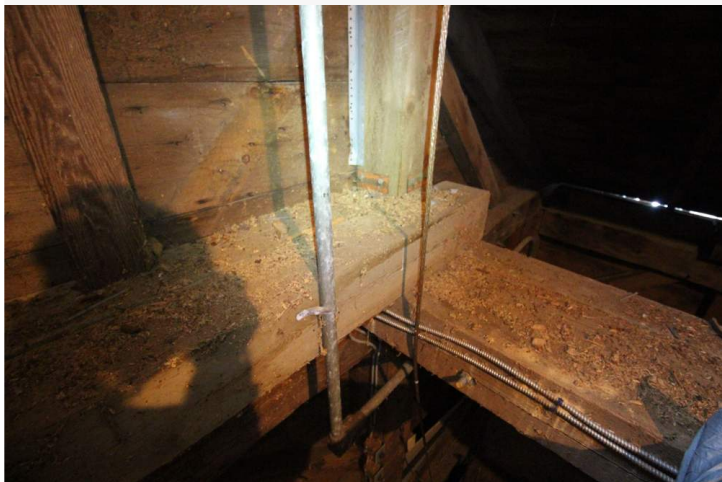
13

Front tower sleepers cross bed timbers and support SE tower post. The post has been severed and is secured to the sleepers with angle iron and lag screws.

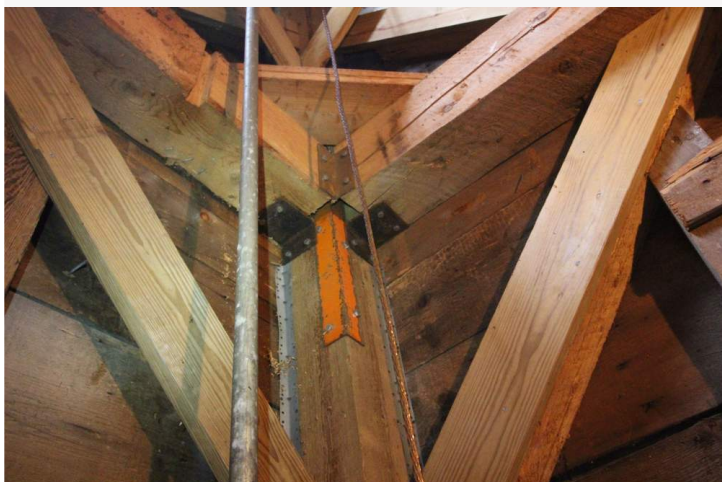
14

When the SE post was installed, all joinery was severed. Many of the tower girts were also replaced, and connected to the tower post with angle iron. Unfortunately, the tower posts were undersized, and there are significant gaps between the ends of the girts and the face of the tower post. These should be filled, and additional shear blocks installed.

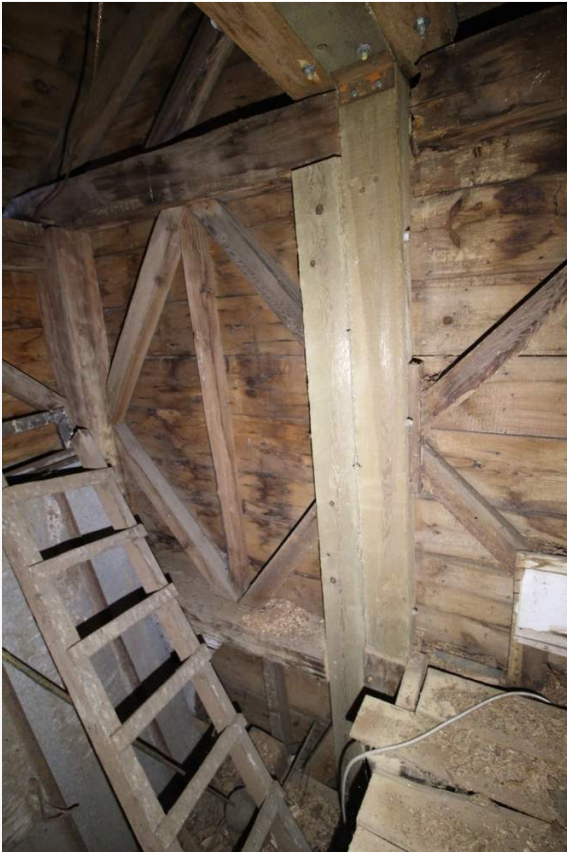
15

The NE front tower post was also replaced. This is the section immediately BELOW the bed timbers. The replacement section was butt cut and stacked upon the original post, it can be seen in the lower center of the frame. The joint is sistered with a new large 8x8 timber, which is through-bolted to the replacement section.

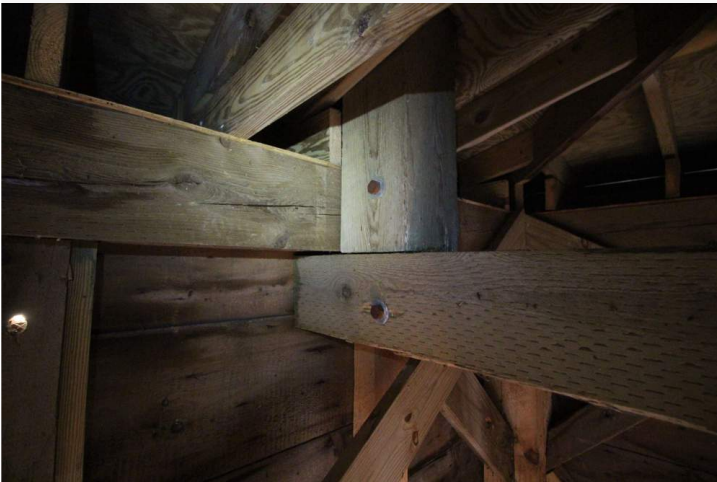
22

The belfry posts land on the belfry bed timbers, and are through-bolted. A section of angle iron crosses the joint on the opposite side. Everything is secured to the plates, but are the plates secured to the tower posts?

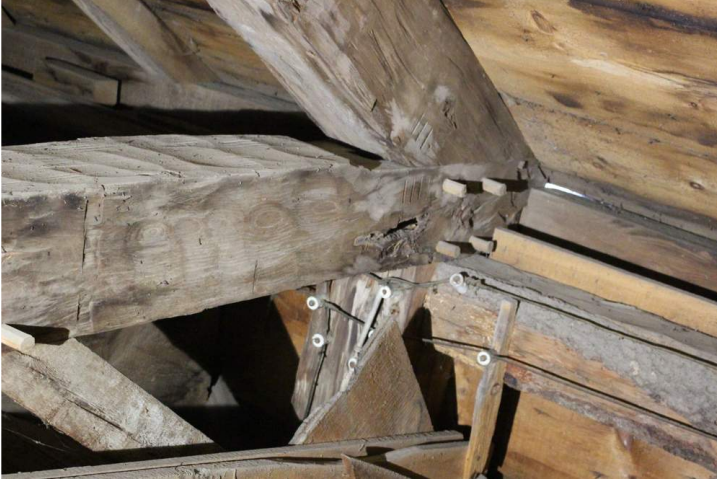
7

Bent 3, principal rafter and bottom chord. The north end of the bottom chord has a hole in the end that will require a face fix or other repair. The marriage marks indicate that the bents were originally numbered from rear to front.

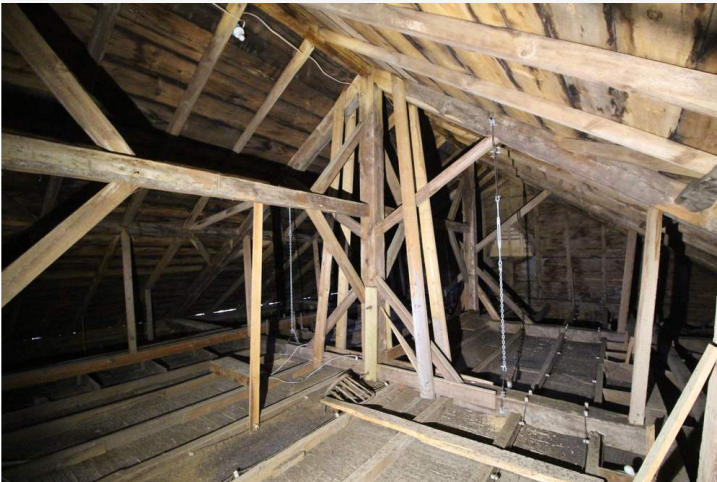
12

Bent 4 truss. The bent 4 bottom chord has suffered extensive water damage, and has been stabilized with 2x10 KD sisters and additional KD struts that sandwich both the upper chords and bottom chord. There are two additional chains that hang from the principal rafters and support the bottom chord between the king post and the eave plate.

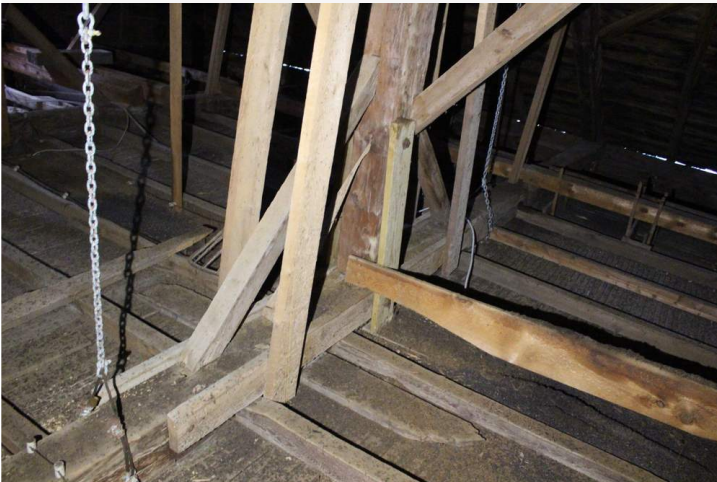
14

Bent 4 truss. The bottom chord, like the rest of the attic, is covered in bat guano.

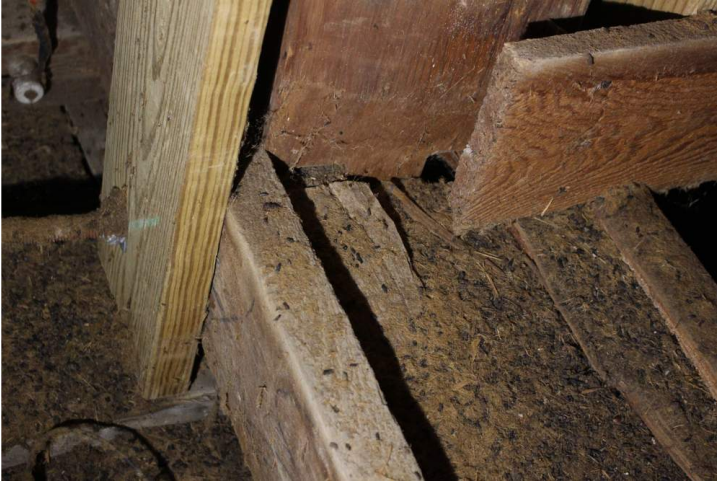
15

Bent 4 truss. There is extensive rot inside the king post mortise.

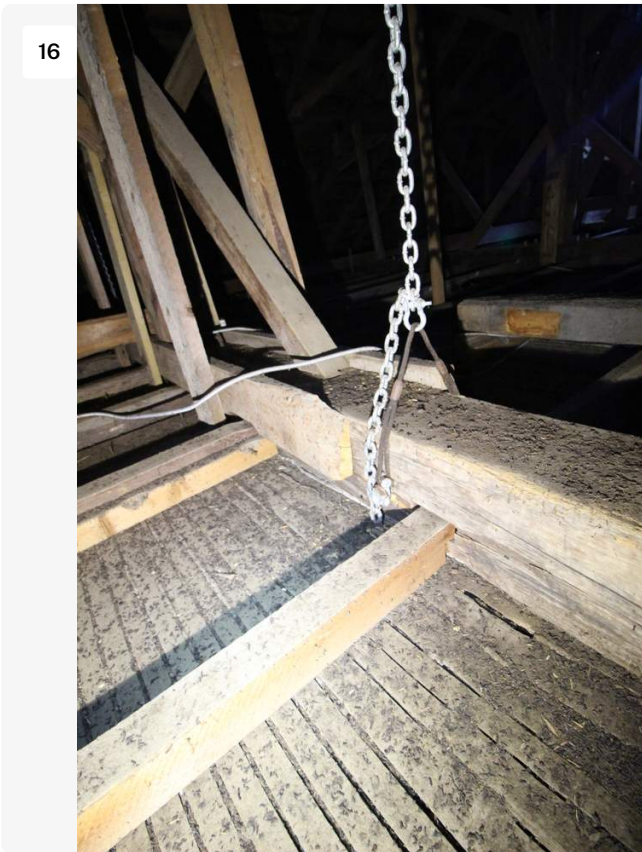
16

Bent 4 truss. Past the sisters, the bottom chord is picked up with a chain and cable, between the king post and the plate.

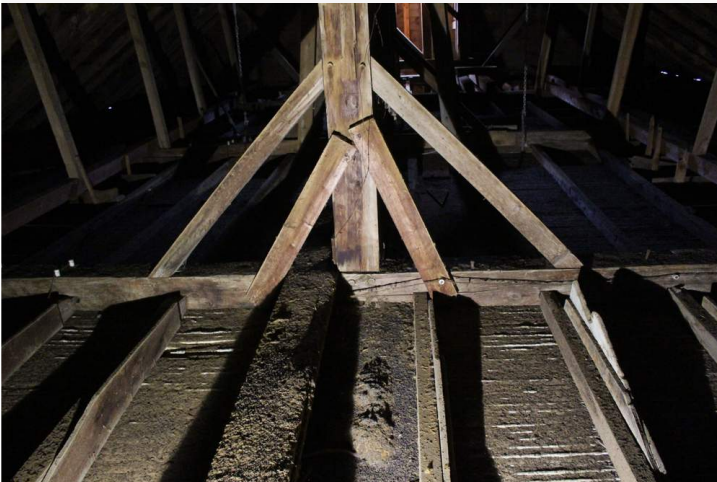
20

Bent 5 truss. The bottom chord is also rotted directly beneath the king post. Two gussets have been added to stabilize the bottom chord, but this is not a long-lasting repair.

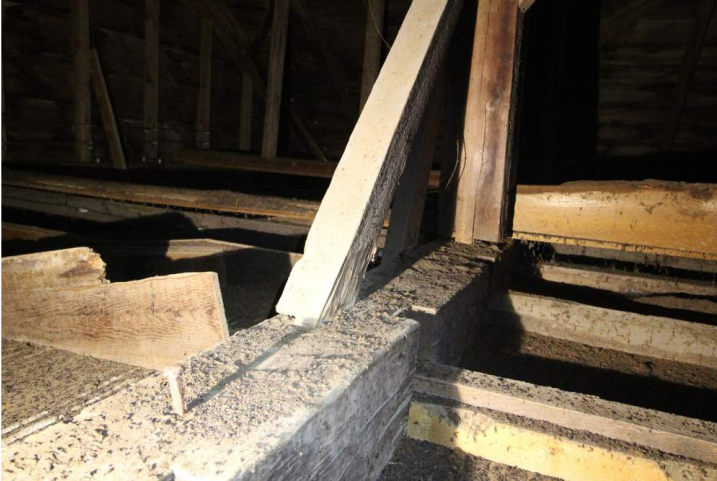
21

Bent 5 bottom chord and king post connection. The bottom chord has separated from the king post and the descending braces. There is rot in the king post mortise.

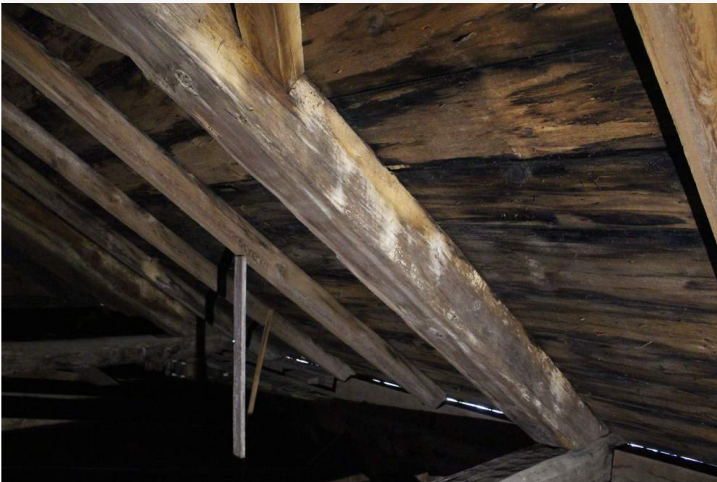
24

Bent 5 south rafter. The Bent 5 rafter shows significant water staining.

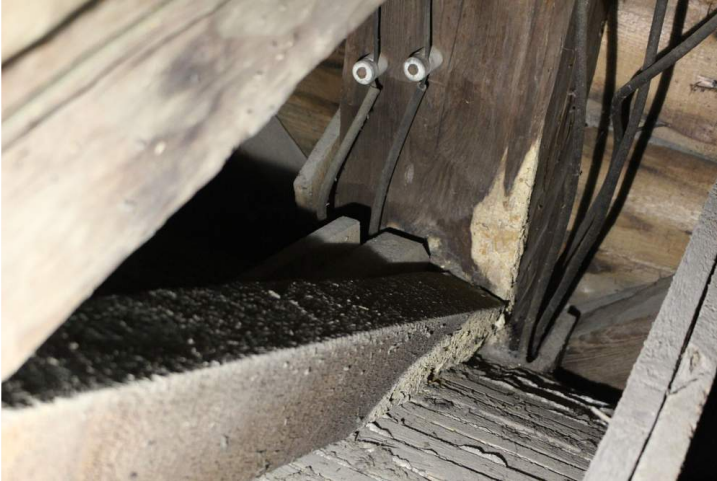
25

Bent 5, south post. The south post is moldy at the intersection with the ascending brace. Both the brace and post will need to be repaired.

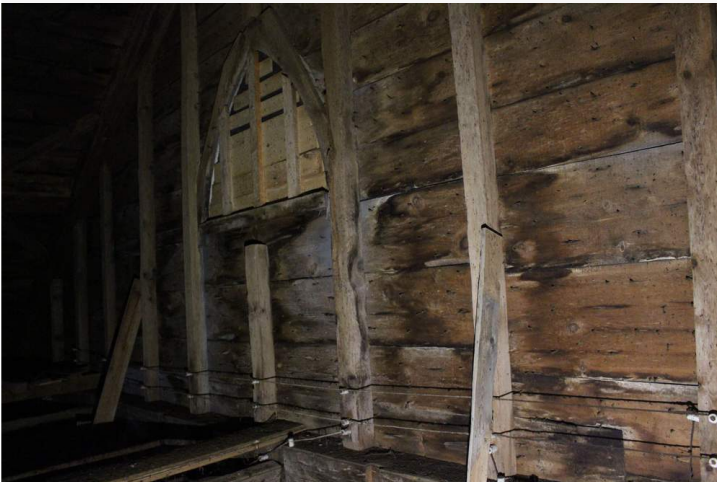
28

The bent 6 sheathing is badly water stained.

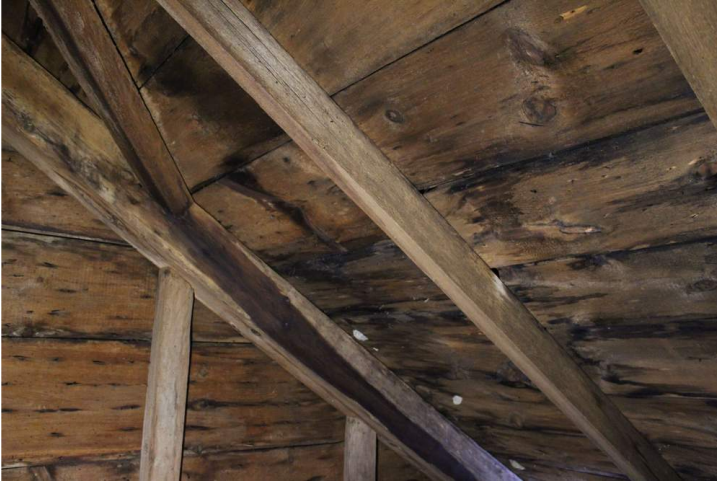
29

The north rafter in bent 6 also shows extensive water staining. We anticipate it will need to be repaired.

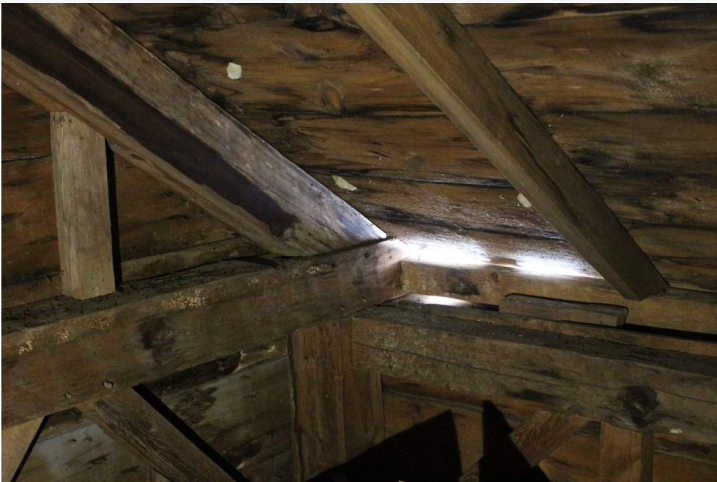
30

The north end of bent 6 is quite open at the cornice.

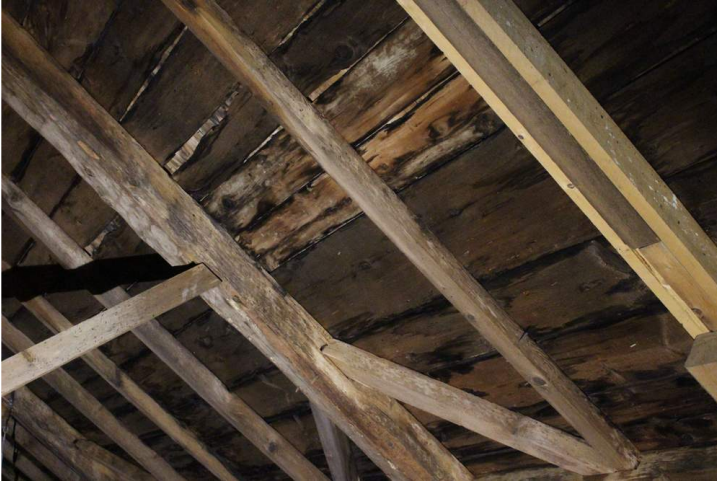
3

The sheathing shows extensive damage and water staining, not all of it recent.

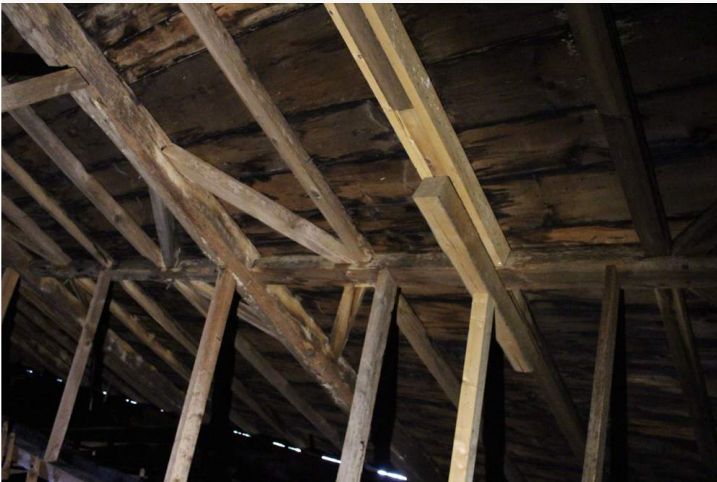
4

Bent 5 rafter shows significant water damage, and a common rafter in the bay behind it has rotted through and been repaired with gussets and a bolster.

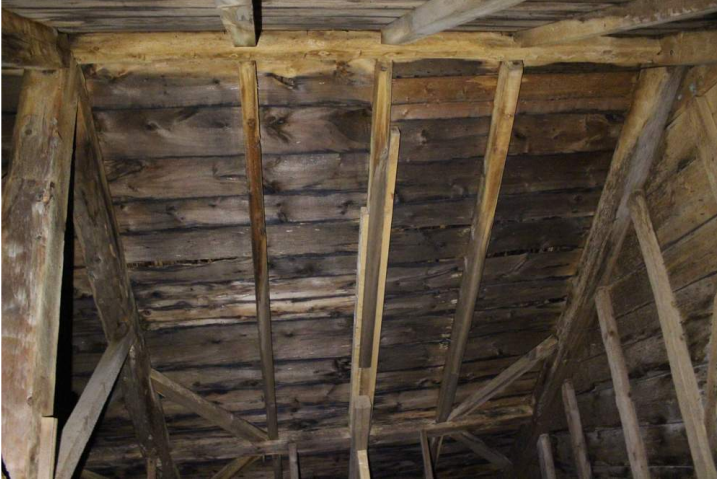
5

The attic is full of bats and their guano. Bats have many benefits, but their guano mixed with any amount of water can damage timbers.

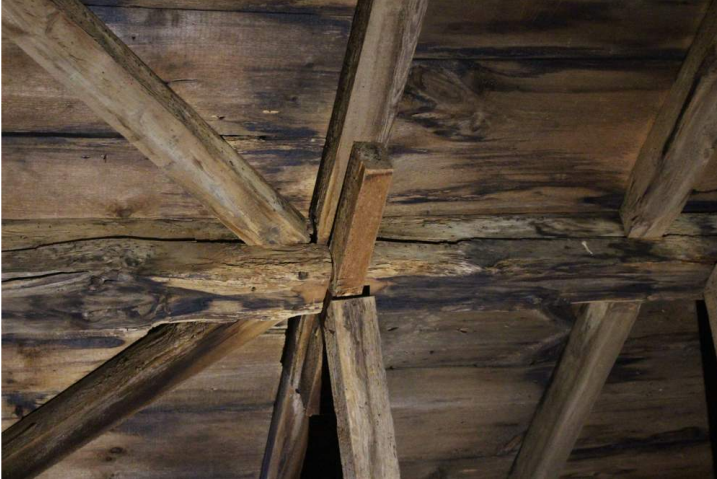
7

This principal purlin has been severed at the first common rafter, and will need to be replaced.
