BOWDOINHAM RECYCLING CENTER

Public Meeting: 9-8-2020

Existing Building Analysis

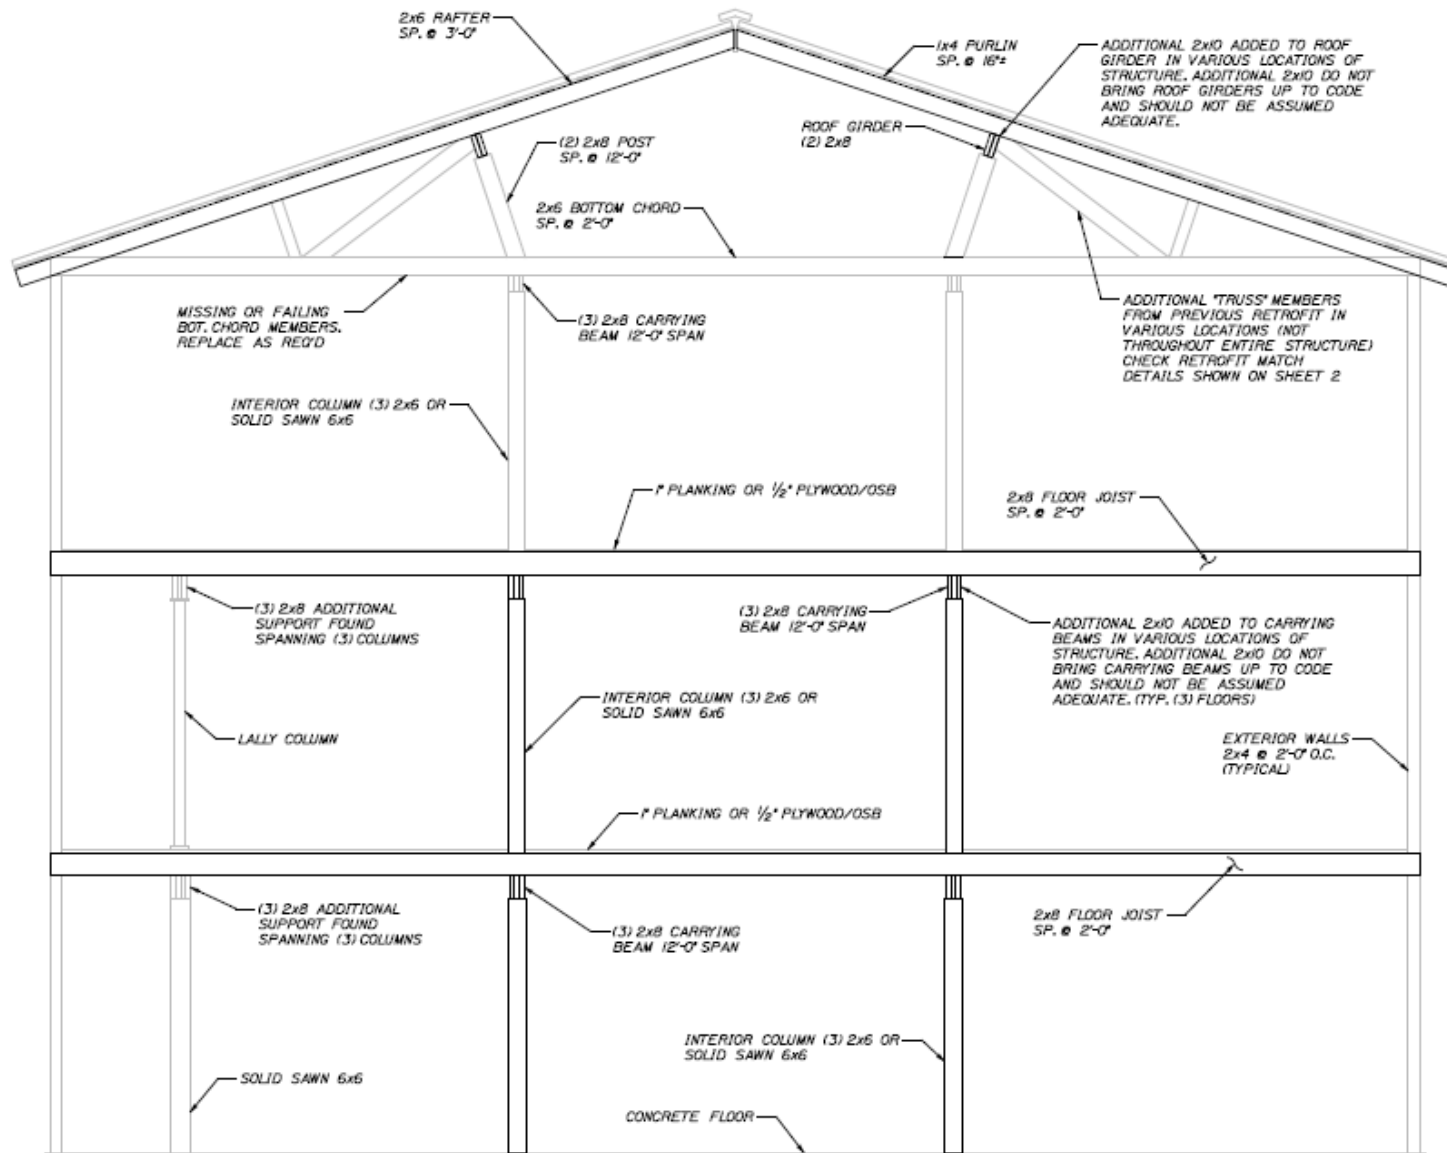
TYPICAL SECTION ~ LOOKING AWAY FROM THE ROAD

1/2" - 1'-0"
 NOTE: MEMBERS IN BOLD ARE UNDERSIZED AND NEED RETROFIT TO BE ABLE TO SUPPORT DESIGN LOADS

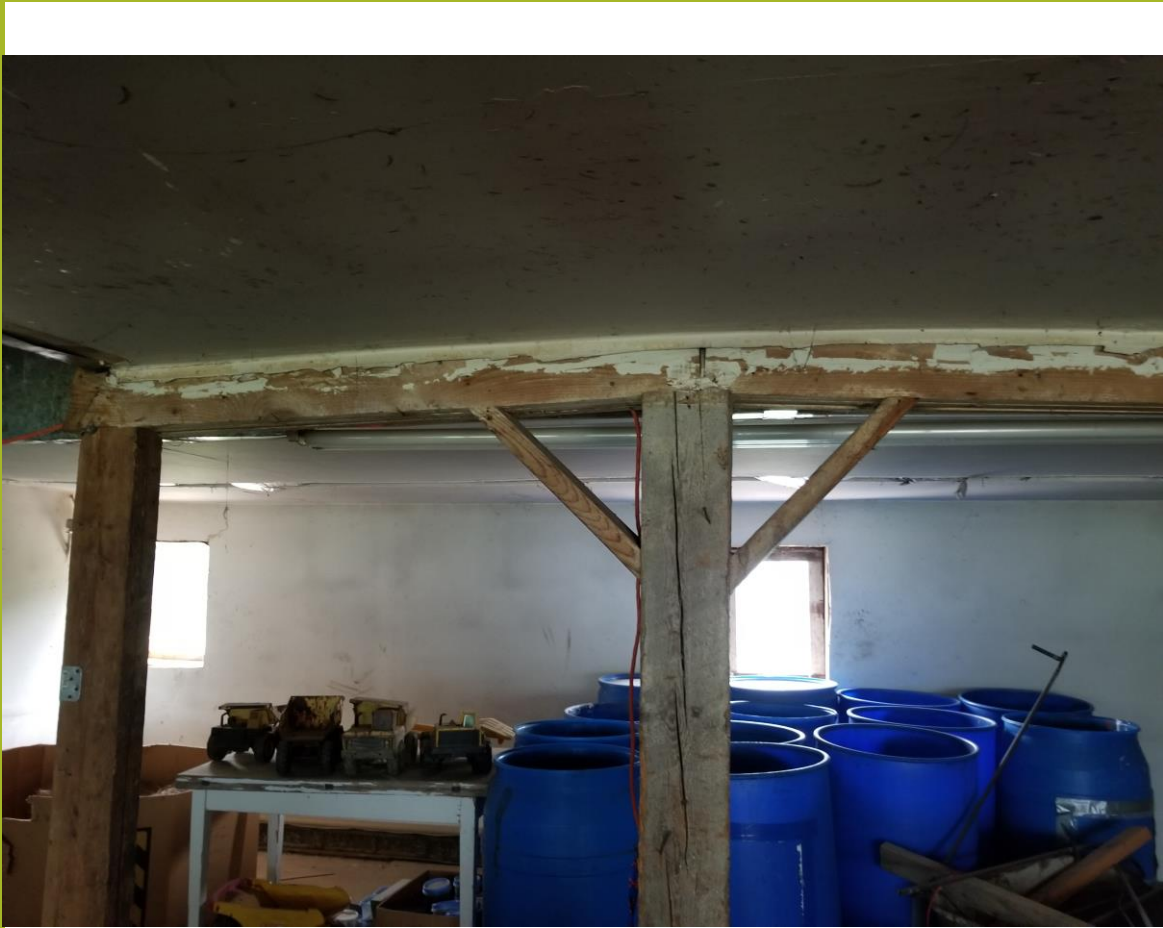
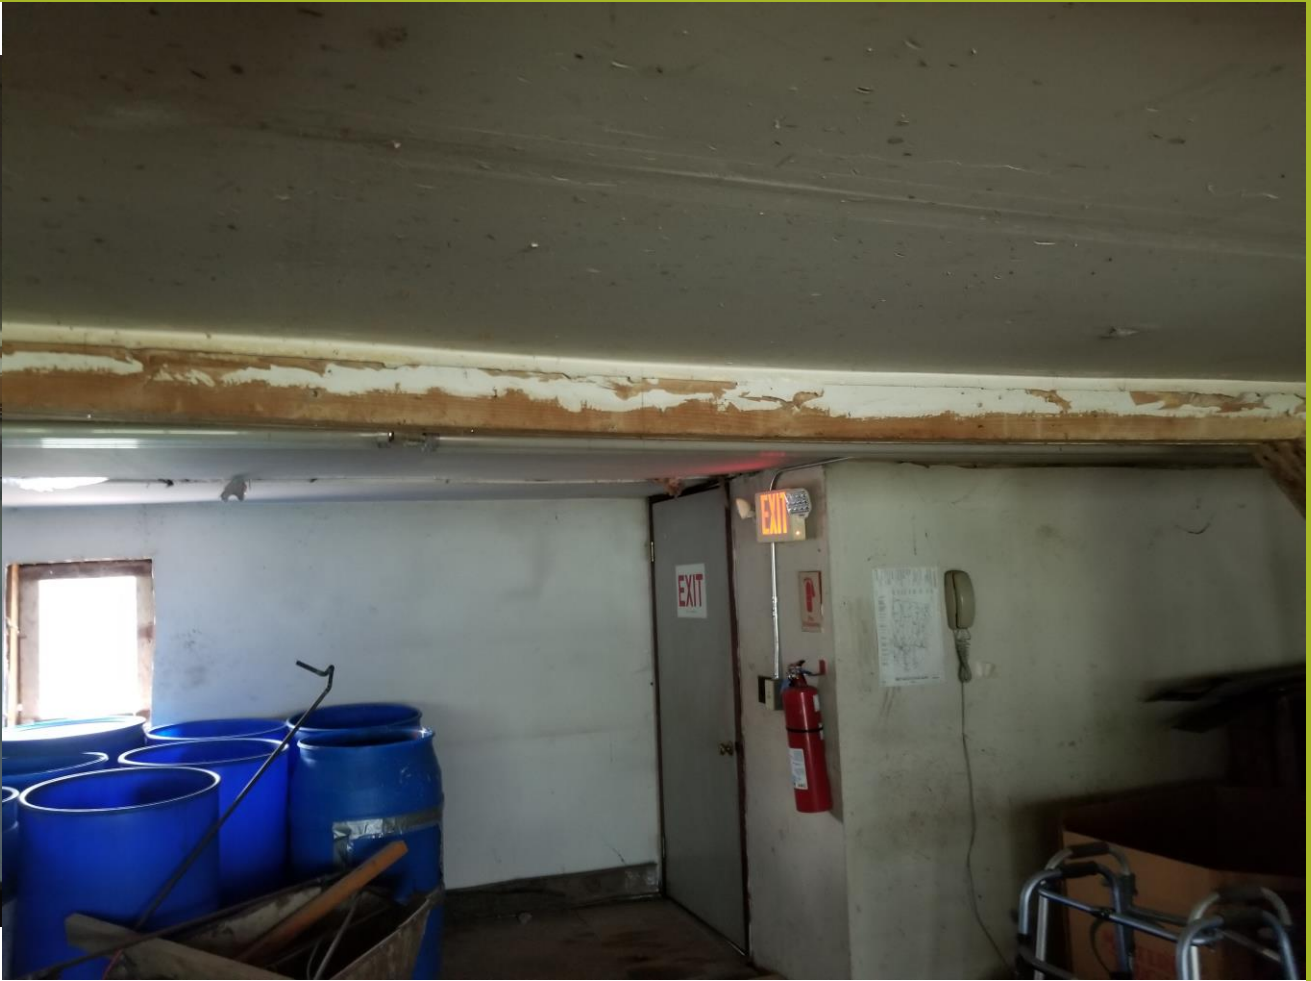
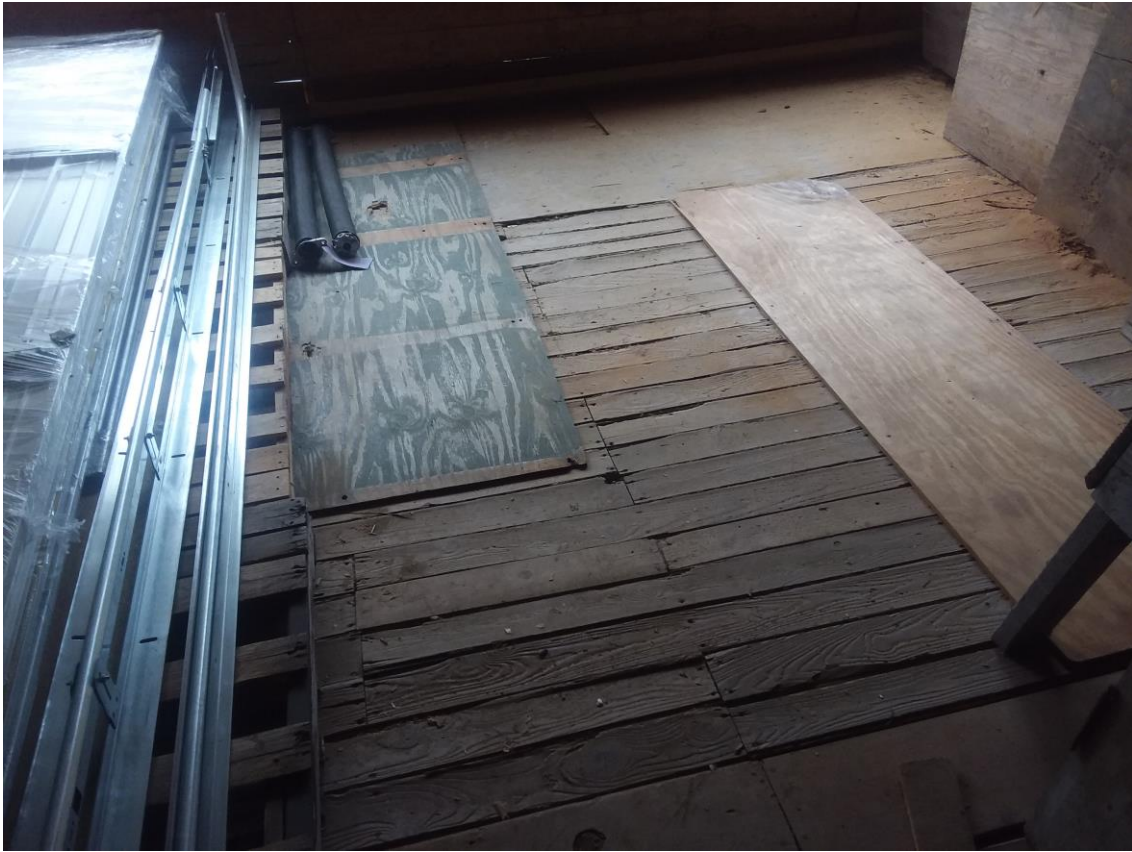
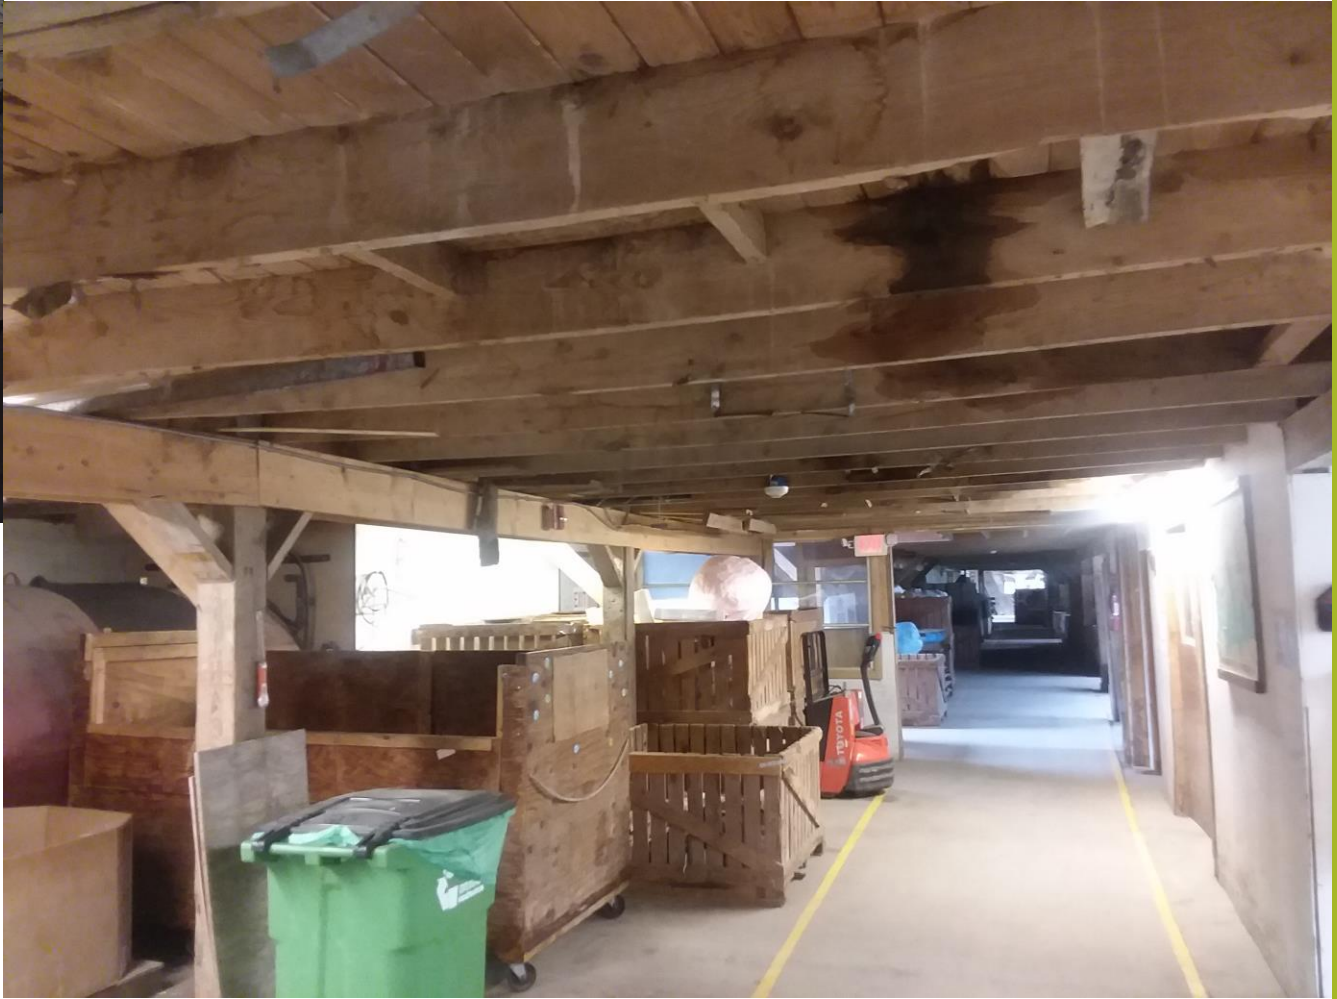
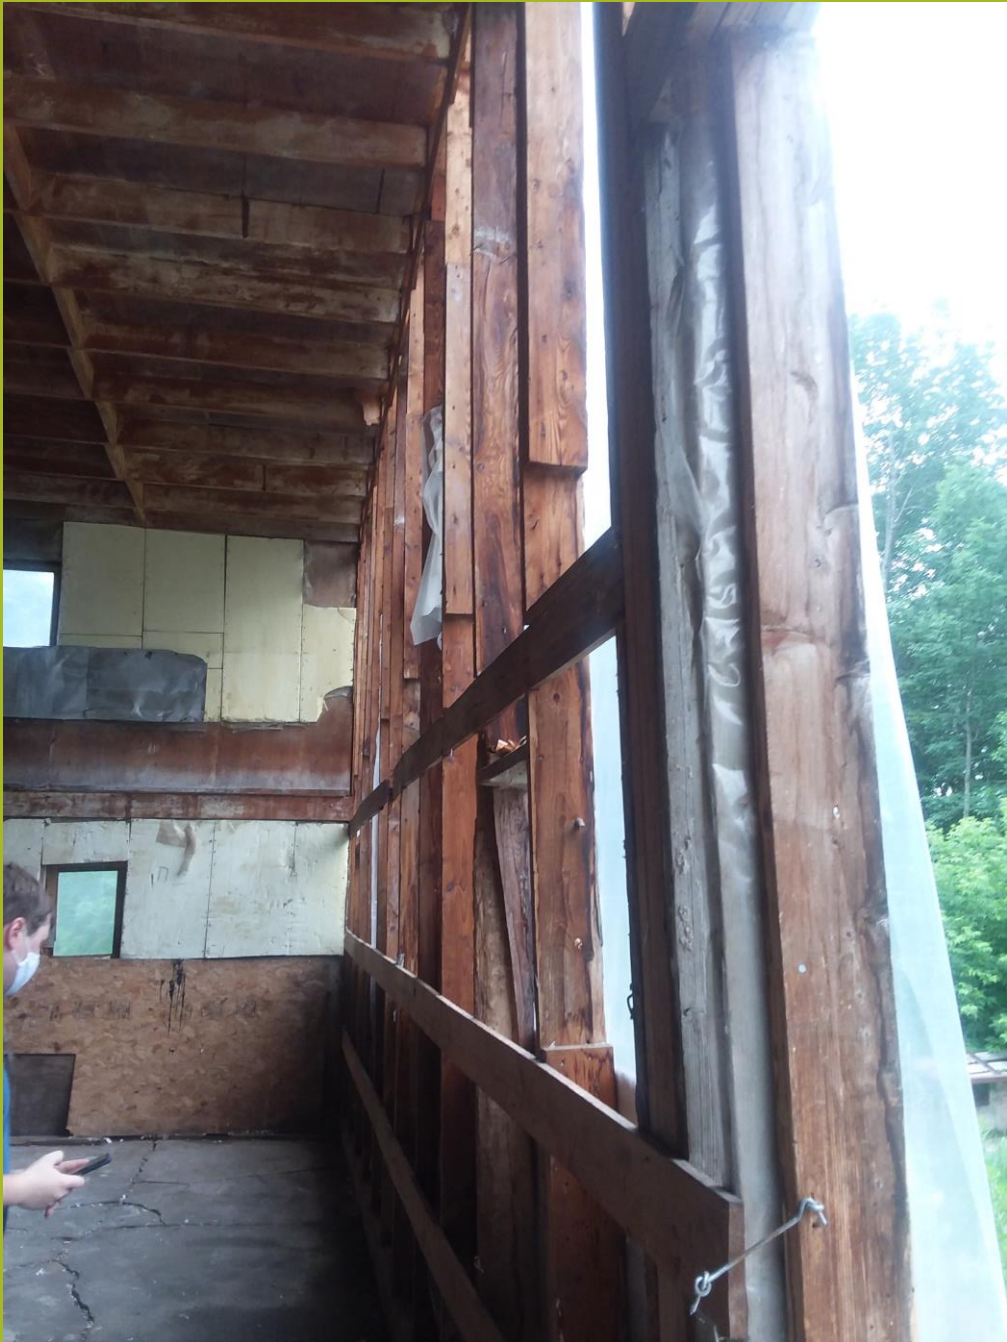
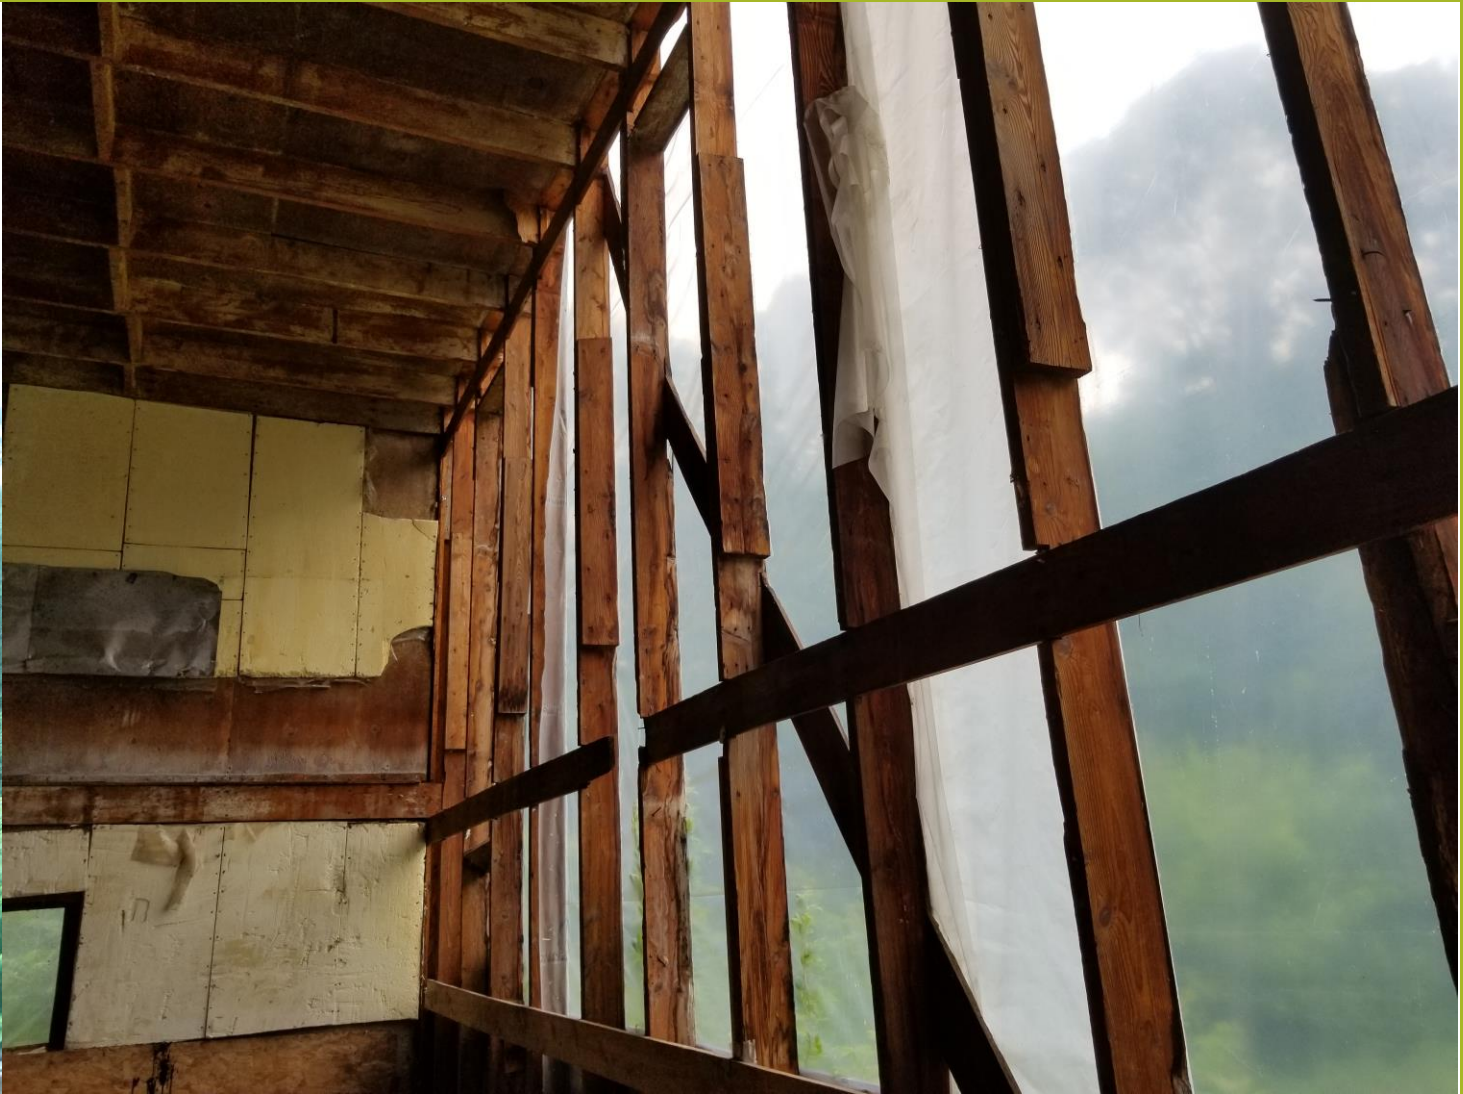
- These repairs are necessary because the building is unsafe in its current configuration.
 - The roof, the existing flooring, the floor joists and beams, and the columns supporting floors 2 and 3 are undersized to carry the required storage loading.
- The overloading of these members has caused noticeable deterioration of the existing structure
