# **STRUCTURAL BARN EVALUATION**

**243 POST ROAD  
BOWDOINHAM, MAINE 04008**

Inspection Date: September 25, 2020

Project No. 20-0377-ME

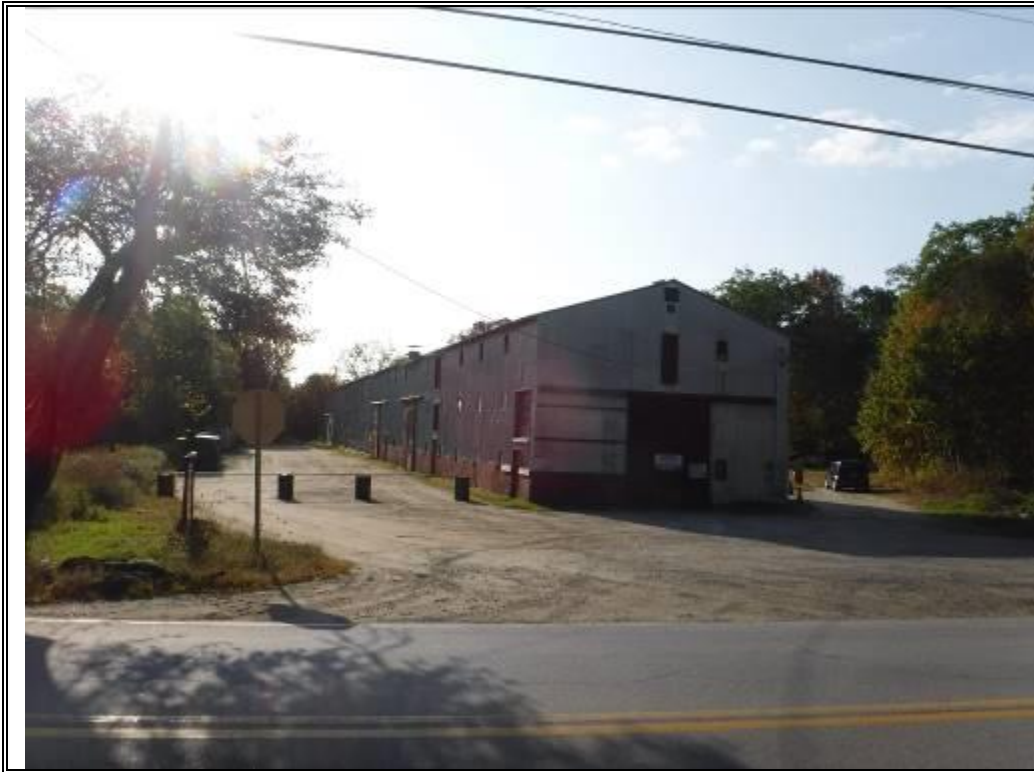
**Photo Number**  
**1**

**Description:**  
North and West  
Exterior

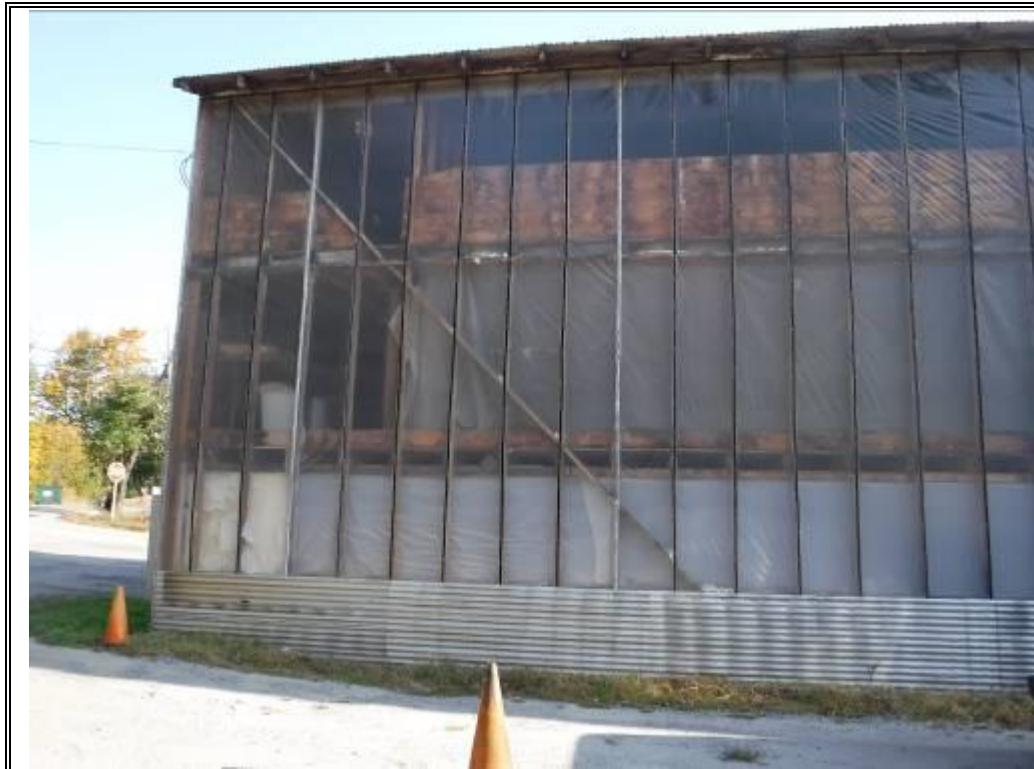
**Photo Number**  
**2**

The south wall of the building is sheathed with plastic sheeting stapled to the studs. Some limited diagonal braces have been let into the wall for the full height of the wall. I recommend that the building be fully evaluated and that parts of the wall be sheathed and fastened as needed per the evaluation. The sheathing would need to be fully attached to bring the shear loads from the roof framing down to the foundation. We discussed installing the sheathing on the inside; this would involve some complications to the wind design analysis. A better solution still allowing the solar gain may be to install the sheathing to the outside of the studs and then install a Trombe-wall type collector to the outside of the sheathing.

**Description:**  
West End of South  
Wall  
Note Let-in  
Bracing, Plastic  
Sheathing

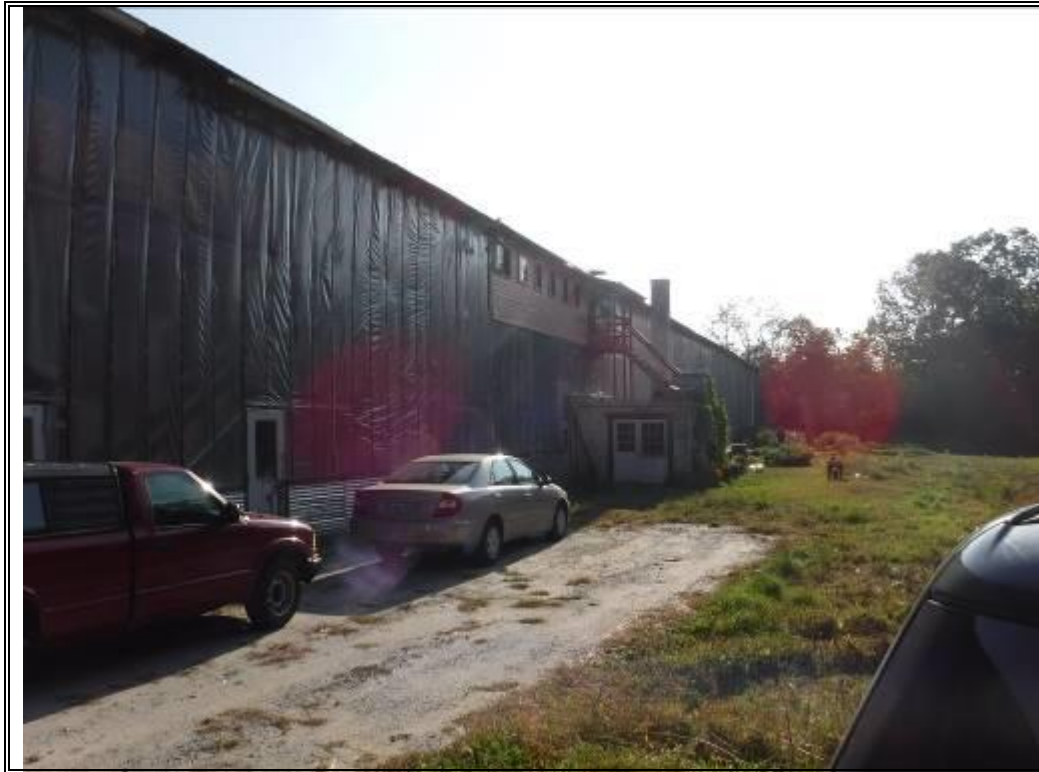
**Photo Number**  
**3**

**Description:**  
South Exterior,  
Apartment is at the  
3<sup>rd</sup> Floor

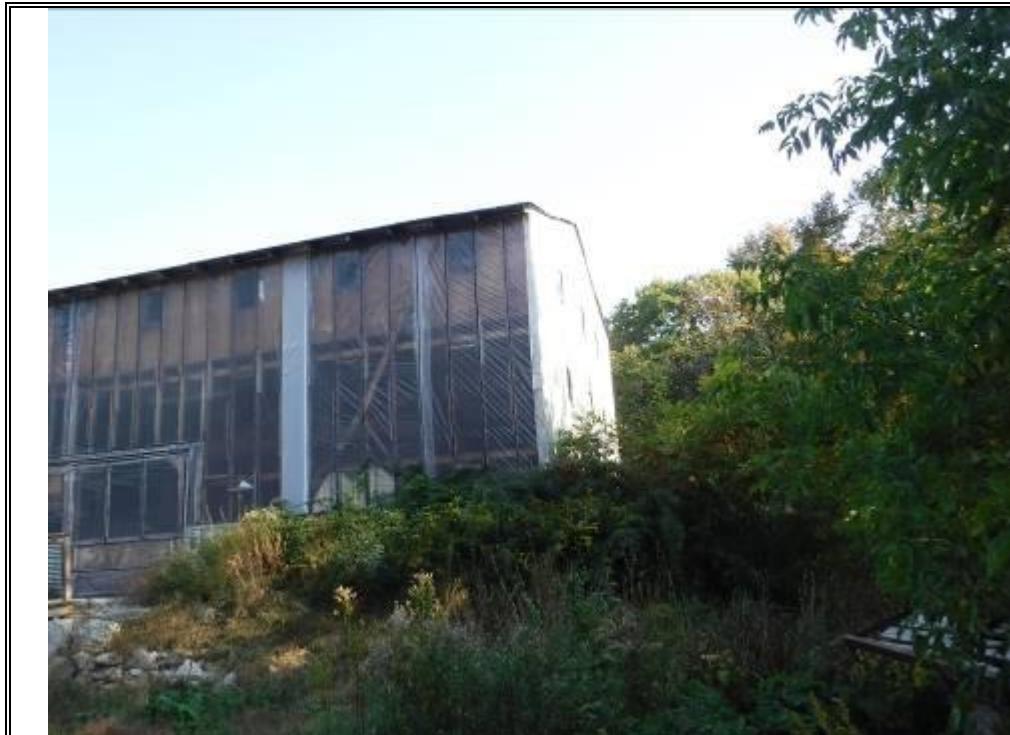
**Photo Number**  
**4**

**Description:**  
East end of South  
Wall, East Exterior

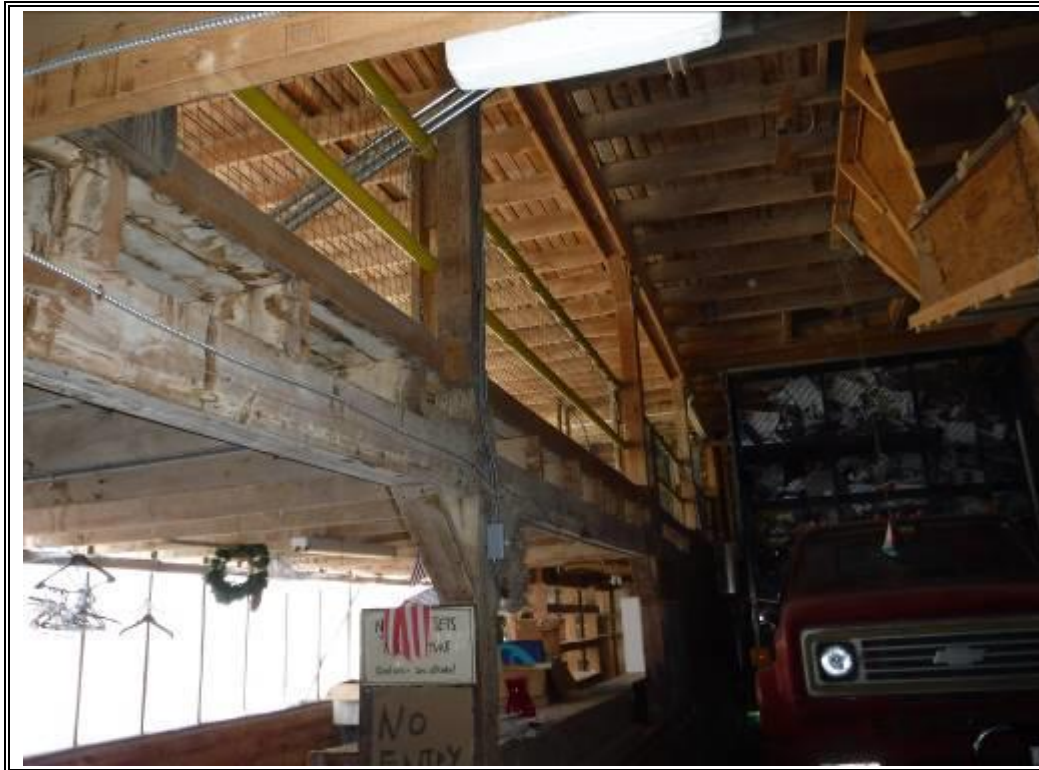
**5**

West end bays with third floor roof hatch for truck loading

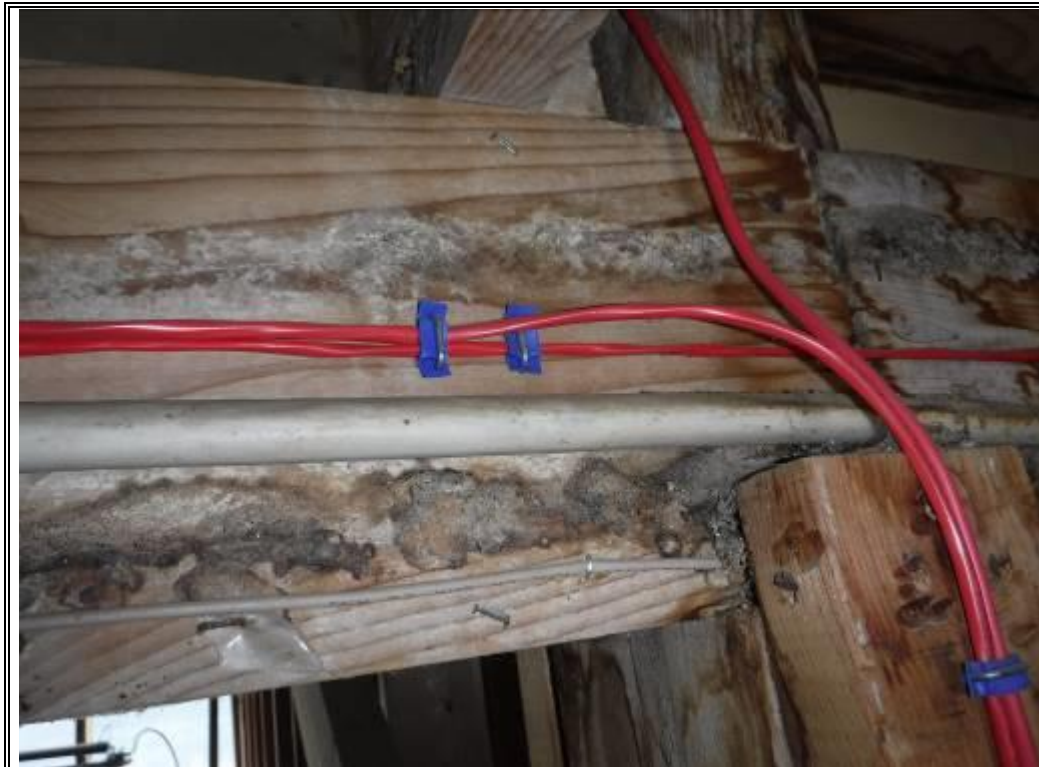
**6**

chicken pee debris on location of previous power lines

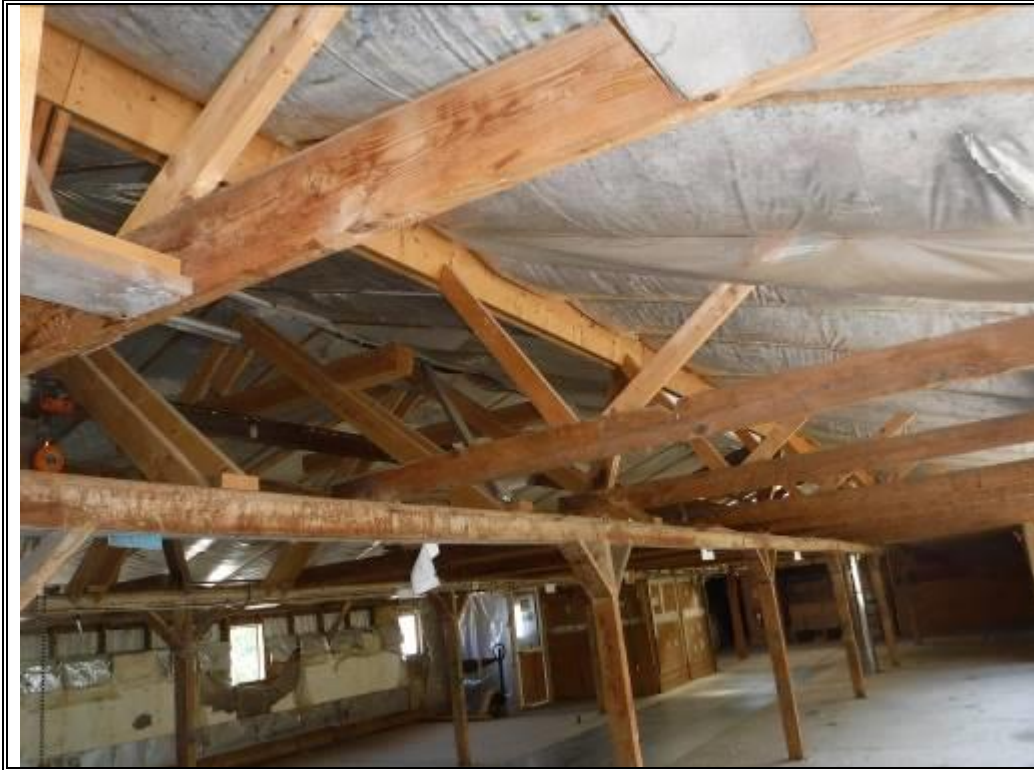
**Photo Number**  
**7**

The calculated load on the third floor at the west end should include 5 psf of added dead load for the 1/8" steel plate. The live load for this area should be planned for the expected weight of the bales handled, and the weight of the pallet jack. Assuming a pallet jack weighing 200#, and a bale of materials handled at not-to-exceed 1000#, and multiplying by a factor of safety of 1.2 (20%), with a pallet being 4'x4', gives a floor live load rating requirement of 90 psf for the west end in the center and north bays. The floor joists, floor sheathing, beams and posts should be upgraded to handle this amount, down to the floor slab, but only in the area where this load occurs.

**Description:**  
southwest end 3rd  
with pallet jack,  
insulation at roof  
framing

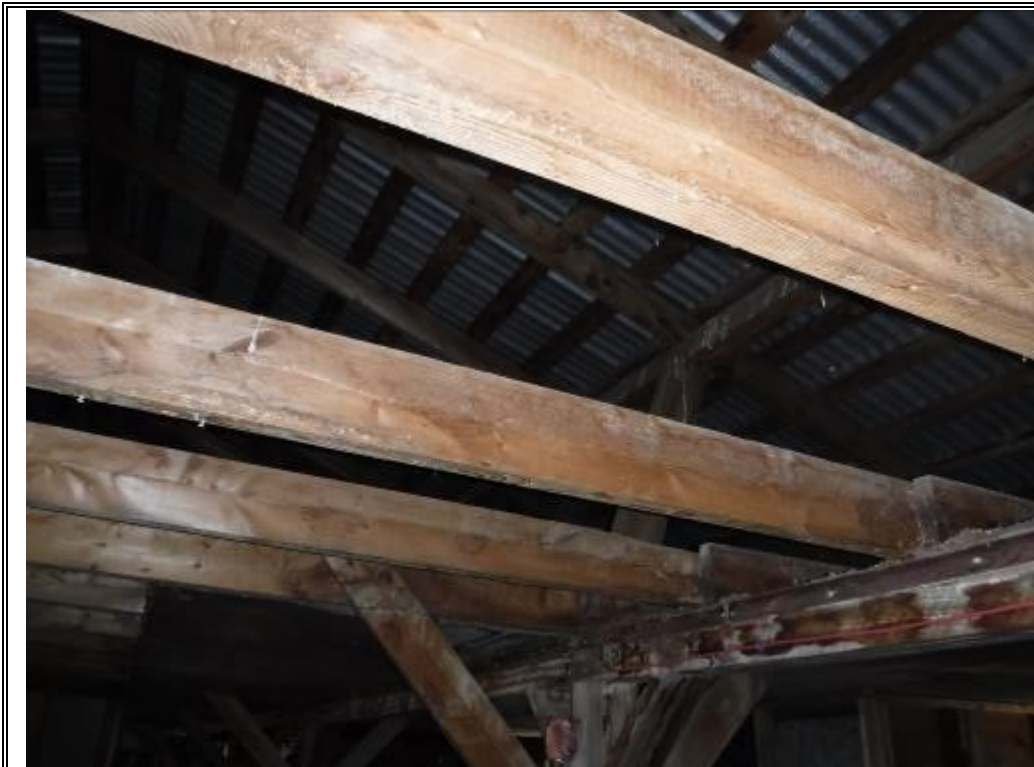
**Photo Number**  
**8**

**Description:**  
typical roof  
framing no  
insulation

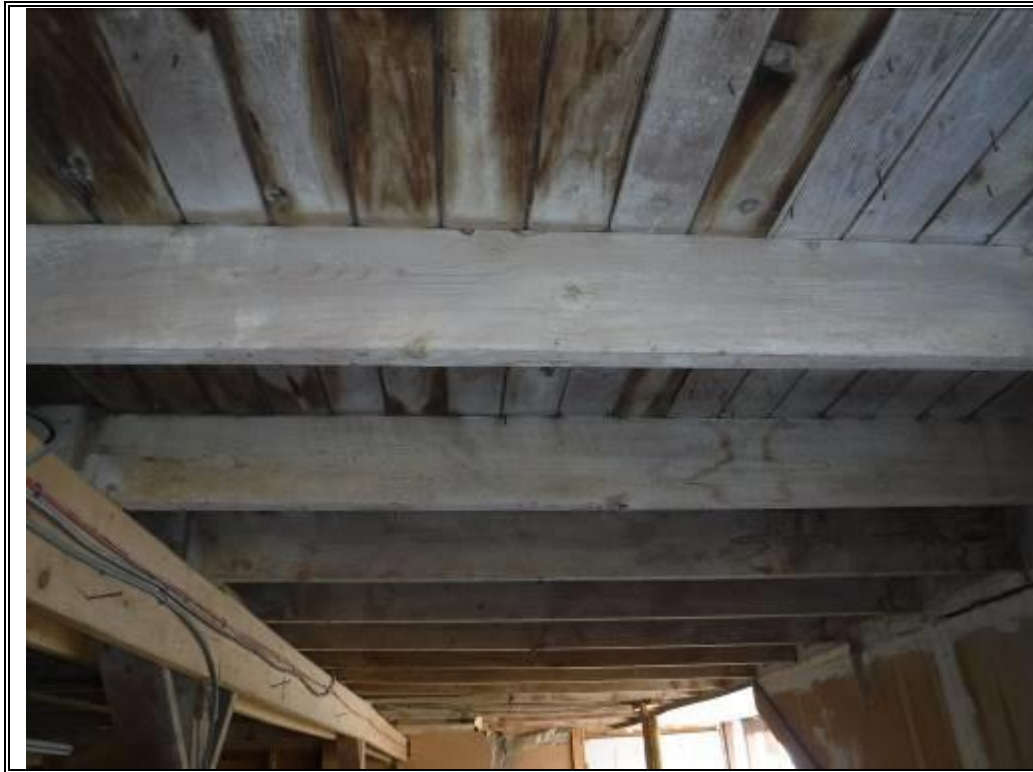
**Photo Number**  
**13**

**Description:**  
typical joist and  
floor sheathing  
condition

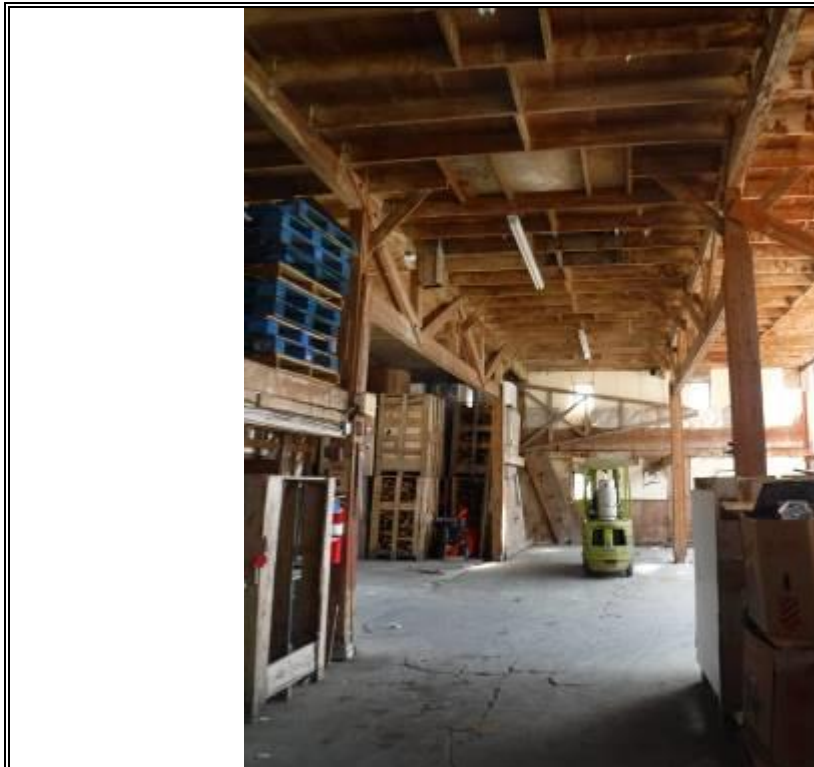
**Photo Number**  
**14**

**Description:**  
south bay with  
second floor  
removed and  
added trusses  
taking column  
loads

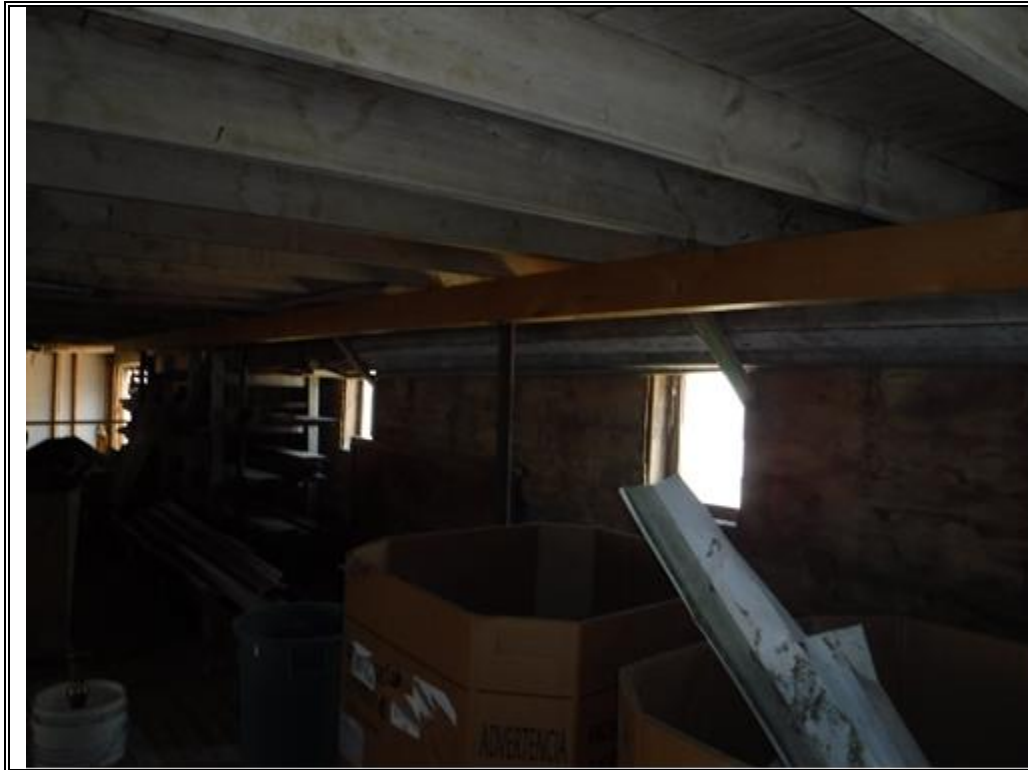
**Photo Number**  
**15**

**Description:**  
added beam to  
support third floor  
north bay

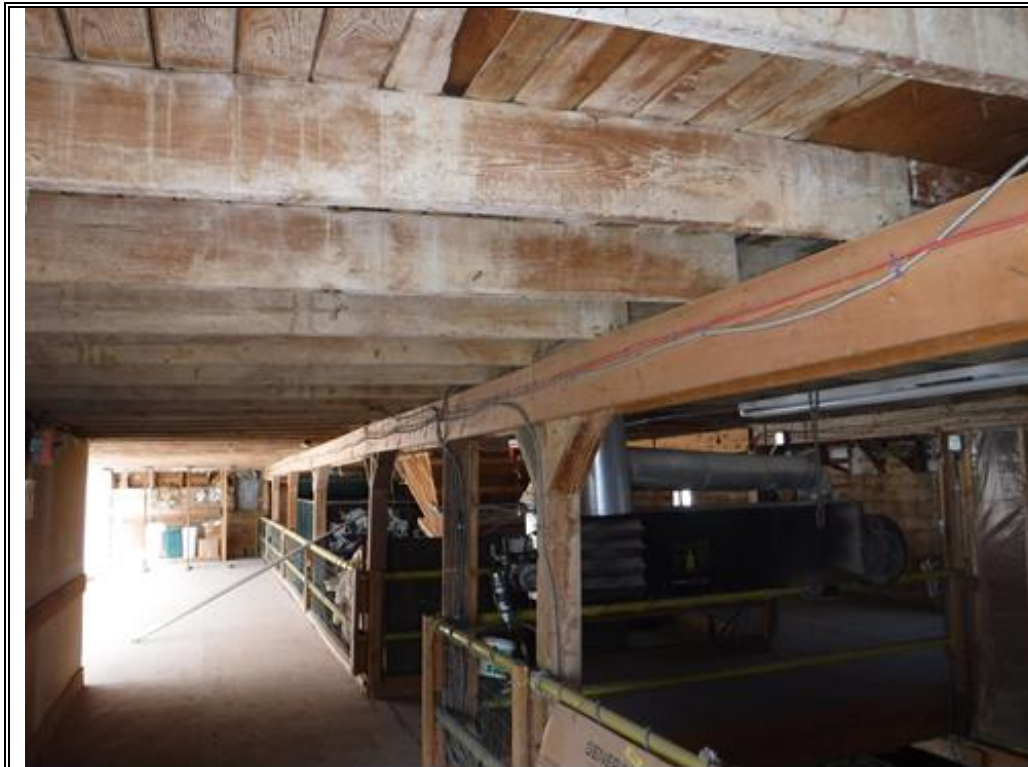
**Photo Number**  
**16**

6. The original interior wood beams have some deflection at the center of the spans for most of the beam spans. Some beams have been reinforced by sistering a 2x10 on each side of the beam.

**Description:**  
typical floor  
framing, with  
beam supporting  
joists strengthened

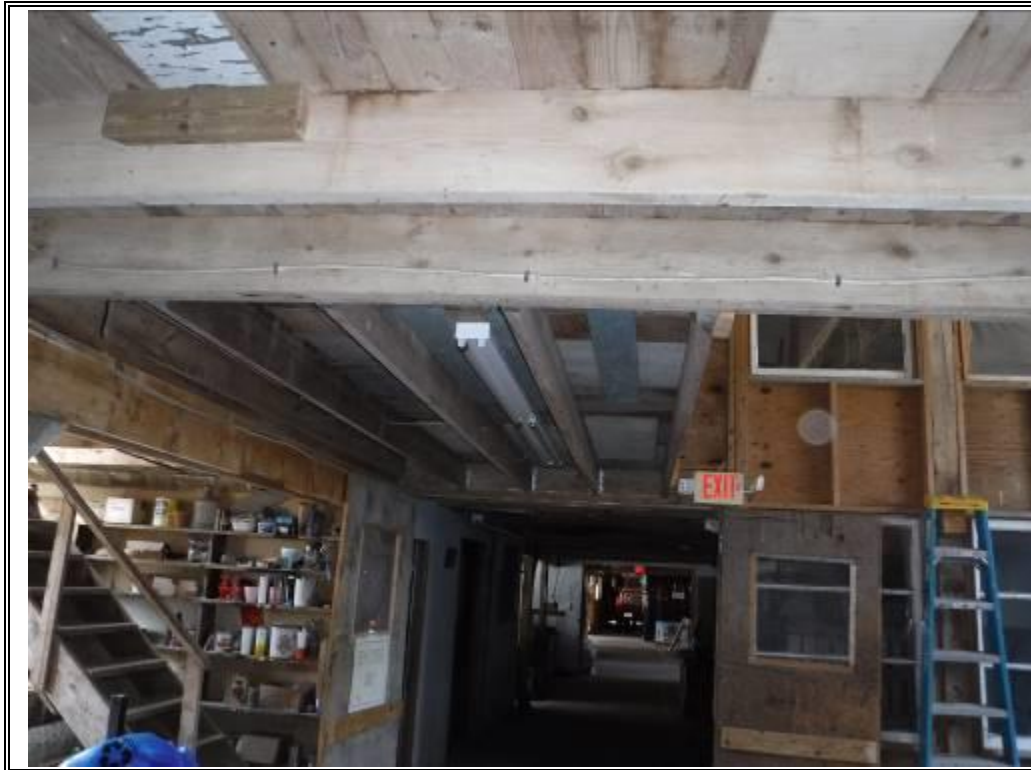
**Photo Number**  
**17**

**Description:**  
area of second  
floor should be  
checked
