November 22, 2010

ADP #10198

Re: Public Works Garage Roof Evaluation

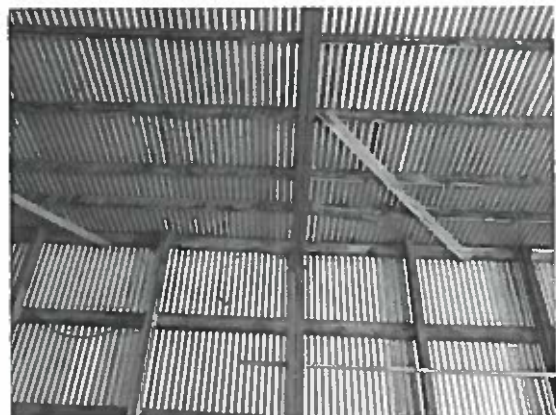
Warning: Some of the steel frame bracing is missing or disconnected. Without the bracing being fully restored, this building is in jeopardy of collapse. I strongly urge the Town to have repairs made immediately before significant snow accumulations.

1. Several frame braces have been cut disconnected or otherwise missing. These diagonal and horizontal member braces are critical to the performance of the structure. Our structural analysis assumed they were all in place and properly connected. Without all of the bracing reconnected, this building roof is in jeopardy of collapse. The photo to the right shows a missing brace and a broken purlin.
