Air Quality Management Services, Inc.

Re: Mold & Asbestos Assessment at 8 River Road property in Bowdoinham, Maine.

AQM Project #: 25-846

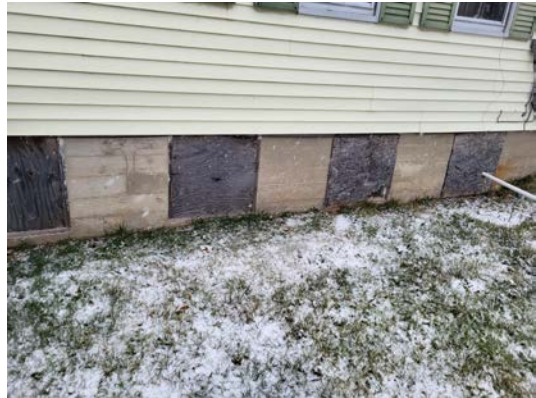
Degraded window coverings on foundation

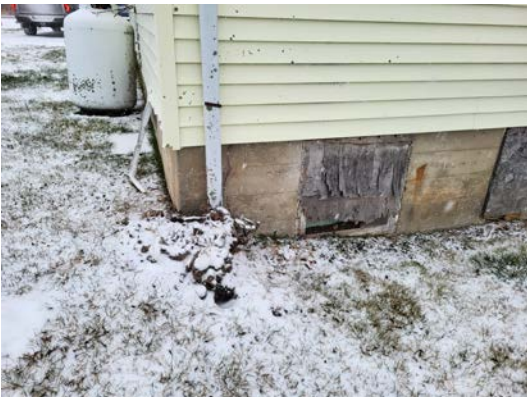
- Gutters are present on each roof line, however downspouts appear to deposit water along and at foundation, therefore water from these downspouts may leak into Basement.

Downspouts appear to deposit water along foundation

- Consult a Professional Engineer or a competent qualified contractor to control groundwater intrusion into the Basement and/or prevent saturated soil surrounding the foundation / slab by: installing exterior foundation perimeter drainage, sloping the ground away from the foundation / slab 5% (6" for every 10'), installing gutters (If gutters are to be installed ensure they are kept free of debris and the downspouts direct water well-away from the foundation), and water proofing the foundation walls or utilizing other like systems. May consider installation of sump (fitted with pump) in the Basement.

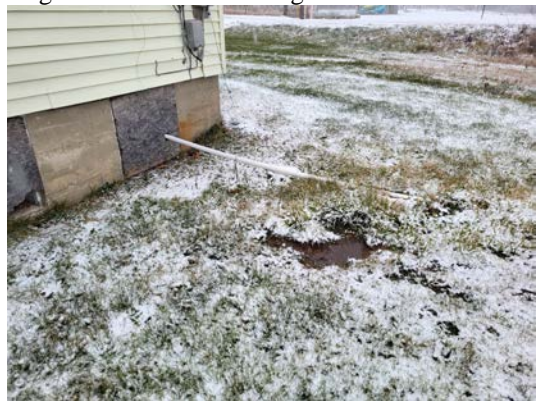
- Water is pouring into the Basement through foundation wall. Water is pooling in the Basement. Some water is draining into sump and pumped out.
 - Where water is pumped (rear side of Building), water is saturating ground therefore potentially draining back into Basement.

- In this case, the ground around this Building appears very saturated and AQM observed a stream of water leaking in the Basement. It may take considerable effort to control water from entering the Basement, such as excavation and water control systems (weeping drain and foundation water proofing).

Saturated soils on rear of Building

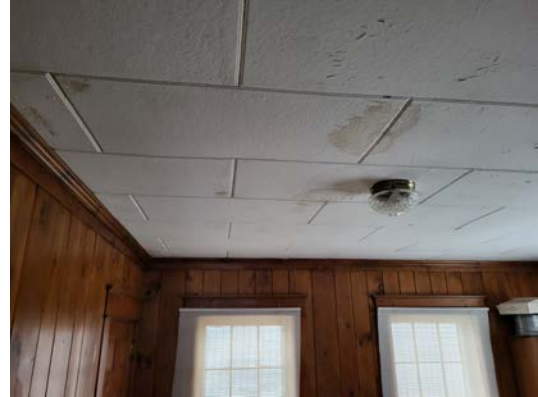
- AQM observed numerous water stained ceiling tiles. Tenant reported roof leaks with the roof being repaired / replaced. Cannot rule out rodent activity (urine) could be source of some staining.

Water stained ceiling tiles

- Remove and replace water damaged floor boards and ceiling tiles to affect cleaning. May need to extend Containment to 1st floor to control release of dusts into the 1st floor during removal of water stained ceiling tiles.

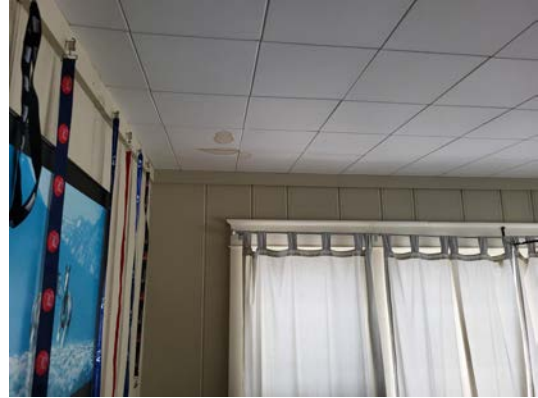
Water stained ceiling tiles

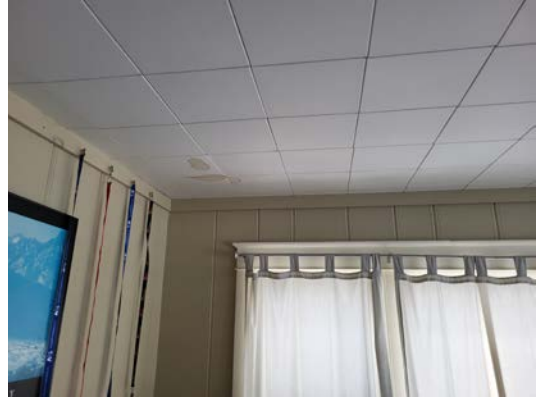
Water stained ceiling tiles

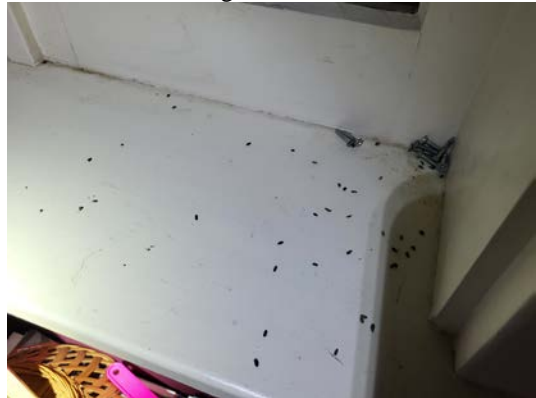
- AQM observed rodent activity in the 1st floor and Attic. Droppings observed on surfaces. Exposure to rodent antigens may produce allergic reactions in individuals susceptible to such allergens.

Signs of rodent activity

- This level of cleaning should be used for the 1st floor to address dusty conditions and rodent activity (i.e. droppings). Professional level cleaning not warranted but may provide the best results.

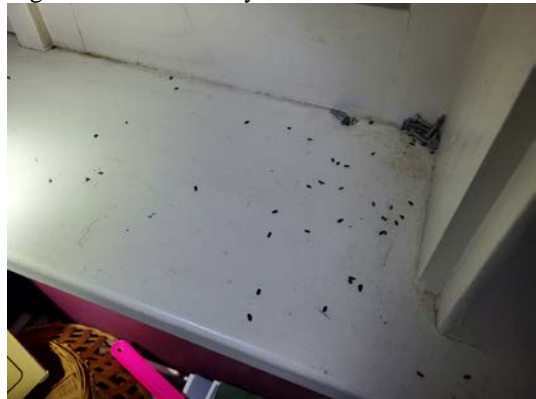
Signs of rodent activity

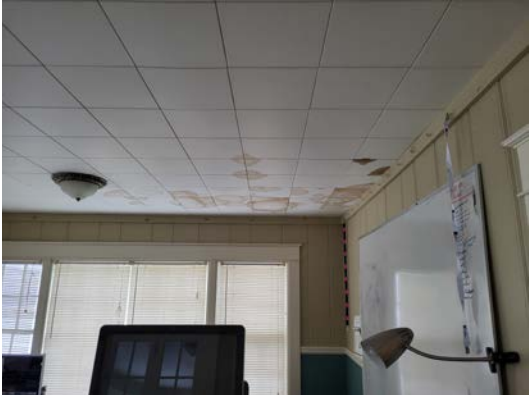
Water stained ceiling tiles

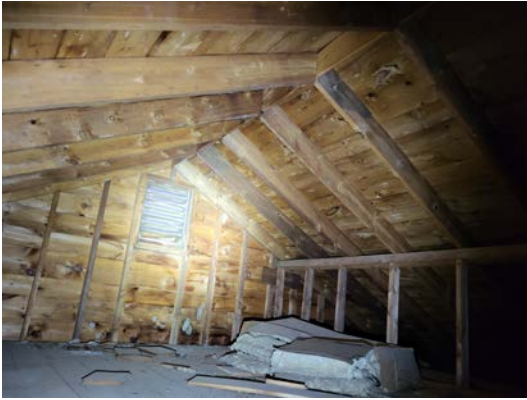
Signs of rodent activity

- Attic:
 - Remove all insulation to affect cleaning; mold growth may shed from surfaces and deposit in insulation. Also, this is recommended to affect cleaning and removal of rodent activity (droppings), using Detail Clean (see Definitions) methods.

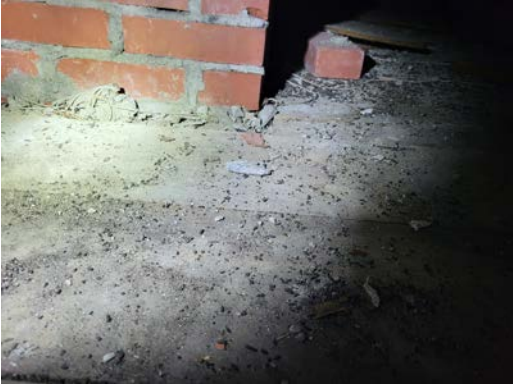
Signs of rodent activity

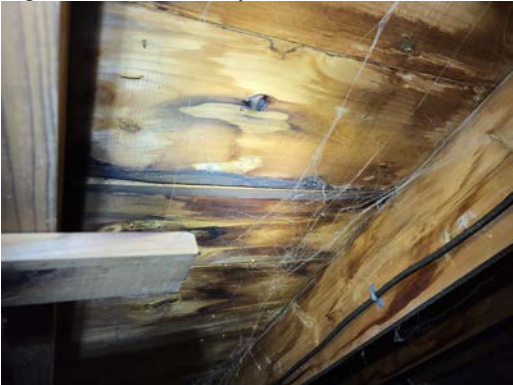
- AQM observed some mold on roof sheathing surfaces. This growth is likely a result of reported roof leaks. Mostly, surfaces in the Attic appeared free of observed mold and weathered.

Wood is weathered in some areas, with minor signs of mold growth (black streaks)

- Clean / Treat (see Definitions) roof sheathing / rafter and gable end surfaces in areas of mold growth.
- Basement:
 - Remove all insulation (fibrous / foam board) / contents / items / (any items cleaned in-place should be at the approval / discretion of the Remediation Contractor and Owner).

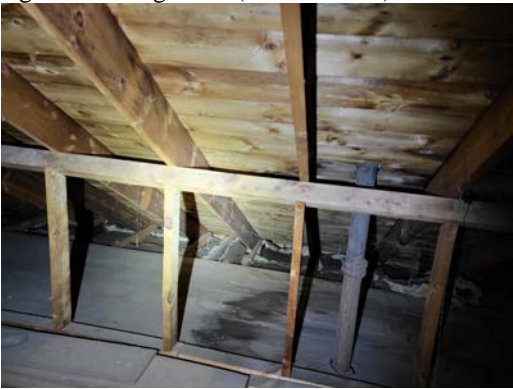
Signs of water impact round this plumbing vent stack

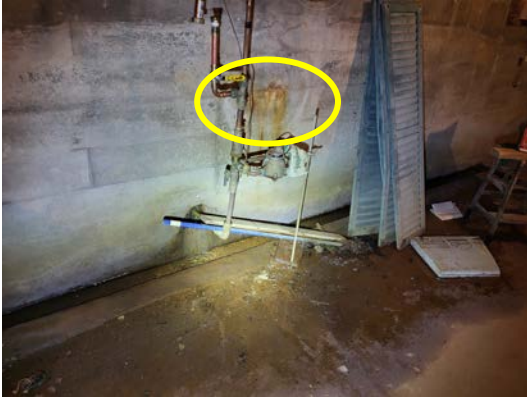
Water pouring in foundation wall

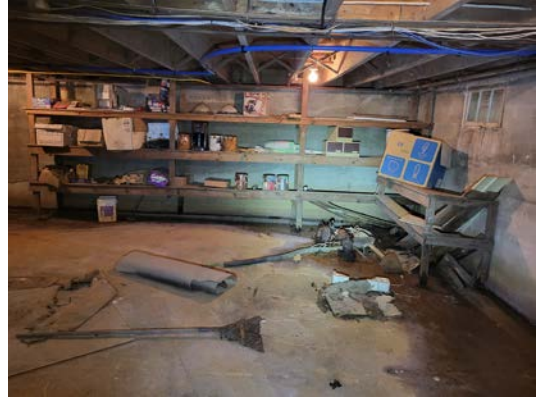
Shelving system is rotten

- Remove all attachments on walls (i.e. pegboards / shelving units / plywood panels, if present) to affect cleaning.
 - Remove all workbenches and built-in shelving units (if present) to affect cleaning.

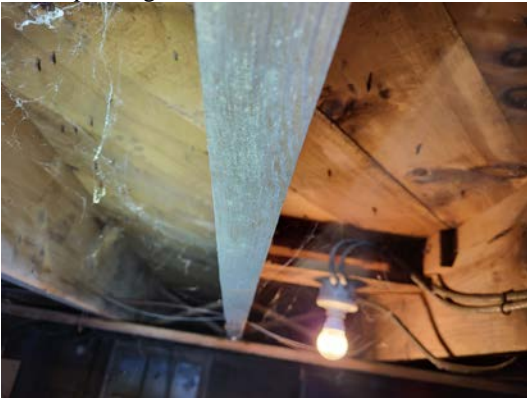
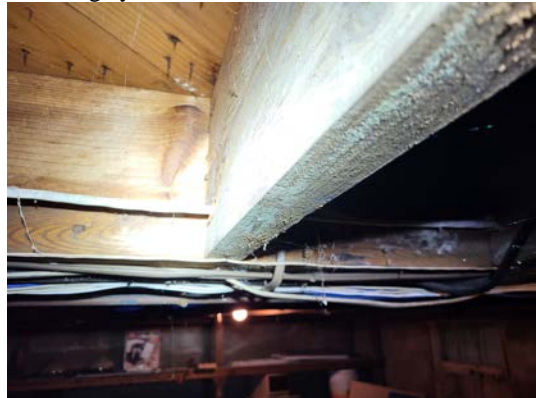
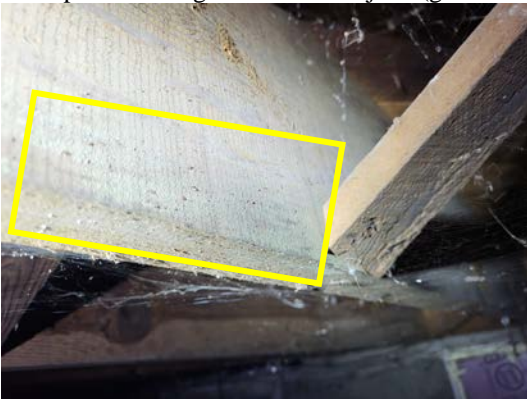
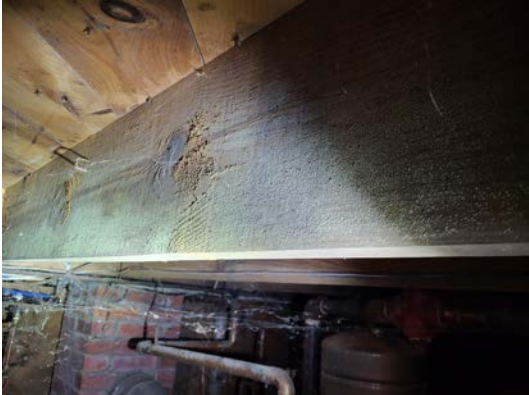
- AQM observed mold growth on surfaces in the Basement. Such surfaces are contents / items and Ceiling surfaces (i.e. floor joists). Location and pattern of this growth is consistent with surface condensation issues from uncontrolled humidity. Water intrusion may exacerbate humidity and condensation issues especially if water pools and becomes stagnant.

Result for air sample (A3) identified elevated levels of Basidiospores mold spores, as compared to the outdoor control (A1). This is likely related to degraded/rotten wood surfaces in the Basement as these types of spores are commonly associated with wood decay especially in the outdoor environment.

Result for this surface sample confirmed levels and types of mold growth of concern.

Example of mold growth on floor joist (green dots)

- Dry, Clean / Treat (see Definitions) all remaining, exposed surfaces.

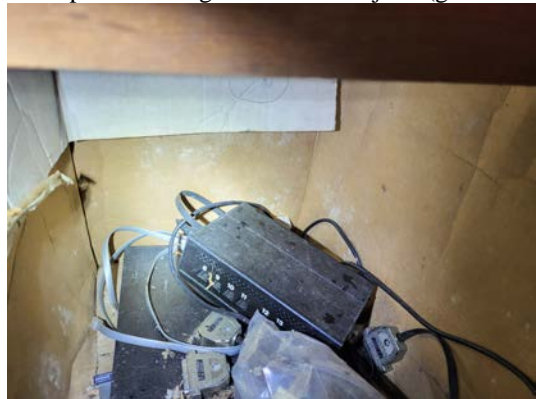
Mold growth on stored items

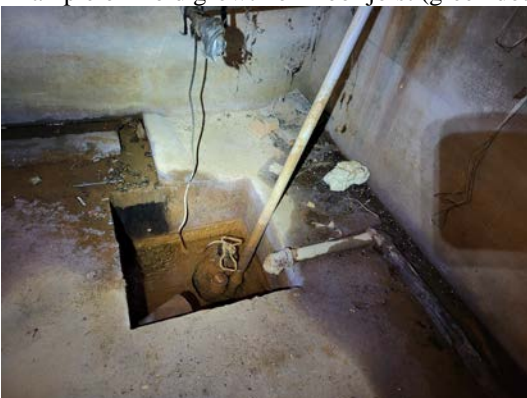
There is a sump pump

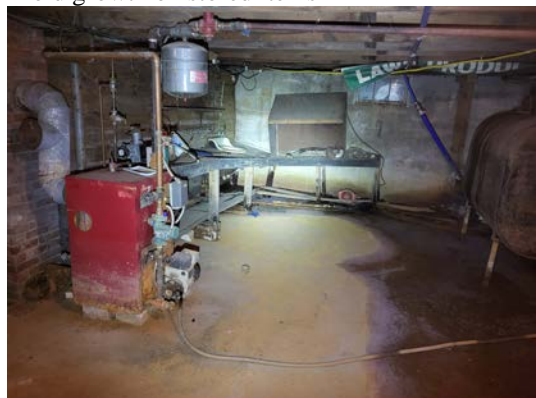
Pooling water

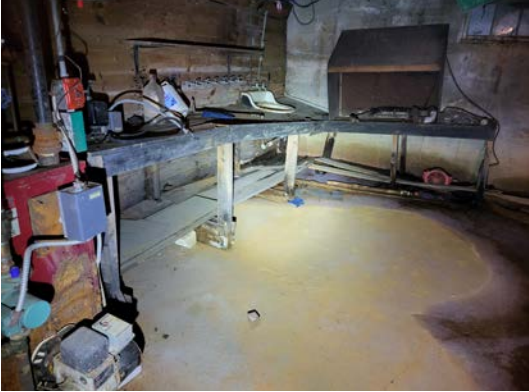
Degraded shelving unit and wall system

- Remove all wood wall systems, only if not load-bearing.
 - Remove all attachments on the ceiling (i.e. duct work and fiberboard, if present) to affect cleaning.

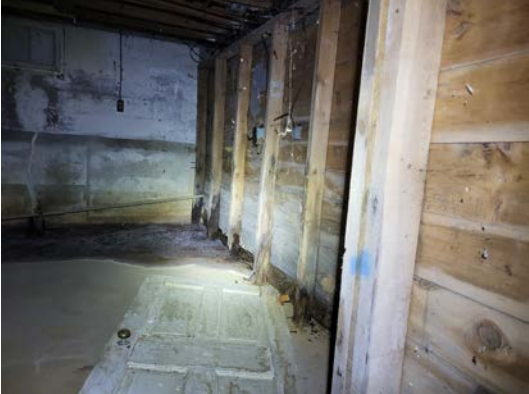
Pooling water and degraded wall system
