April 7, 2023

Re: Limited Phase II Environmental Site Assessment
Bowdoinham Recycling Barn
243 Post Road, Bowdoinham, ME

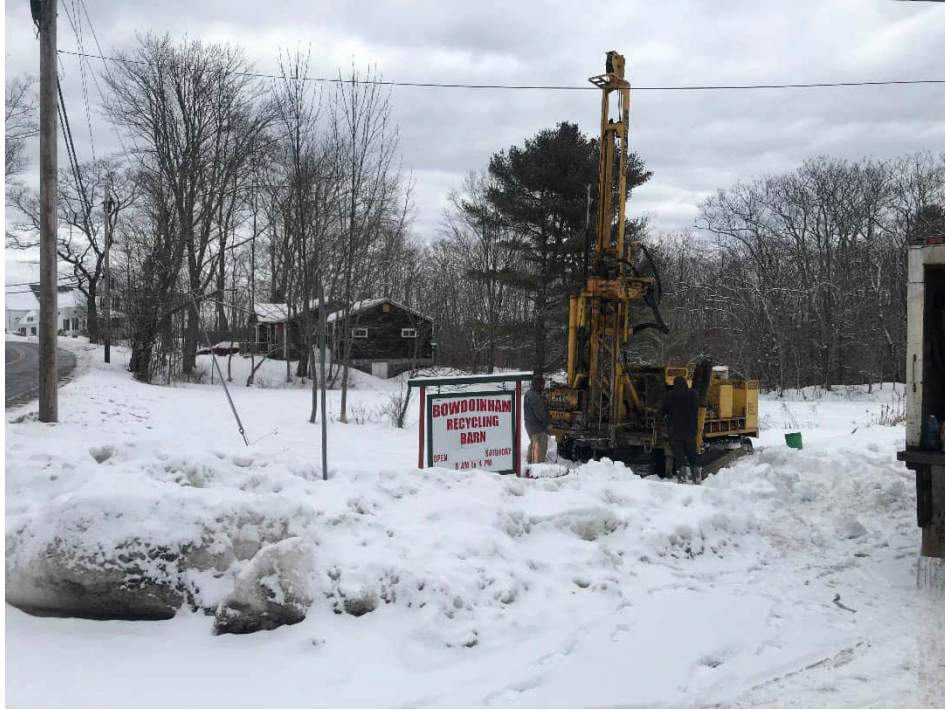
Photo #1: A view of drillers installing upgradient monitoring well along Post Road facing north.

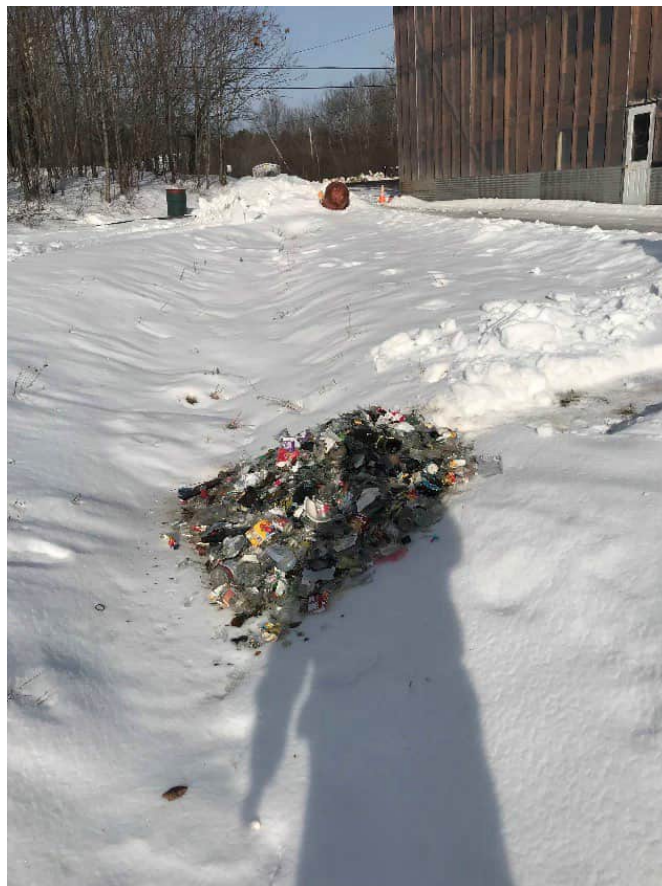
Photo #2: A view of waste glass material dumped on site facing west. Note: This material waste dumped on site during the first day of field work (material placed on top of snow).

- **Test Pit 6 (AOC-8, “Waste Glass Dumping Area”):** A test pit was installed at this location to a depth of approximately five feet BGS adjacent to a pile of waste glass that was dumped above grade. The soil was inspected and determined not to contain waste material. No staining or odor was noted. As such, the test pit was stopped at this depth and backfilled, and no soil samples were collected at this location.

- One area of the site was observed to contain waste materials (broken glass, bottle caps, and labels) dumped above grade (AOC-8). This area is located on the southern side of the building approximately thirty feet south of the UST grave.

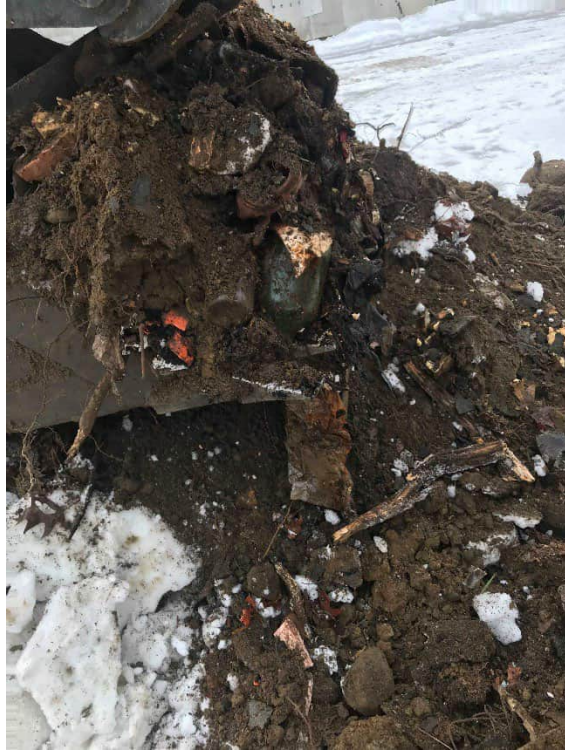
Photo #3: A view of the buried waste observed in Test Pit 3 in the “Paint Dump” area on the northern side of the Recycling Barn.

- **Test Pit 3 (AOC-5, “Paint Dump” area on northern side of Recycling Barn upgradient of MW-102):** A soil sample was collected from this location at a depth of 4 to 5 feet BGS. This test pit was installed to an approximate depth of eight to nine feet BGS where bedrock was encountered (refusal). No staining or odor was noted. A variety of solid waste was noted at this location (approximately 0.5 to 4 foot BGS) and included glass bottles, plastic, metal pipes, painted wood, a toilet seat, fiberglass insulation, and various other wastes. Soil results at this location are characterized by elevated arsenic and a slightly elevated pesticide results. Arsenic was detected at 10.8 mg/kg exceeding the leaching to groundwater RAG of 0.83 mg/Kg and the residential RAG of 9.3 mg/Kg. All other metal results were below applicable RAGs. The pesticide 4,4'-DDT was detected at 18 micrograms per kilogram (ug/Kg). This pesticide result is below applicable criteria, but above background as this compound is not naturally occurring. TPH, VOCs, GRO, and herbicides were not detected above MDLs.

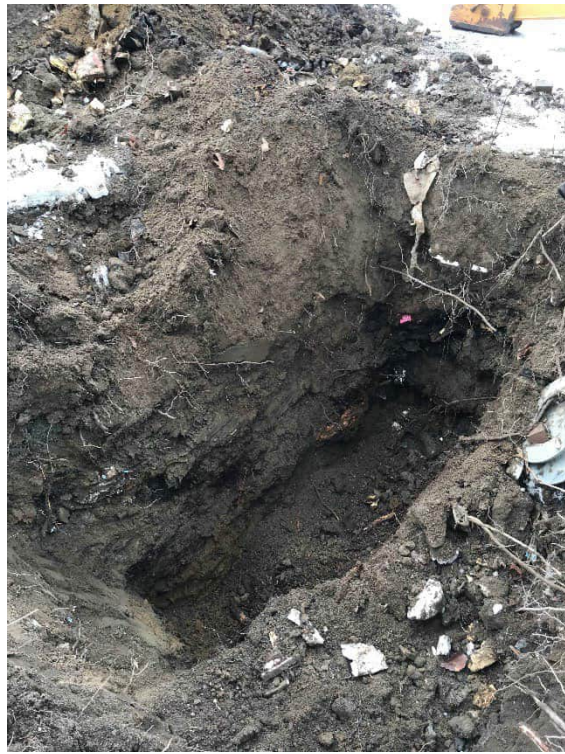
Photo #4: Another view of Test Pit 3 in the “Paint Dump” area on the northern side of the Recycling Barn. Note: waste material buried below grade.

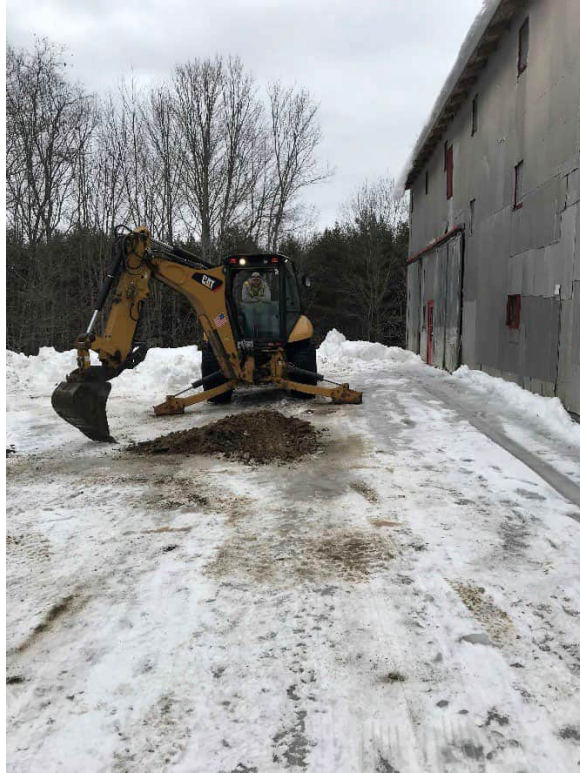
Photo #5: A view of Test Pit 4 in the “Antifreeze Pit” area of the site. Note: the machine was not able to break through densely packed and frozen material to examine this area and collect a sample.

Two areas were investigated with no samples were collected. An attempt was made to complete a test pit at AOC-6, the "Antifreeze Pit" area identified by the Town's Public Works staff. Due to the combination of frozen conditions and densely compacted material, the backhoe was not able to penetrate beyond approximately 1 to 4 inches below ground surface (BGS). As such, no sample was collected at this location. A test pit was excavated at AOC-8, the "Waste Glass Dumping Area" to approximately 5 feet BGS. This test pit bisected a drainage trench which quickly filled with water. No obvious buried waste was observed at this location, and the test pit was backfilled without sampling.

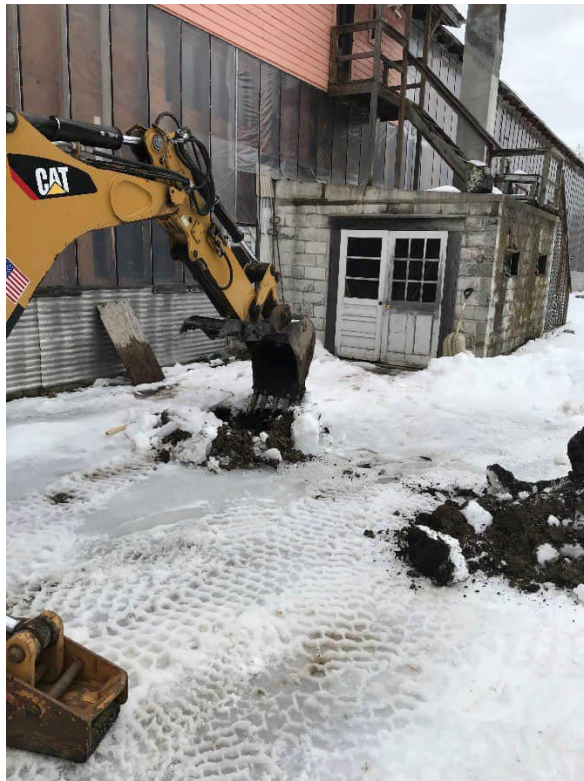
Photo #6: A view of Test Pit 1 (former UST location) on the southern side of the Recycling Barn facing east. Note: boiler located in cinder block room in background.

- **Test Pit 1 (AOC-2, UST grave on southern side of Recycling Barn):** A soil sample was collected from this location at a depth of 8 to 10 feet BGS (estimated bottom of tank grave). This test pit was installed to a depth of approximately ten feet BGS. A weathered petroleum odor was noted in the soil in this pit. A sheen was noted on the water in the test pit. It was also noted that a PID result of 55.3 ppm was noted in the eight to ten foot interval (estimated bottom of tank depth). Soil results at this location are characterized by elevated arsenic results. Arsenic was detected at 13 mg/kg exceeding the leaching to groundwater RAG of 0.83 mg/Kg and the residential RAG of 9.3 mg/Kg. All other metal results were below applicable RAGs. TPH was detected at a concentration of 200 mg/Kg (no criteria listed in RAGs for this parameter). VOCs, pesticides, GRO, and herbicides were not detected above MDLs.

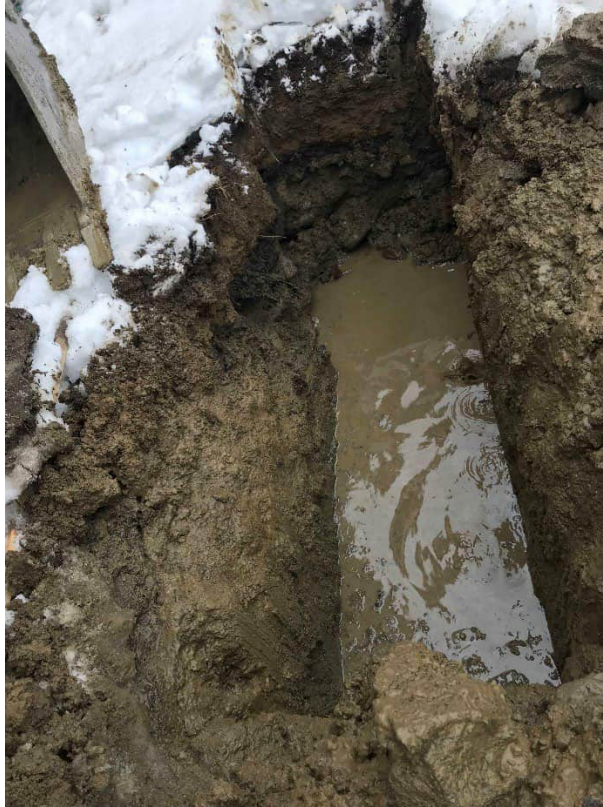
Photo #7: Another view of Test Pit 1, note: shallow water and floating sheen.

- The “Burn Pit” soil sample (AOC-7) was reported with a lead result that exceeds Maine RAGs.
- The UST grave soil sample (AOC-2) had TPH detected at 200 mg/Kg. While specific criteria for this parameter was not identified in Maine RAGs, it is noted that this result is indicative of a petroleum release. It was also noted that a visible sheen was observed on the water table in the test pit, a PID reading of 55.3 ppm was noted at this location, and a petroleum odor was noted. The field observations (sheen, odor, PID reading) are considered alternate lines of evidence of a petroleum release.

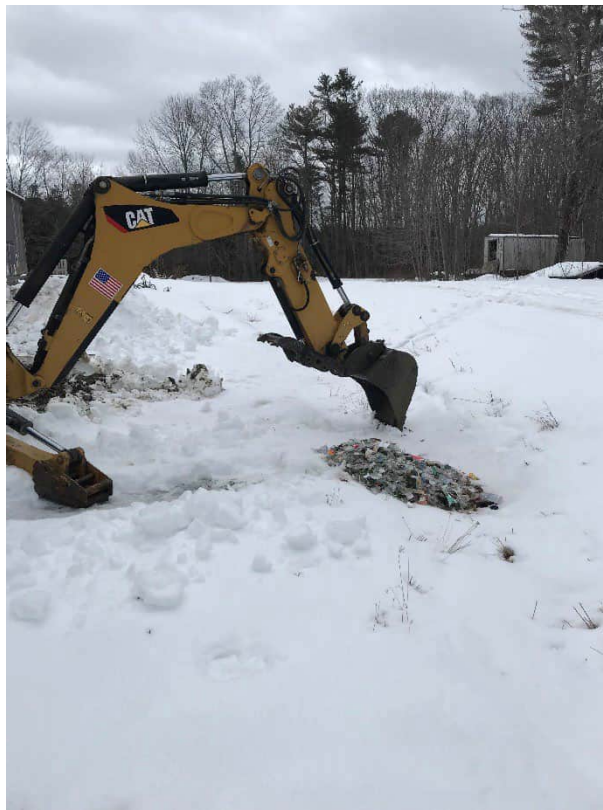
Photo #8: A view of Test Pit 6 at waste glass dumping location facing east.

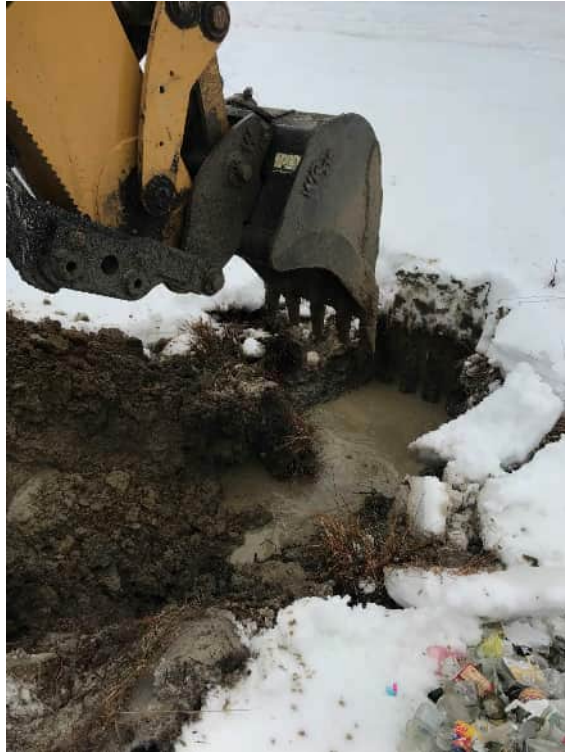
Photo #9: Another view of Test Pit 6. Note: buried waste not identified at this location.

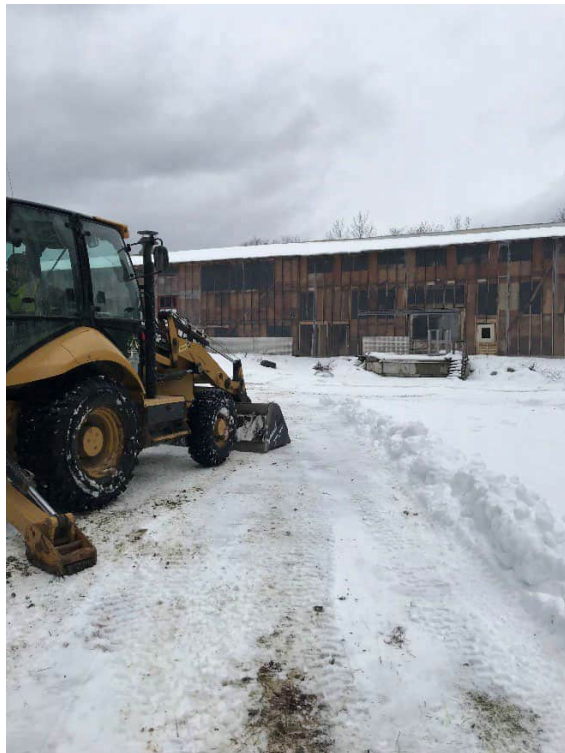
Photo #10: A view of the machine digging in the burn pit, approximately 150 feet south southwest of the loading dock of the Recycling Barn. Note: proposed test pit in “Former Septic Leach Field” to the immediate left of the loading dock. This test pit was not installed at the direction of Town Manager due to concerns that this leach field is actually in use.

- **Test Pit 5 (AOC-7, “Burn Pit” area south of the Recycling Barn):** A soil sample was collected from this location at a depth of 0 to 3 feet BGS. This test pit was installed to an approximate depth of six feet BGS where bedrock was encountered (refusal). It was noted that a variety of waste materials was encountered here (metal, brick, furniture springs, glass bottles, remnants of a steel barrel, plywood) to an approximate depth of three feet BGS. No staining or odor was noted. PID results were 0.0 PPM. Soil results at this location are characterized by elevated arsenic and lead results. Arsenic was detected at 51.4 mg/kg exceeding the leaching to groundwater RAG of 0.83 mg/Kg, the residential RAG of 9.3 mg/Kg, and the commercial worker RAG of 41 mg/Kg. Lead was detected at 1,350 mg/L, which exceeds the leaching to groundwater RAG of 250 mg/Kg, the residential RAG of 140 mg/Kg, and the commercial worker RAG of 440 mg/Kg. All other metal results were below applicable RAGs. TPH, VOCs, GRO, pesticides and herbicides were not detected above MDLs.

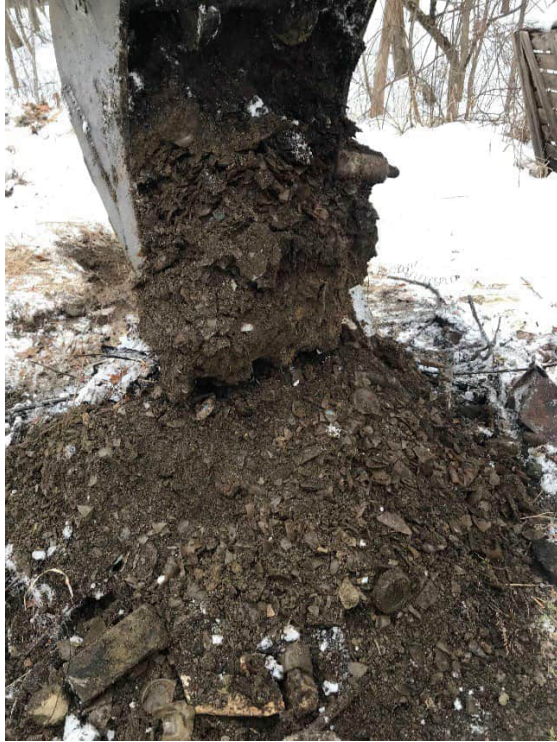
Photo #11: Buried waste material excavated from the "Burn Pit".

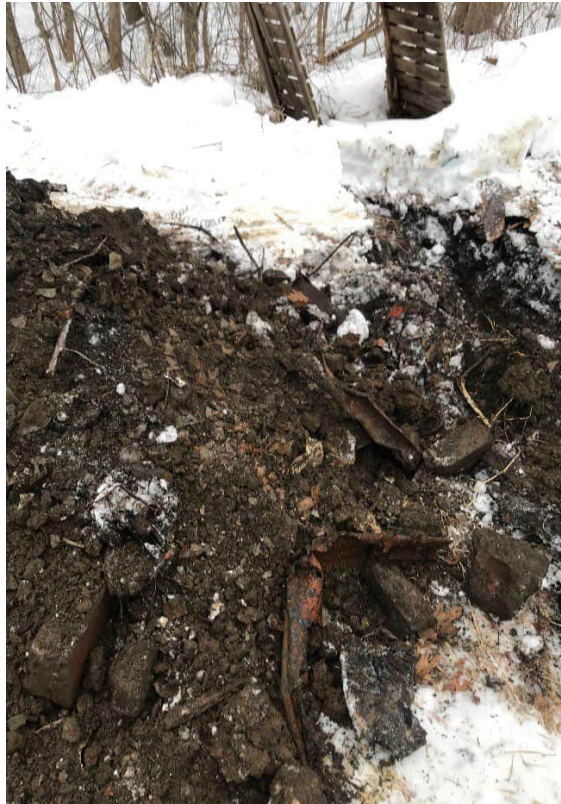
Photo #12: Another view of waste material excavated from the burn pit. Note: remnants of a metal drum.

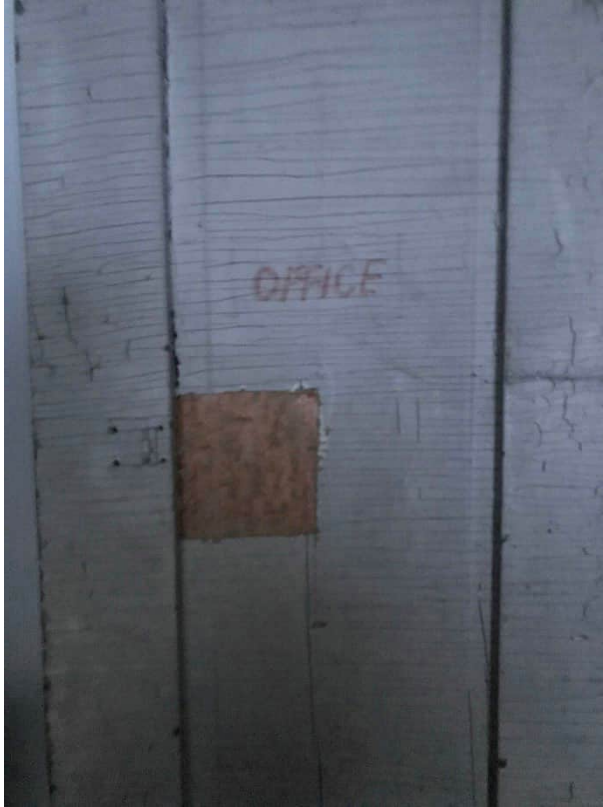
Photo #13: A view of paint sample collection location on painted office door near first floor boiler room. Note: paint removed down to bare substrate (wood) for sampling.

Two areas of painted wood were noted for evaluation: a painted door with noticeably cracked (and layered) paint in an office next to the boiler room, and exterior painted surfaces that had what appeared to be an identical painting history (doors, window frames/sills, and a sign board,

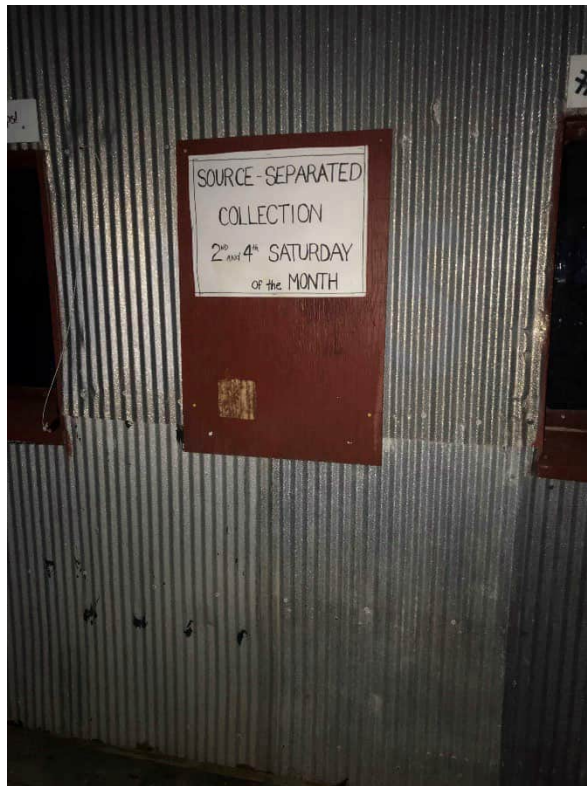
Photo #14: A view of paint sampling location on exterior of building.

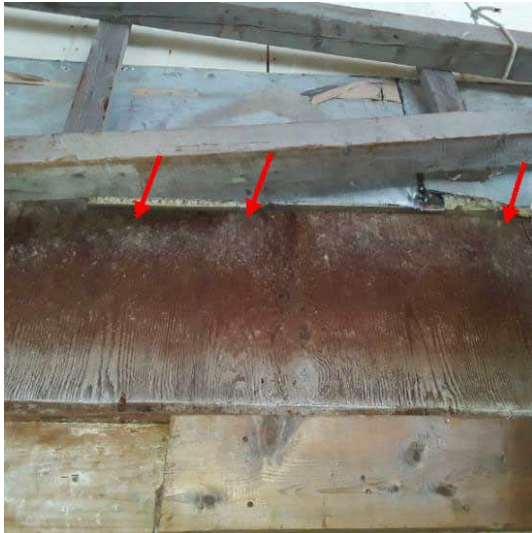
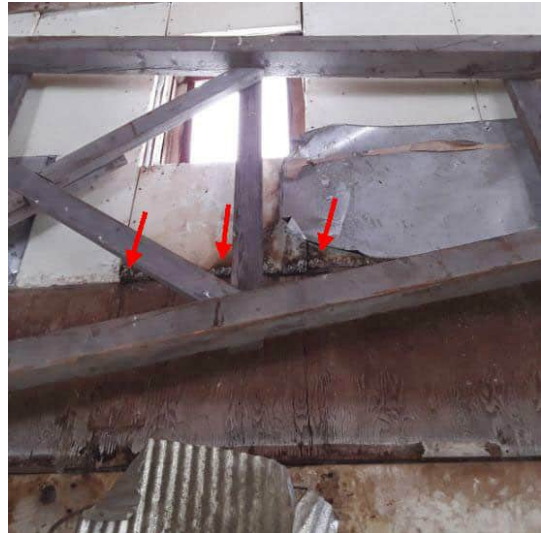
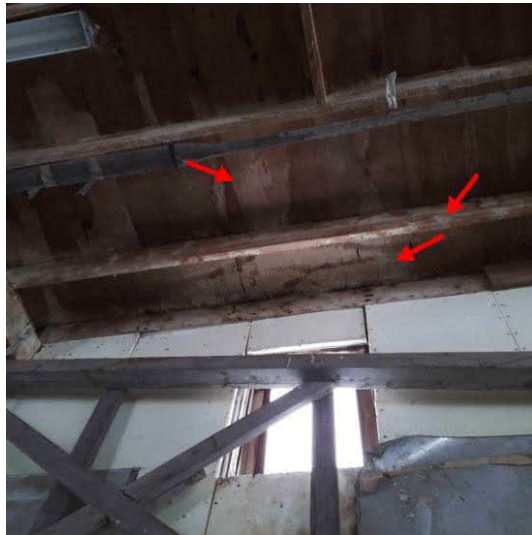
- Suspected fungal growth
- Surface Discoloration Description: multiple areas of discoloration, differing density and color

First Floor East Wall A

First Floor East Wall B

First Floor East Ceiling

Remediation of the mold throughout the building by a qualified mold remediation professional is recommended prior to occupation of the building. However, moisture leaks and humidity issues in the building need to be resolved prior to mold remediation or mold growth will recur.

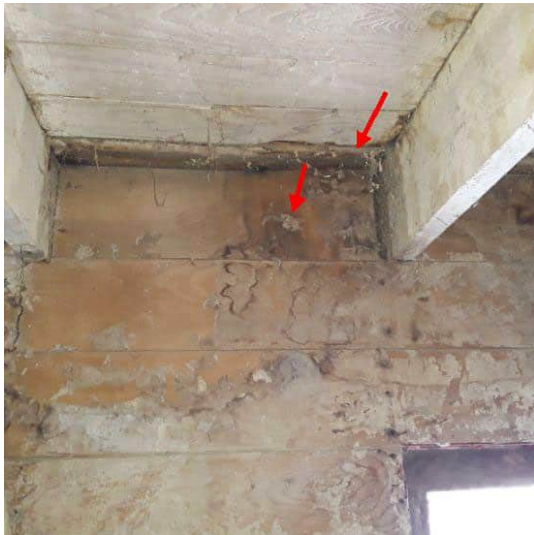
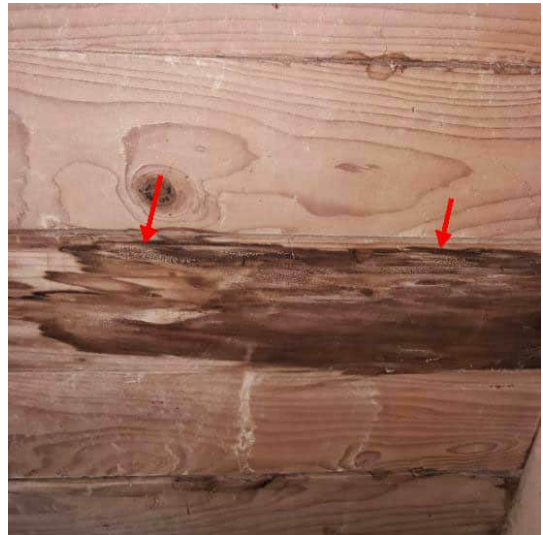
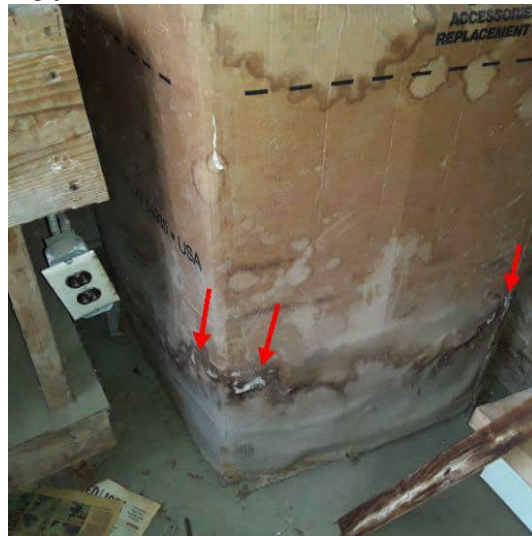
- Suspected fungal growth
- Surface Discoloration Description: multiple areas of discoloration, differing density and color

First Floor Center ceiling joists

First Floor Center ceiling

First Floor Center cardboard box

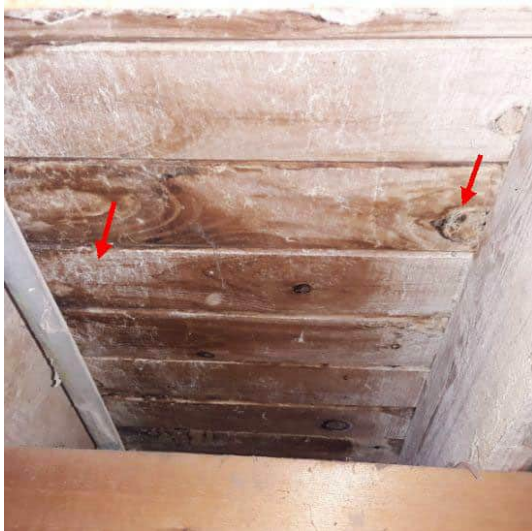
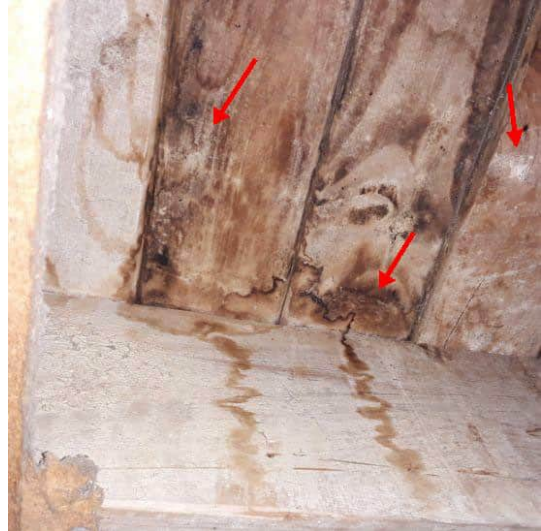
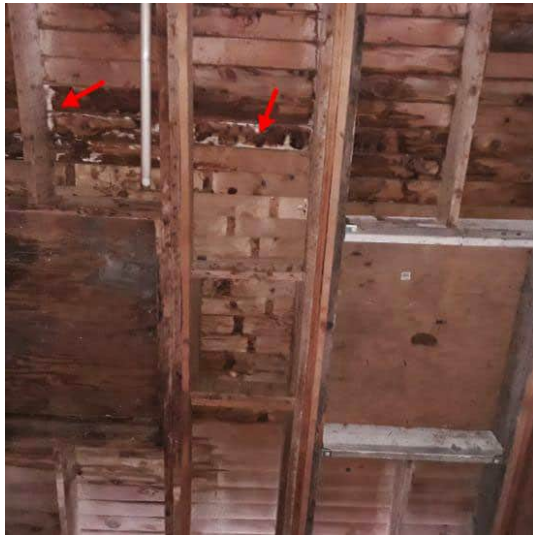
- Suspected fungal growth
- Surface Discoloration Description: multiple areas of discoloration, differing density and color

First Floor West ceiling A

First Floor West ceiling B

First Floor West ceiling C

First Floor West interior wall

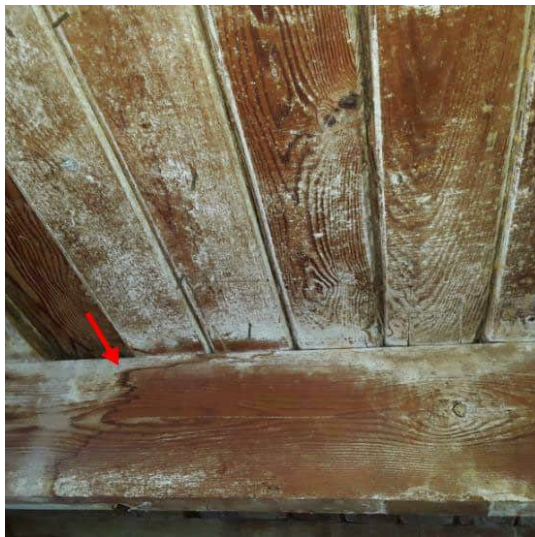
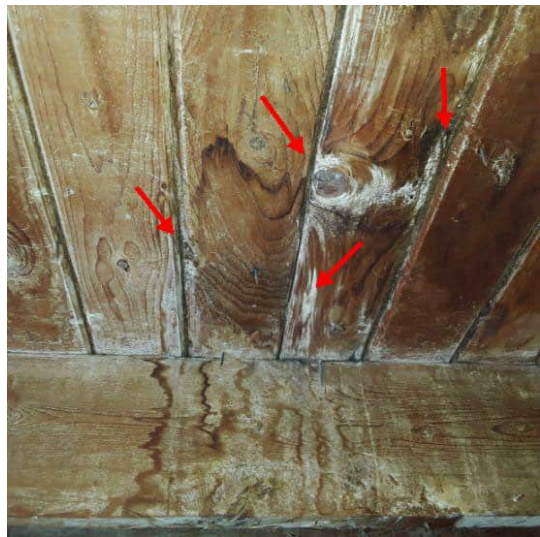
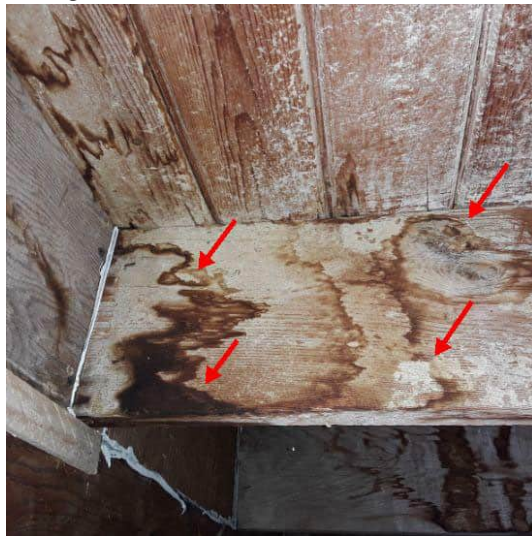
- Suspected fungal growth
- Surface Discoloration Description: multiple areas of discoloration, differing density and color

Second Floor West ceiling A

Second Floor West ceiling B

Second Floor West C

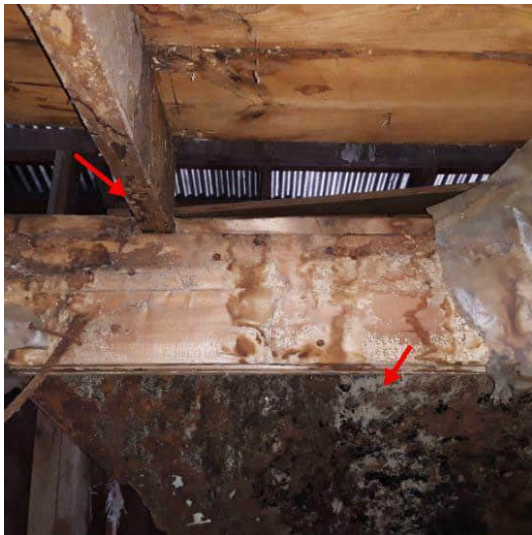
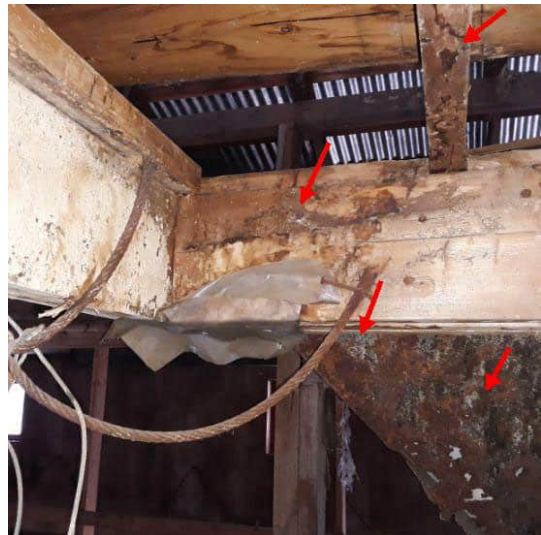
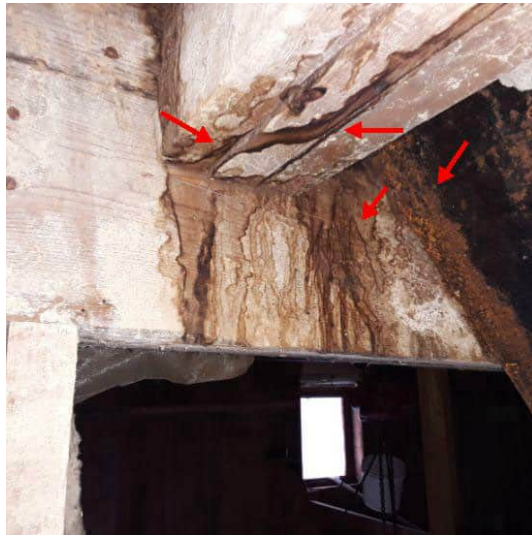
- Suspected fungal growth
- Surface Discoloration Description: multiple areas of discoloration, differing density and color

Third Floor East ceiling joists A

Third Floor East ceiling joists B

Third Floor East ceiling joists C

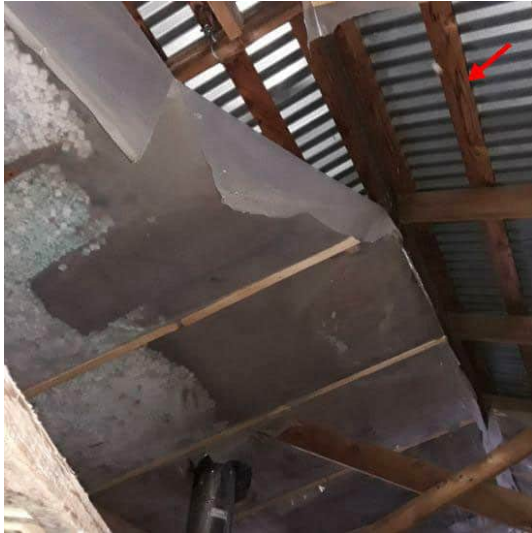
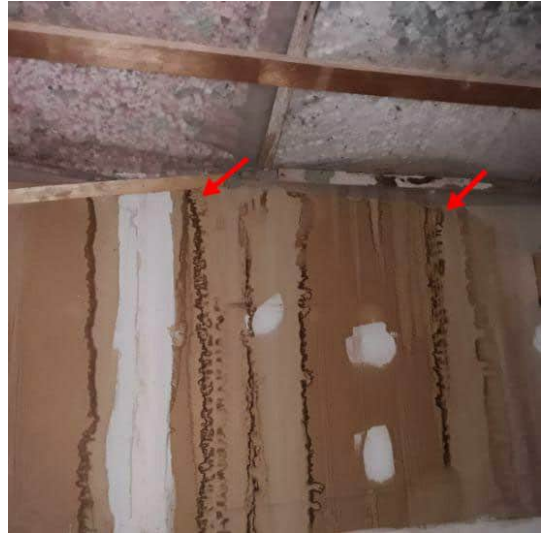
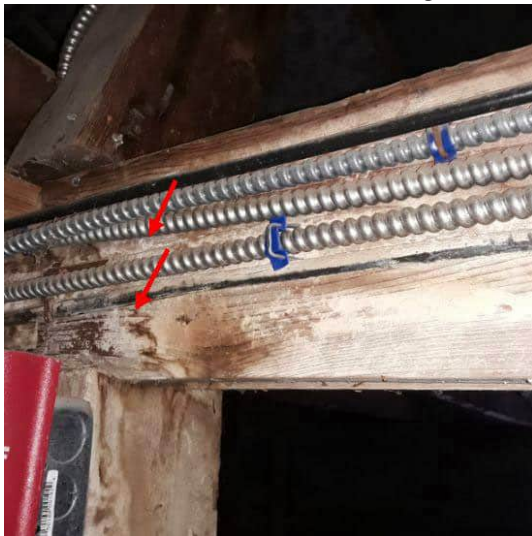
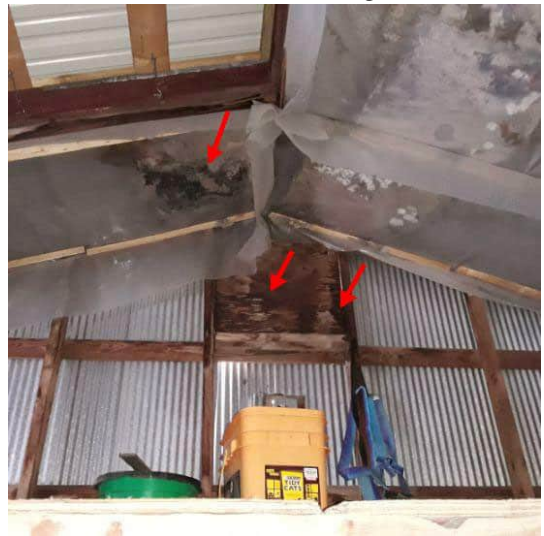
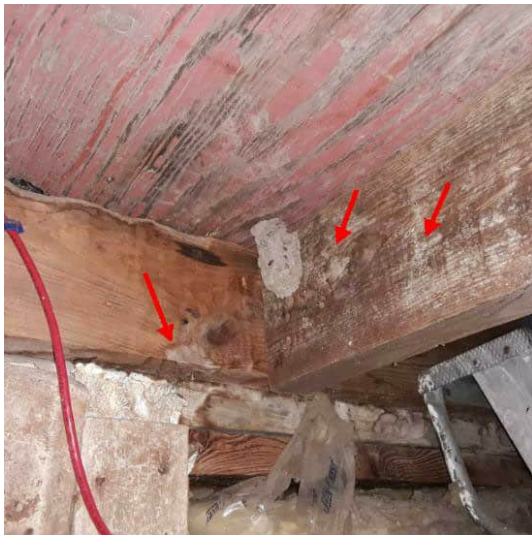
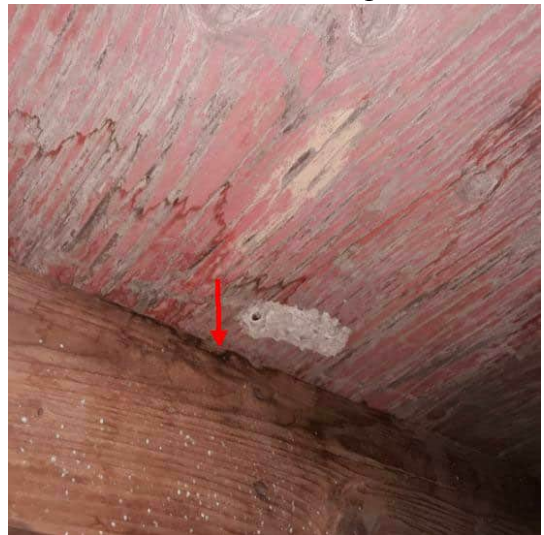
- Suspected fungal growth
- Surface Discoloration Description: multiple areas of discoloration, differing density and color

Third Floor West ceiling

Third Floor West ceiling and wall

Third Floor West wood beam

Third Floor West ceiling joists

Third Floor West ceiling and wall B
