PRESERVATION TIMBER FRAMING
P.O. Box 28
Berwick, ME 03901
www.preservationtimberframing.com

Bowdoinham Town Hall Dwgs
Nicole Briand
13 School St
Bowdoinham, ME 04008

04.12.2023
Issue 001
Jessica MilNeil

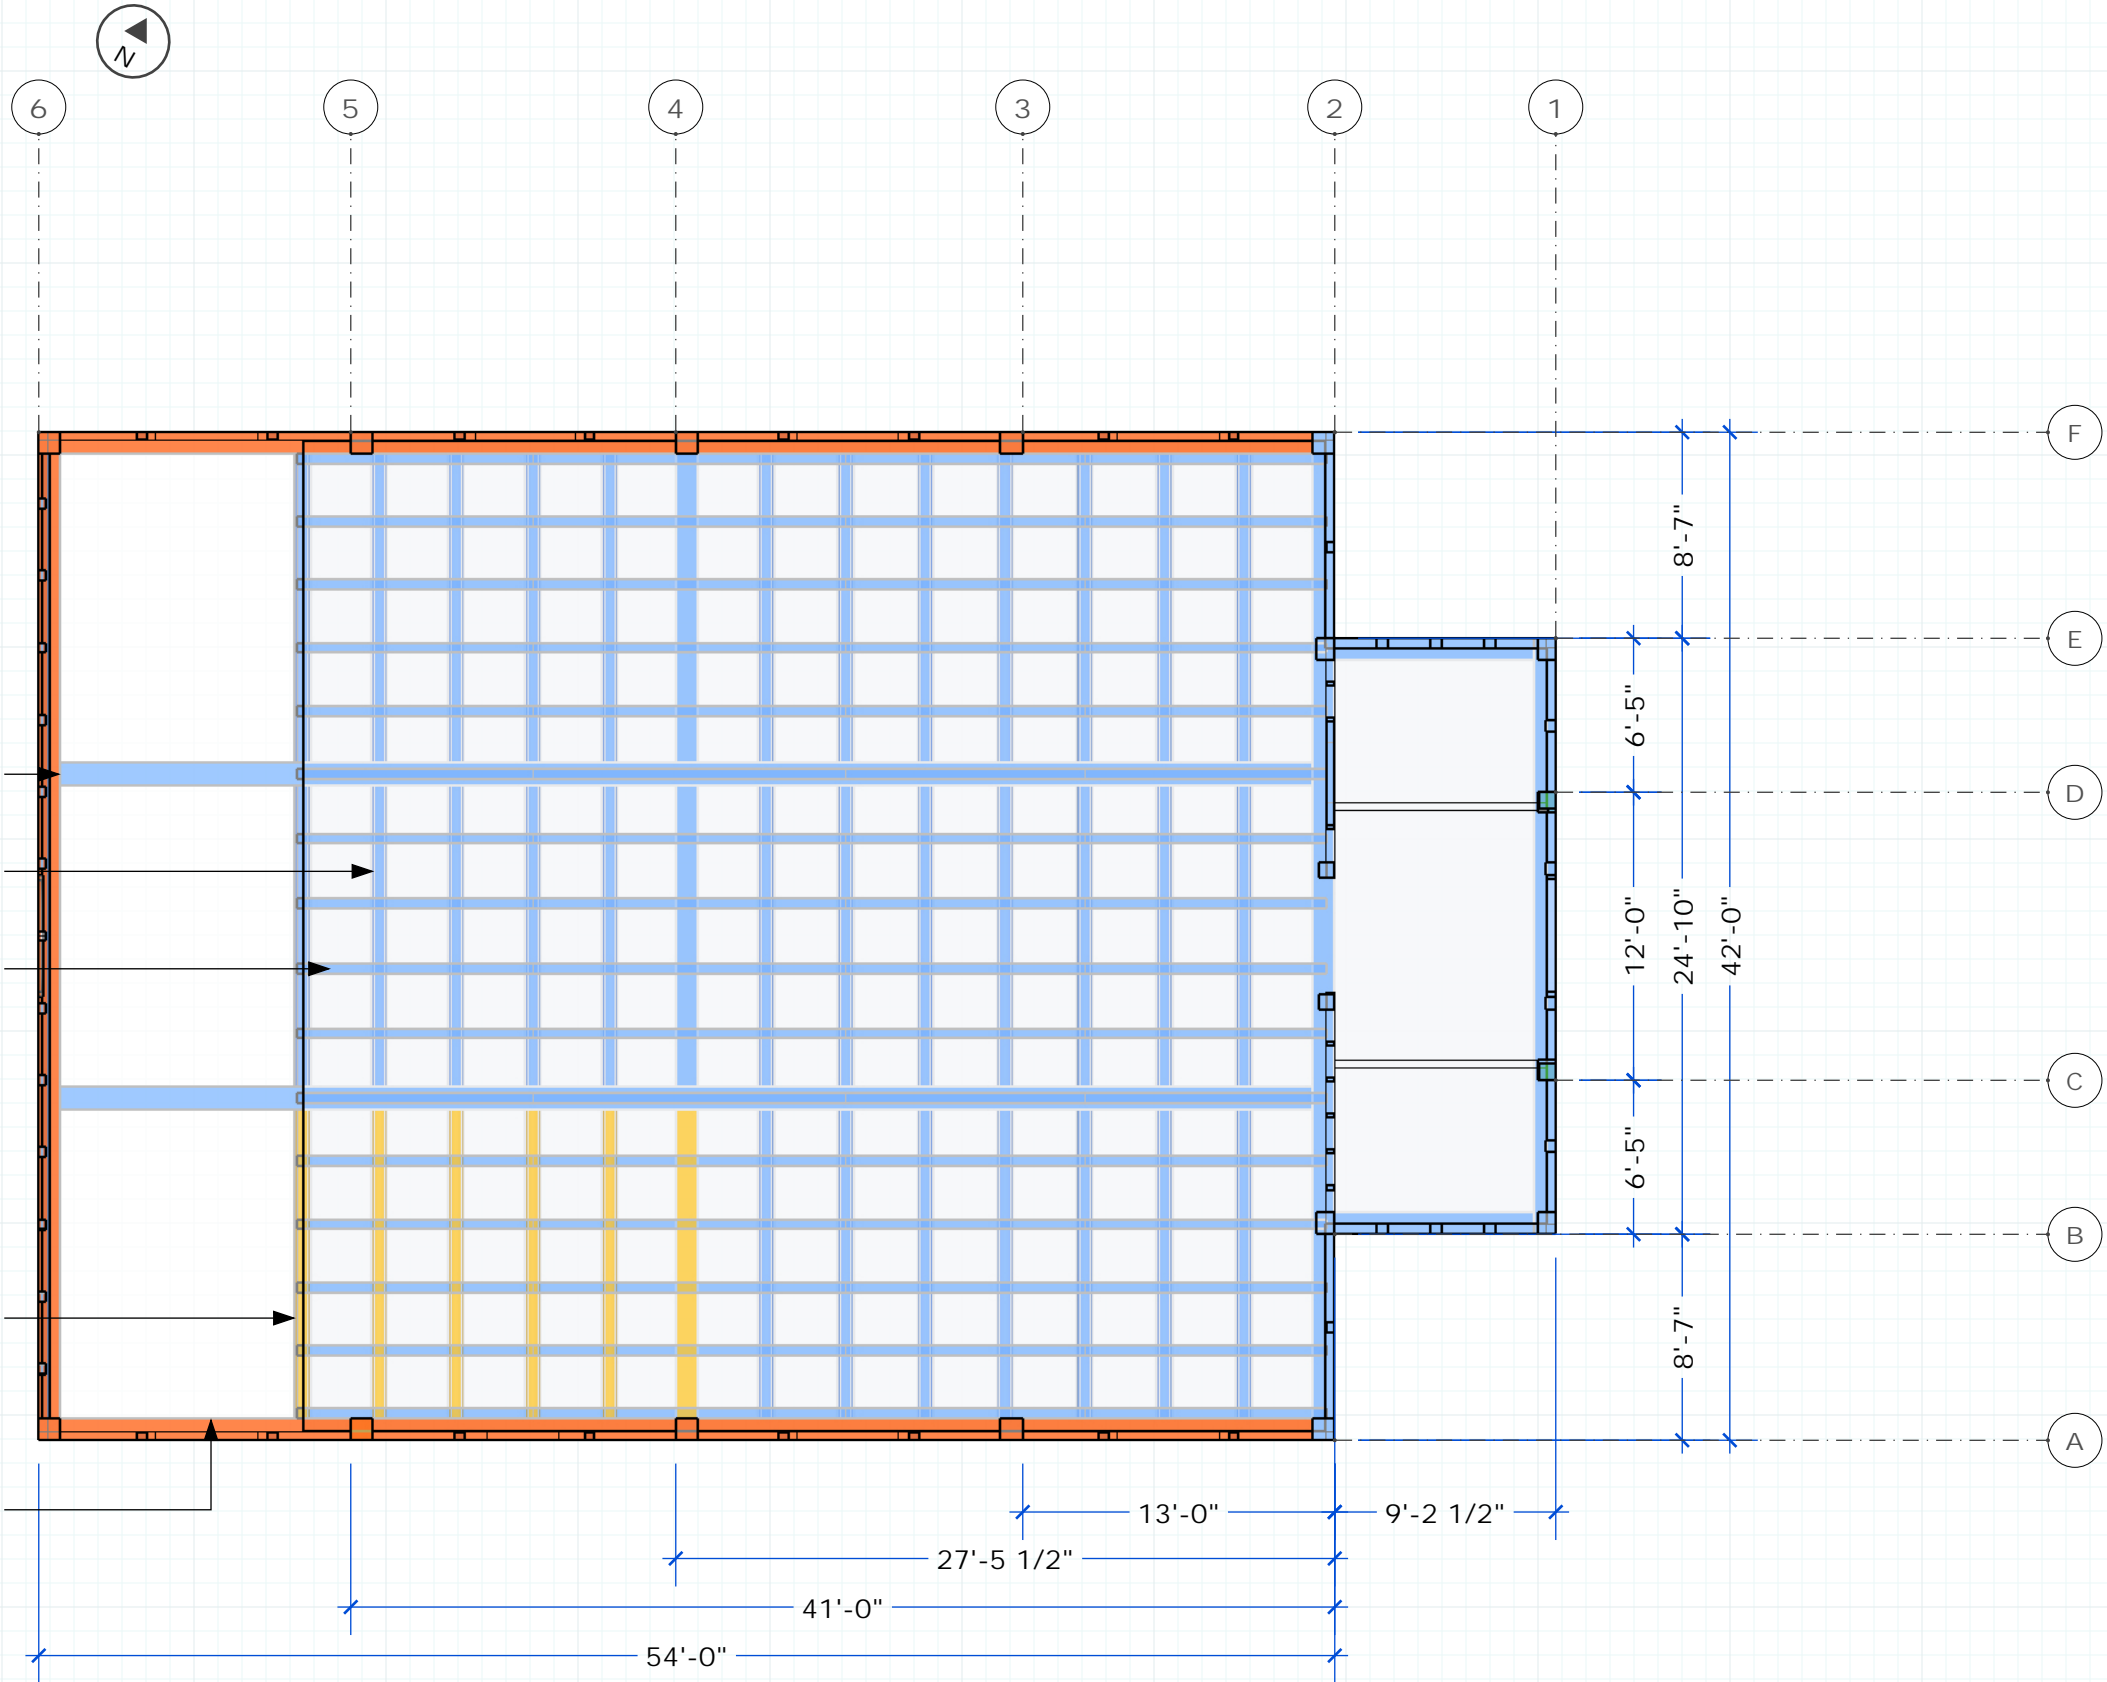
Undercarriage

Longitudinal summer beam

Log joist, 5" diam., 42" o.c.

Floor joist, 4x5, 30" o.c.

Fairly difficult access.

Timber sill has been replaced with short chunks, all connections to log joists have been severed.

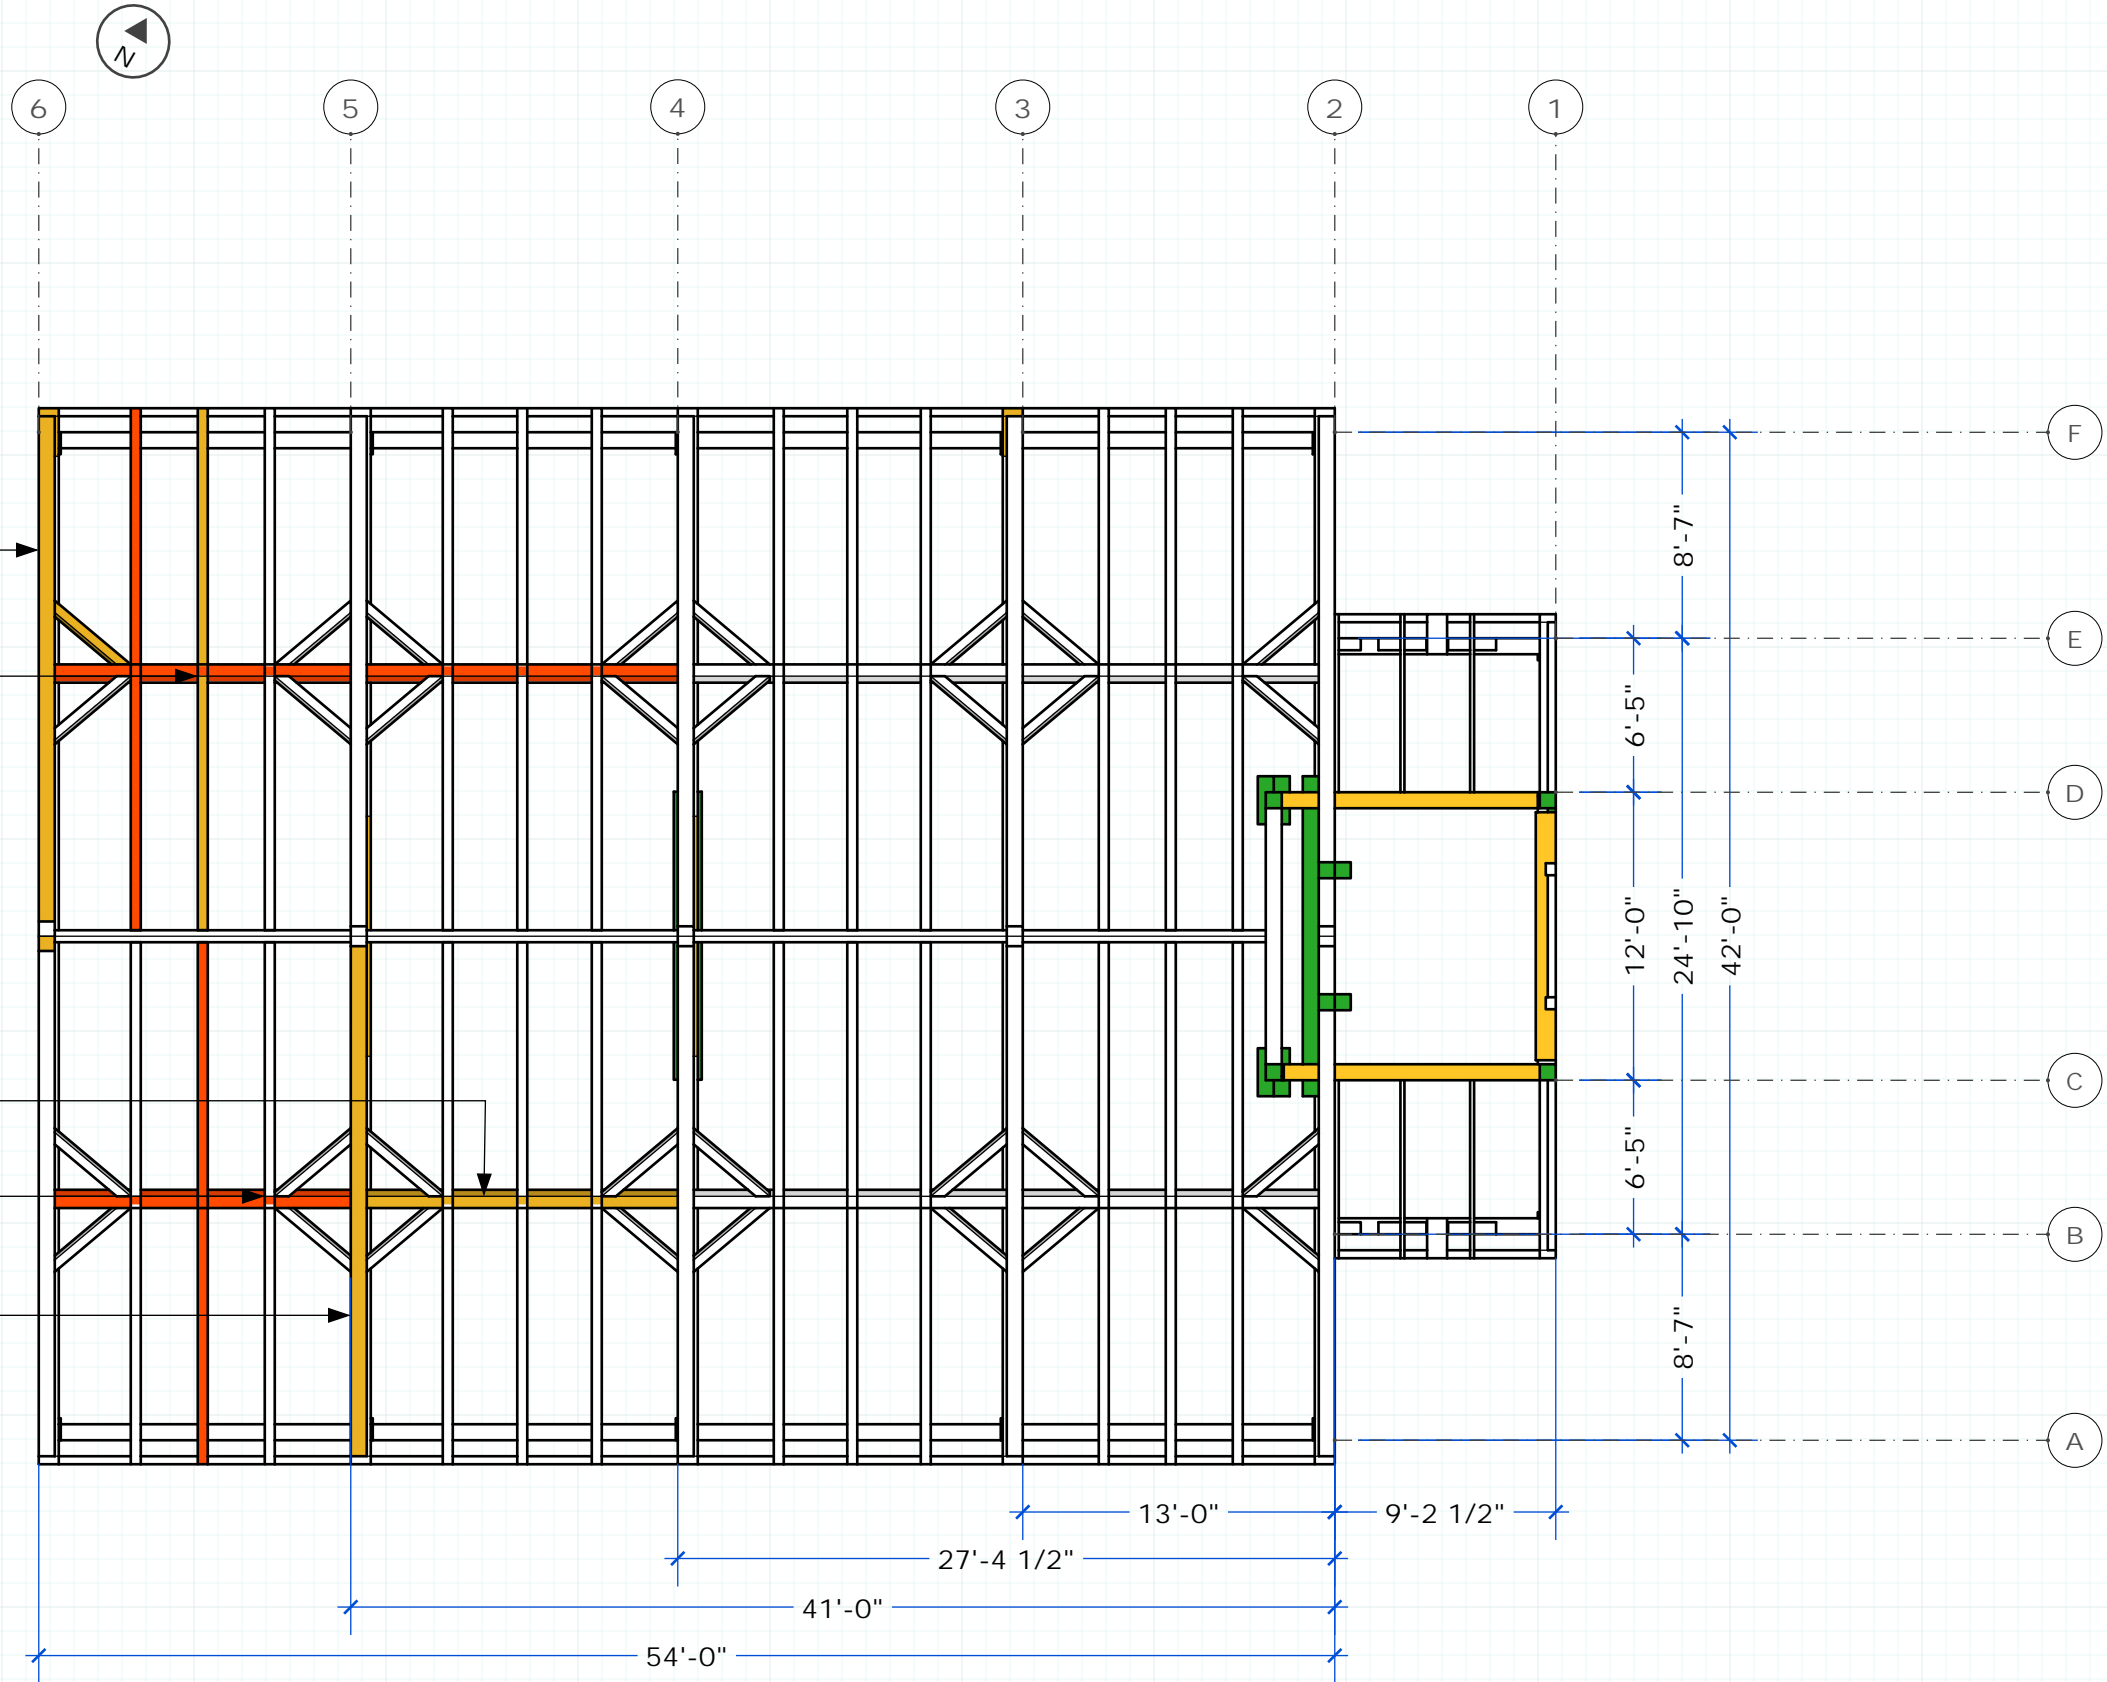
Roof Frame Plan

Rafter shows extensive water staining.

Purlins shows signs of rot.

Purlin shows signs of rot.

Purlin is bolstered at center and shows signs of water damage.

Extreme discoloration on face of rafter indicates rot.

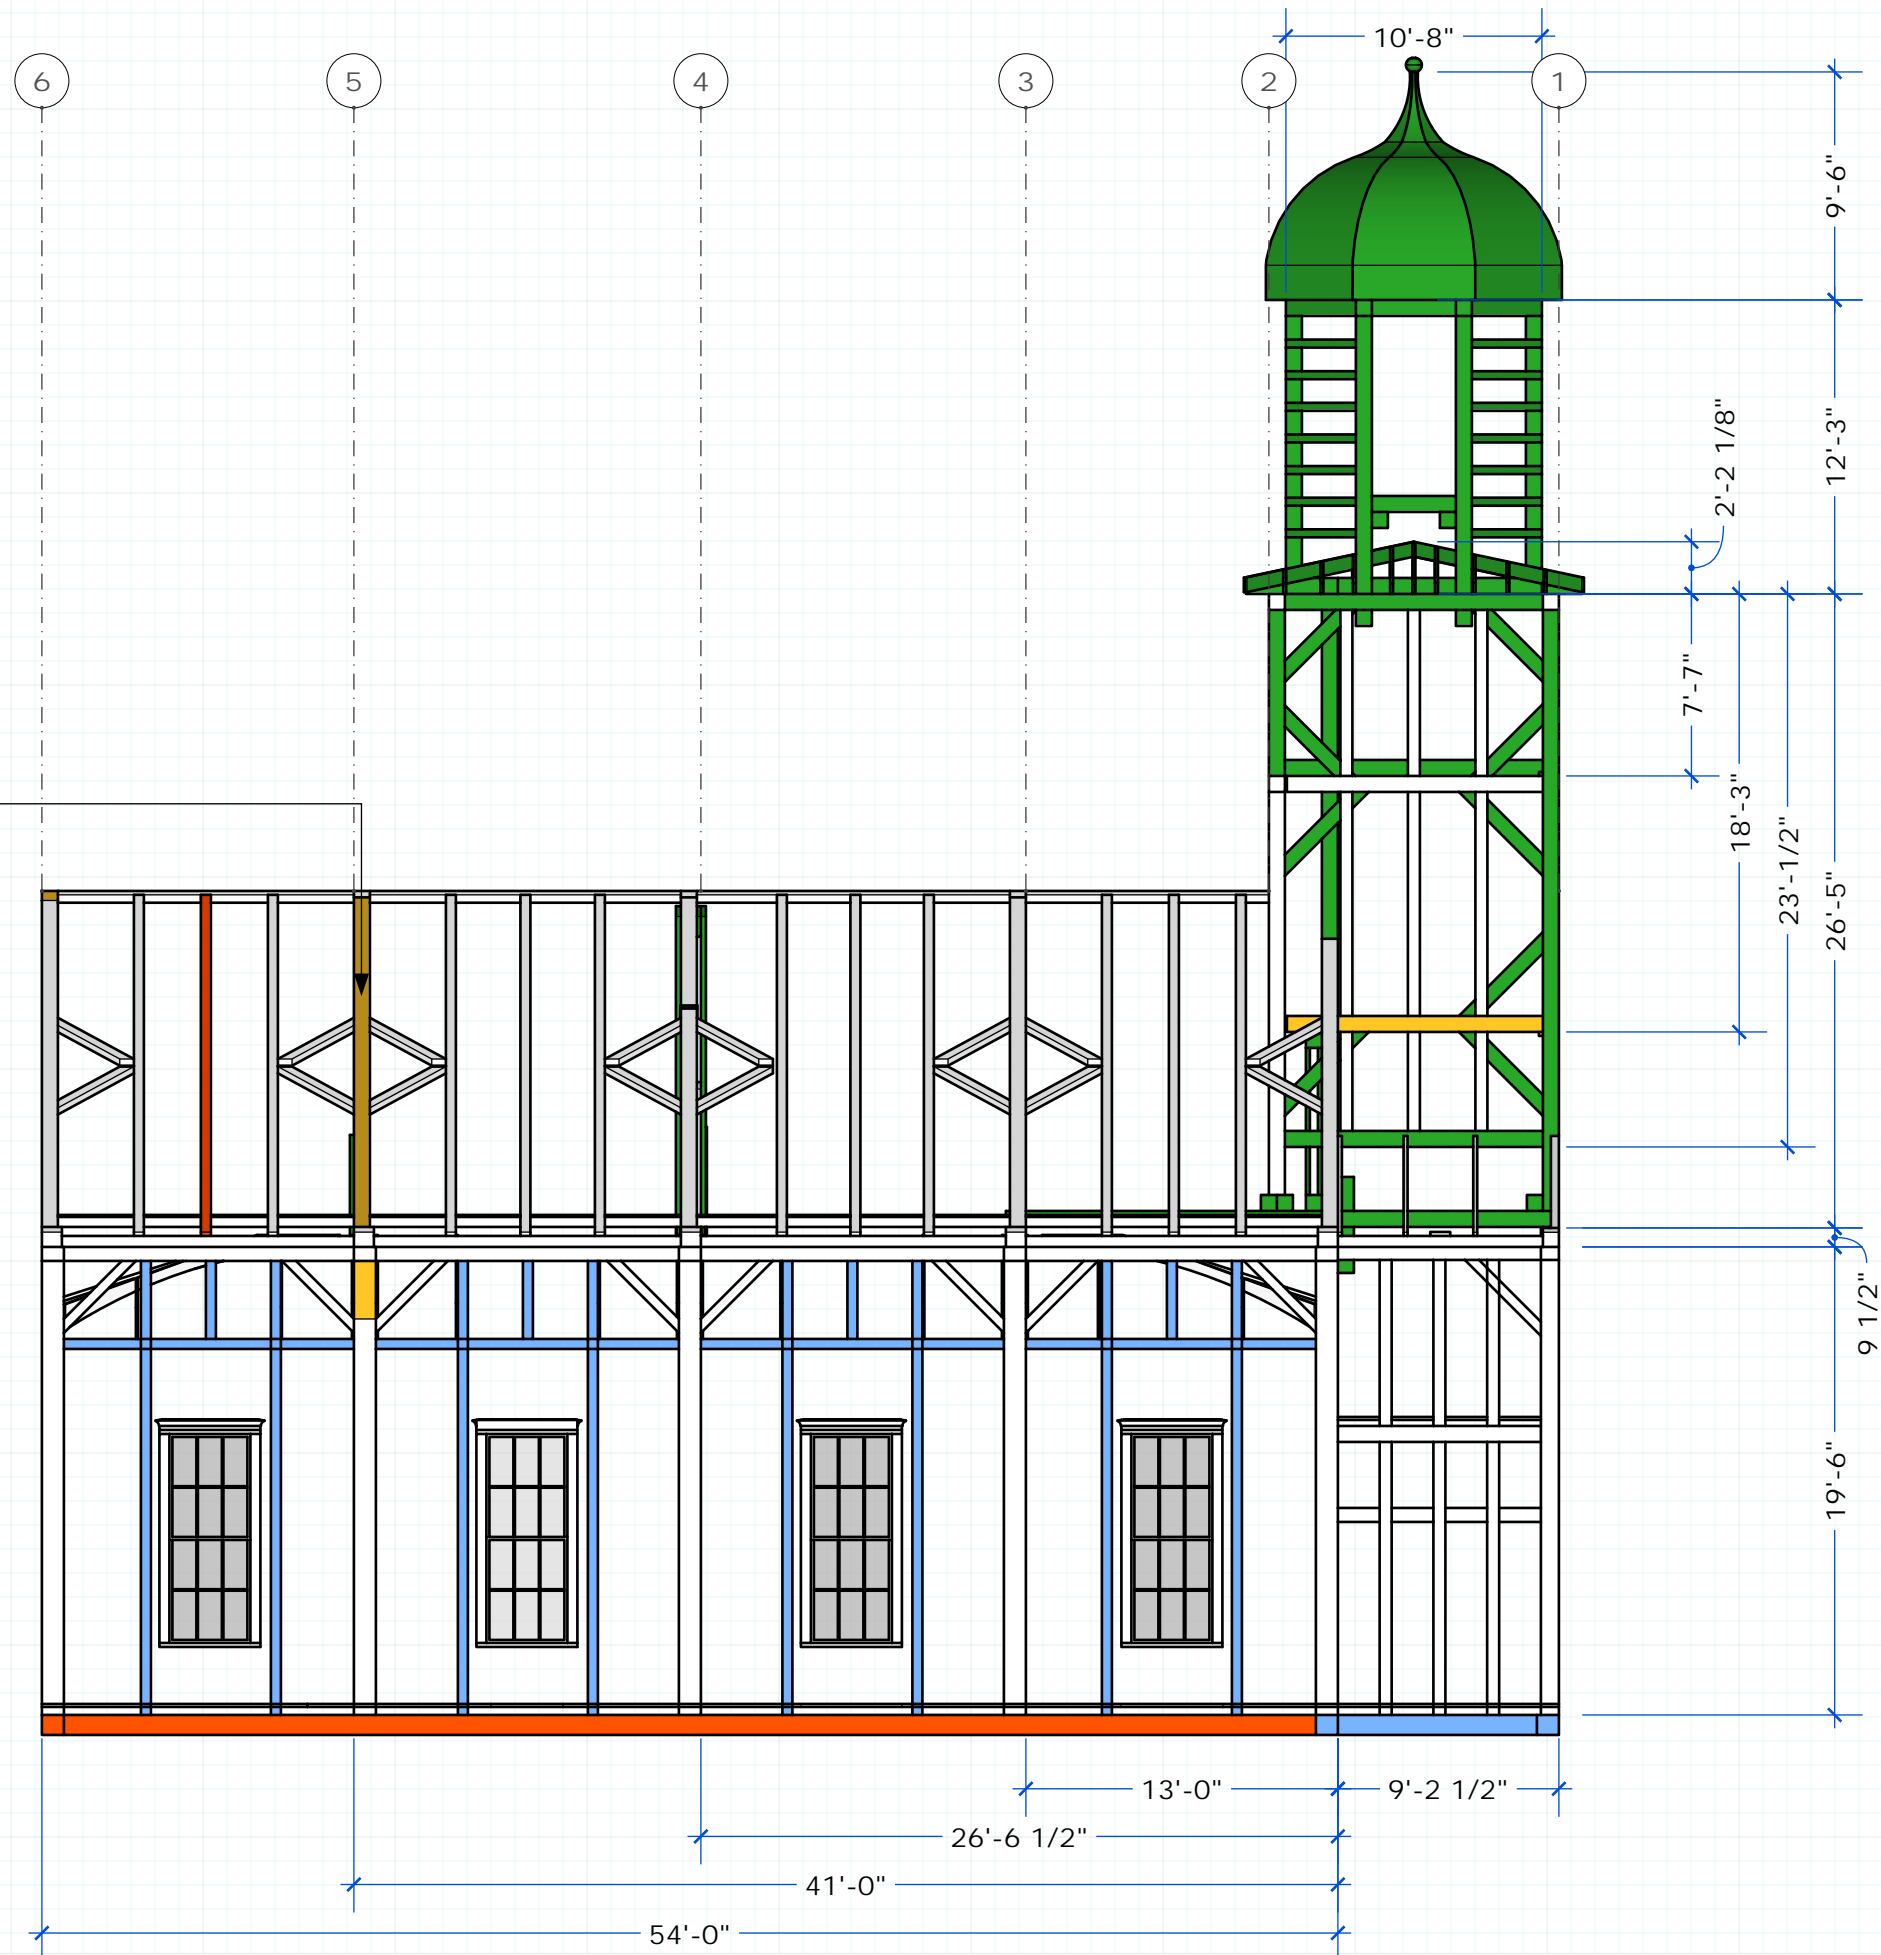
Wall A

Roof sheathing shows extreme water staining at this point

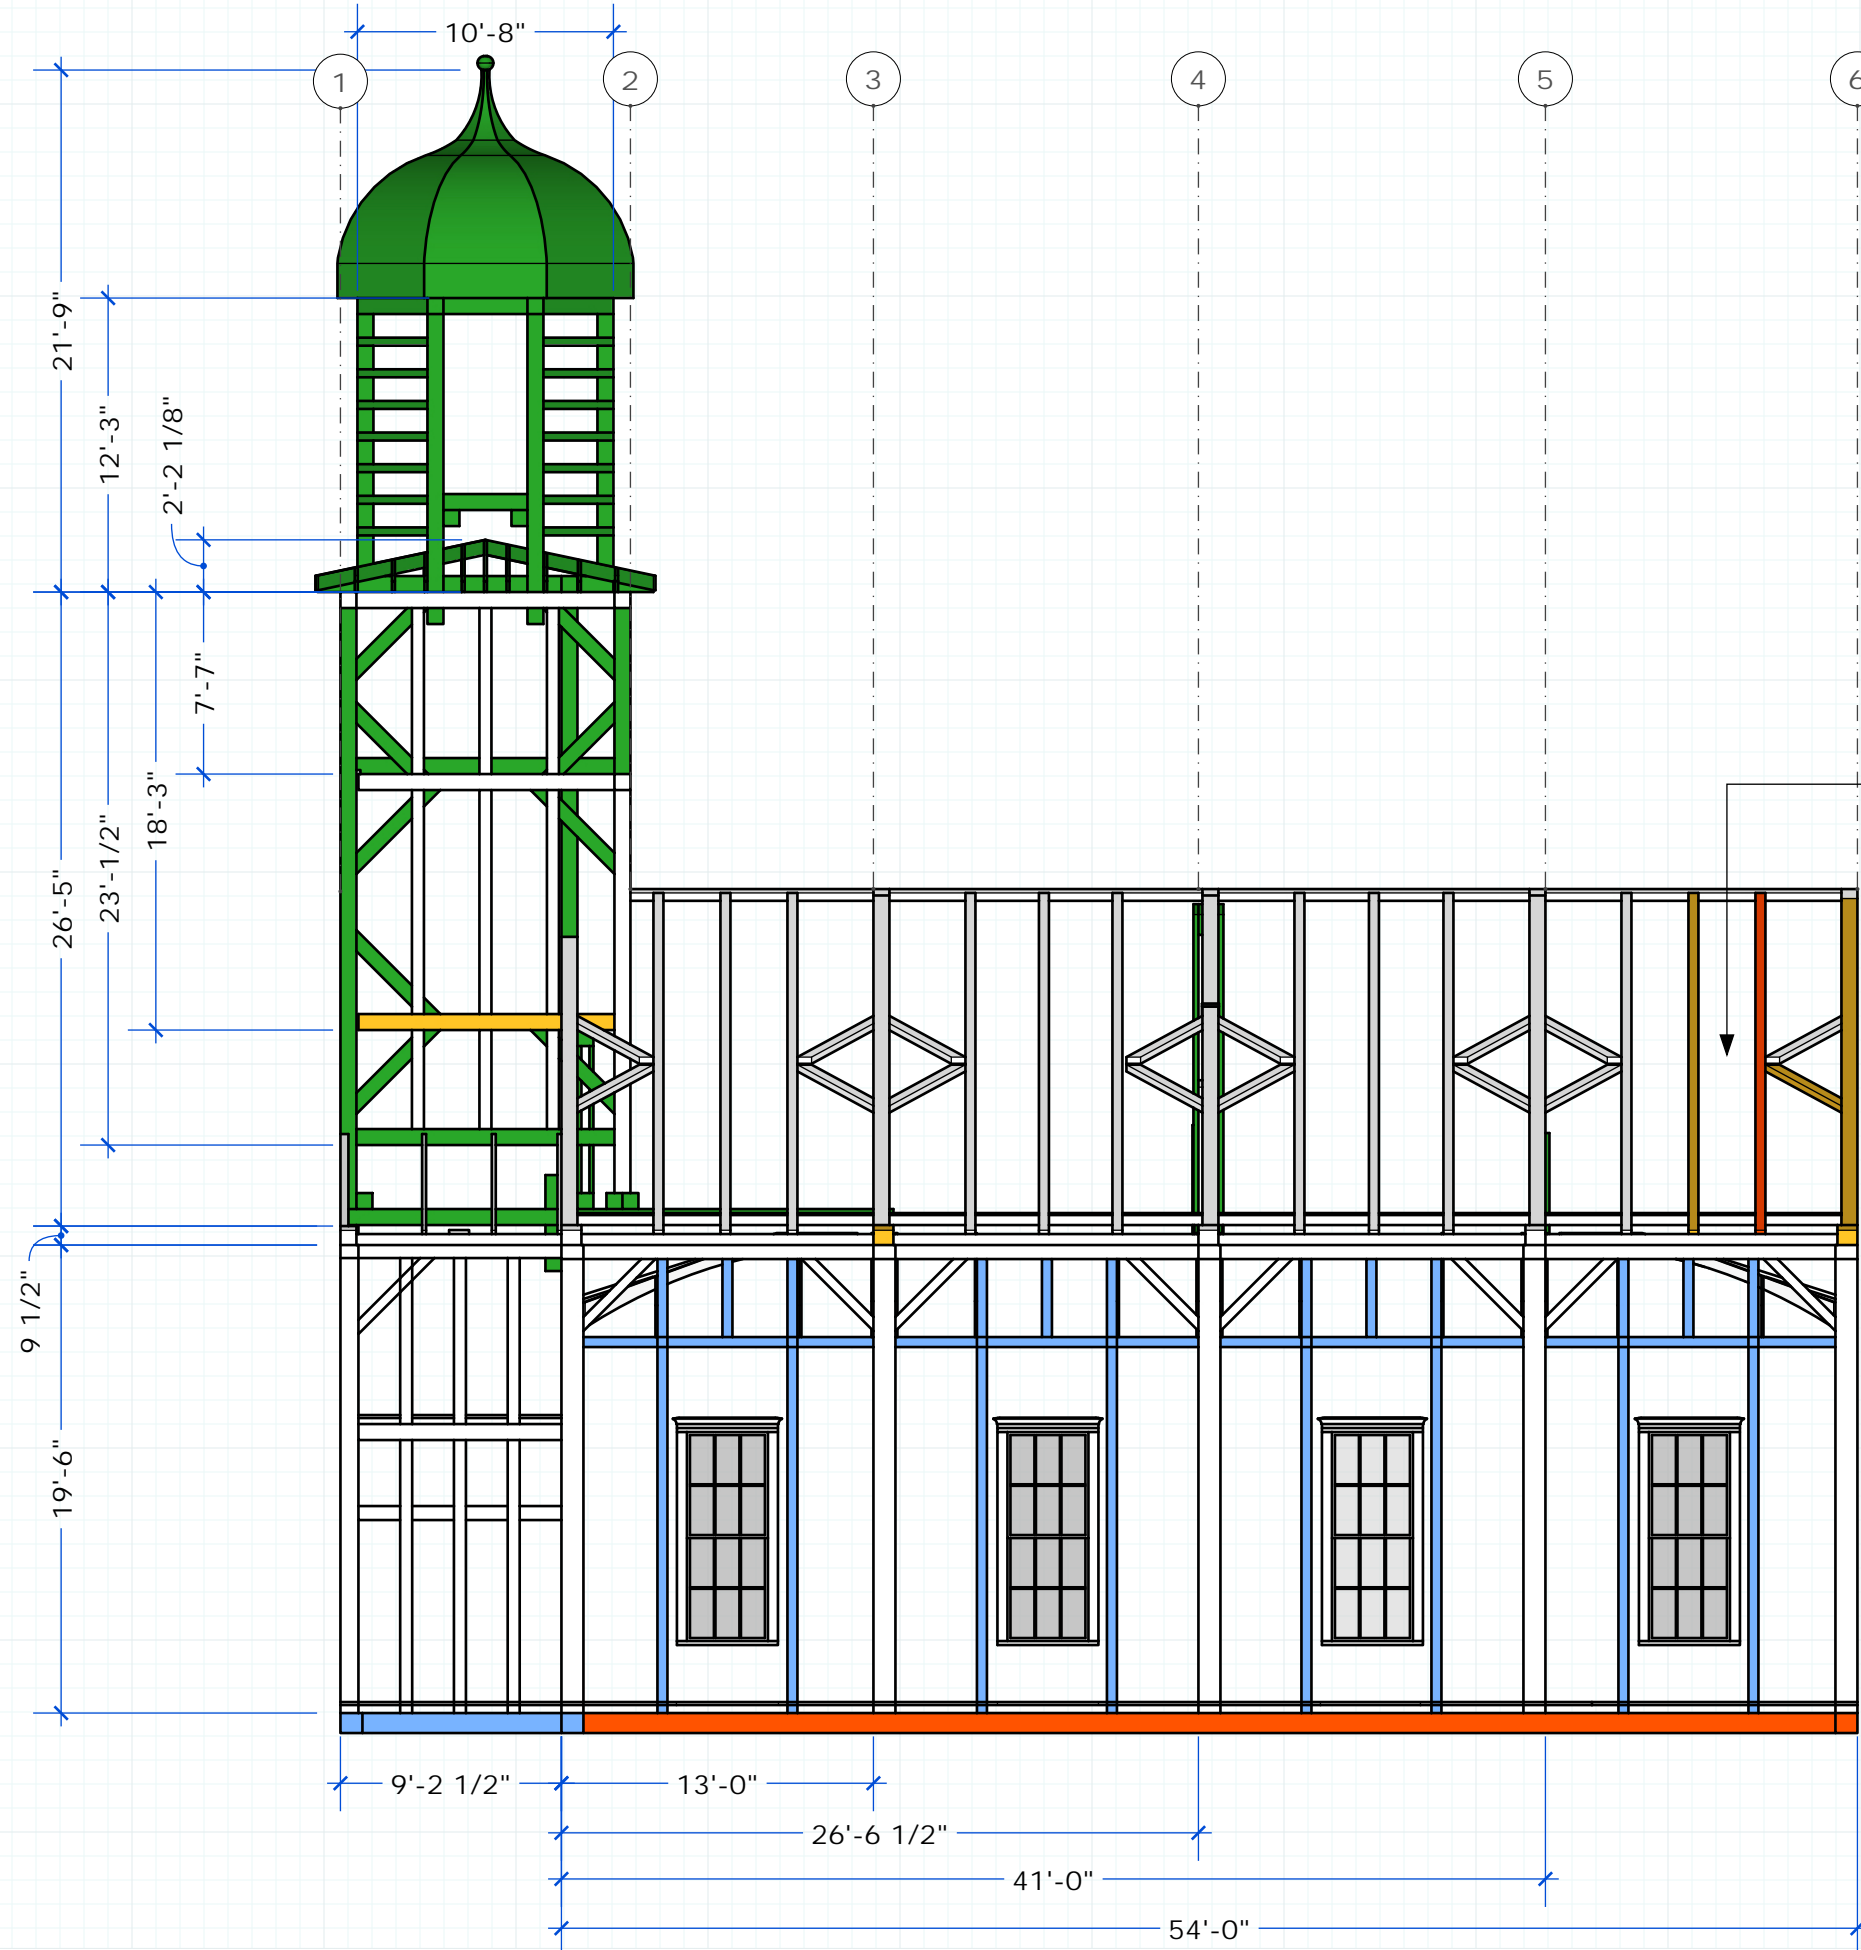
Wall F

Roof sheathing shows excessive water staining
