## **MEMORANDUM**

**Re:** Riverview House – Due Diligence, Environmental Review, and Brownfields Eligibility

**PHASE I ENVIRONMENTAL SITE ASSESSMENT  
RIVERVIEW HOUSE  
8 RIVER ROAD  
BOWDOINHAM, MAINE**

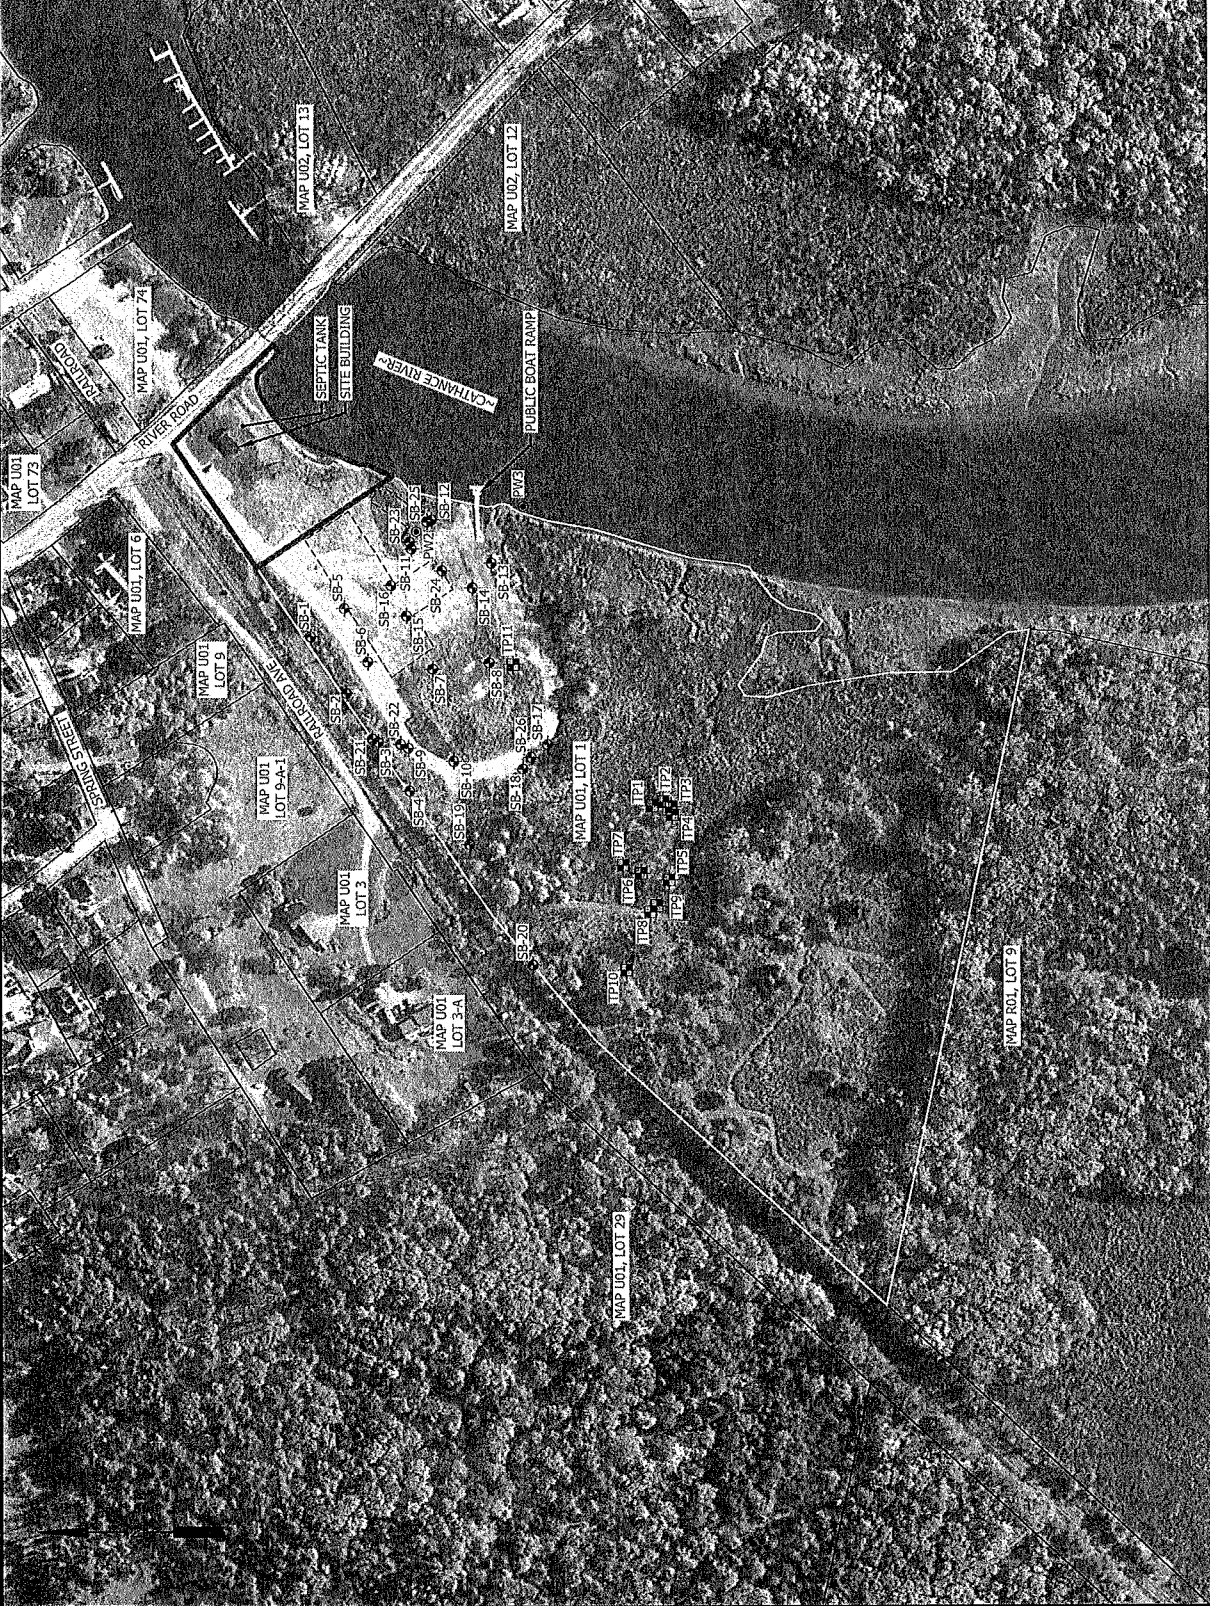
**NOTES:**  
 1. AERIAL PHOTO FROM GOOGLE EARTH, DATED 10/21/2024.  
 2. PARCELS FROM MAINE GIS DATA CATALOG.

**NOTES:**  
 LOT 1 BOUNDARY  
 LOT 2 BOUNDARY  
 FORMER BUILDINGS (APPROXIMATE)  
 ABUTTING PARCELS

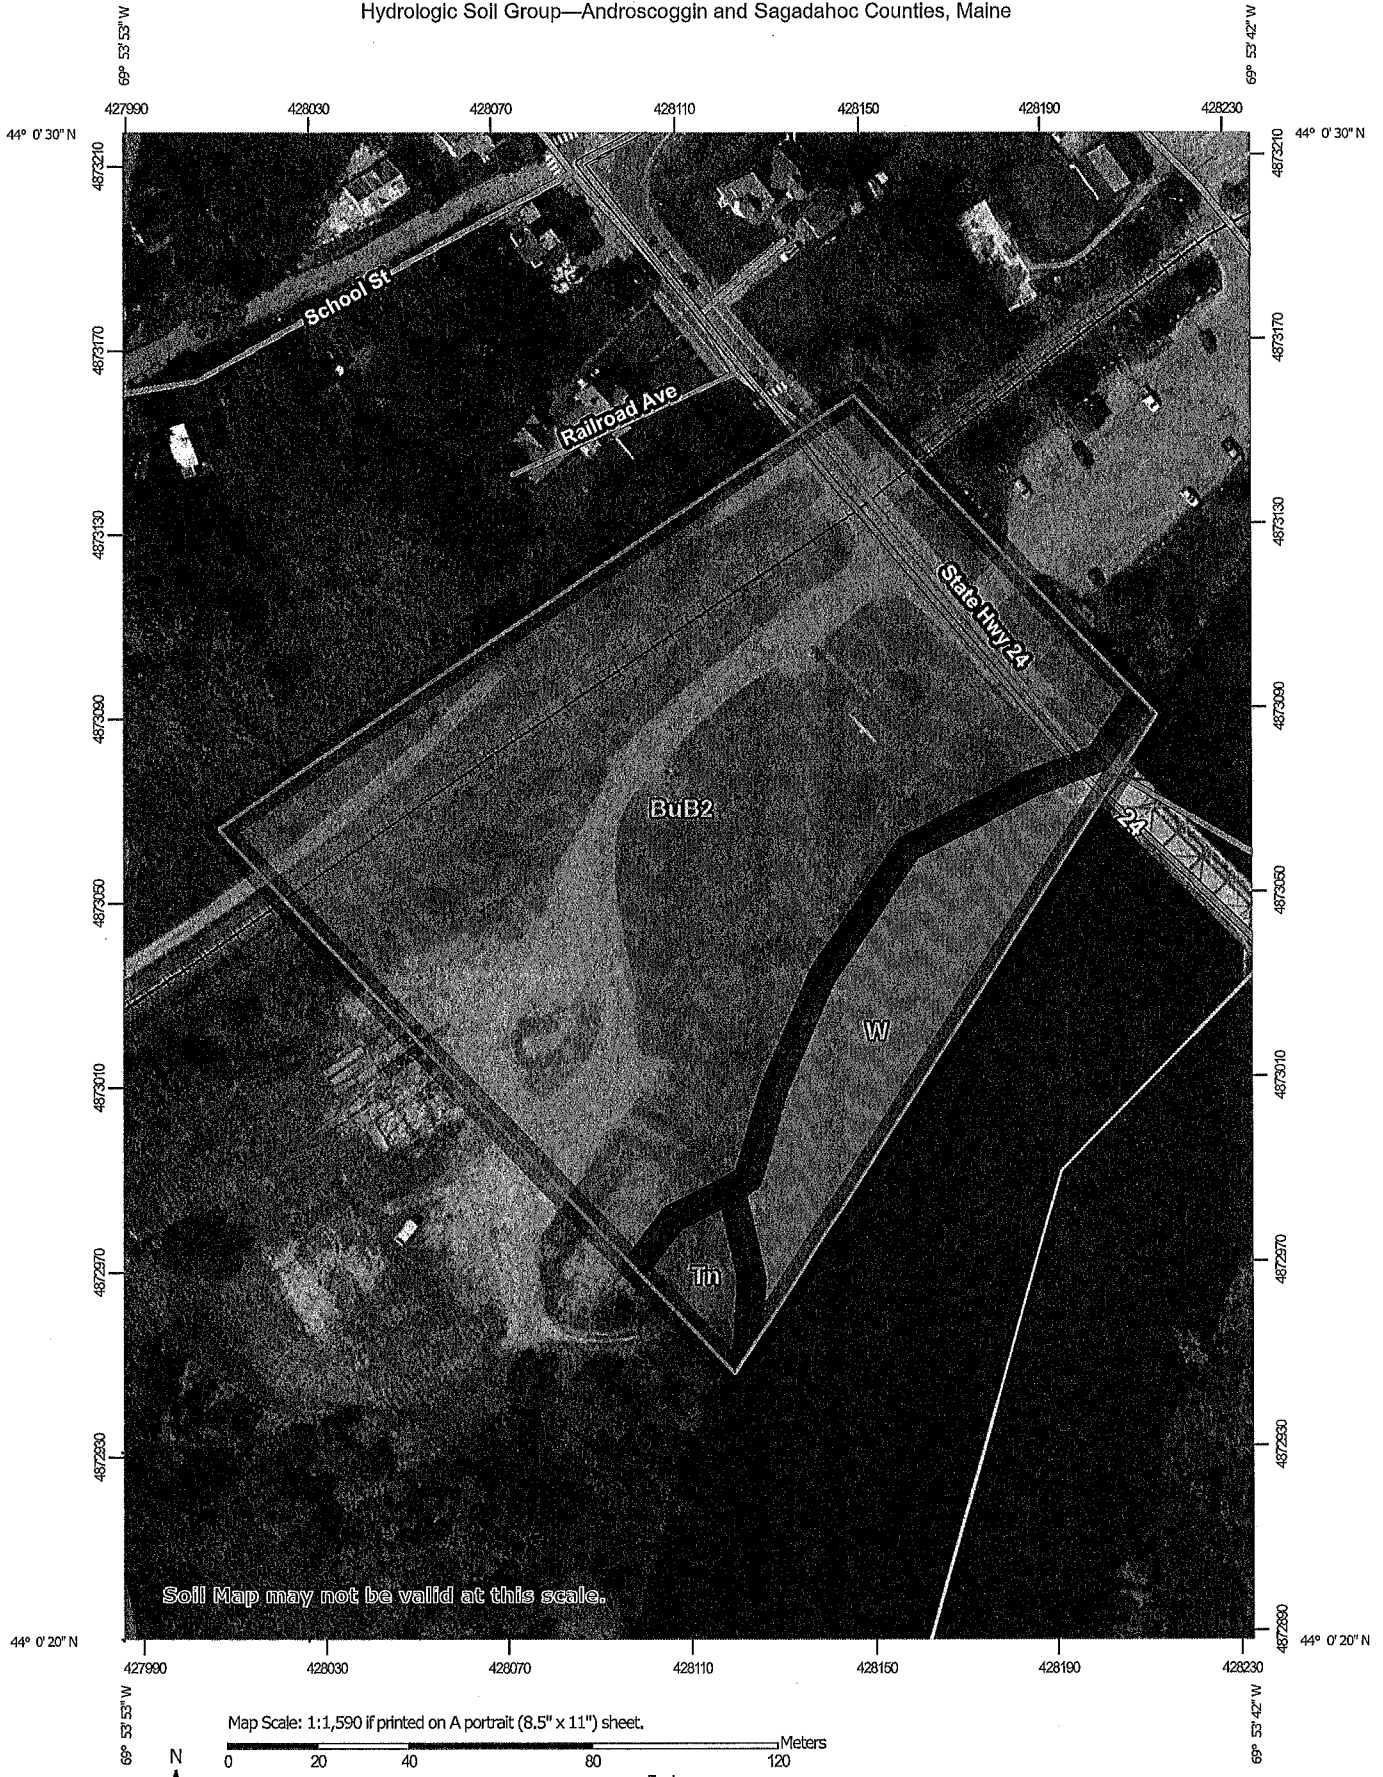
Hydrologic Soil Group—Androscoggin and Sagadahoc Counties, Maine

Map Scale: 1:1,590 if printed on A portrait (8.5" x 11") sheet.
