**PHASE I ENVIRONMENTAL SITE ASSESSMENT  
RIVERVIEW HOUSE  
8 RIVER ROAD  
BOWDOINHAM, MAINE**

Prepared for  
**MIDCOAST COUNCIL OF GOVERNMENTS**  
165 Main Street  
P.O. Box 62  
Damariscotta, Maine 04543

On behalf of  
**TOWN OF BOWDOINHAM**  
13 School Street  
Bowdoinham, Maine

March 13, 2026

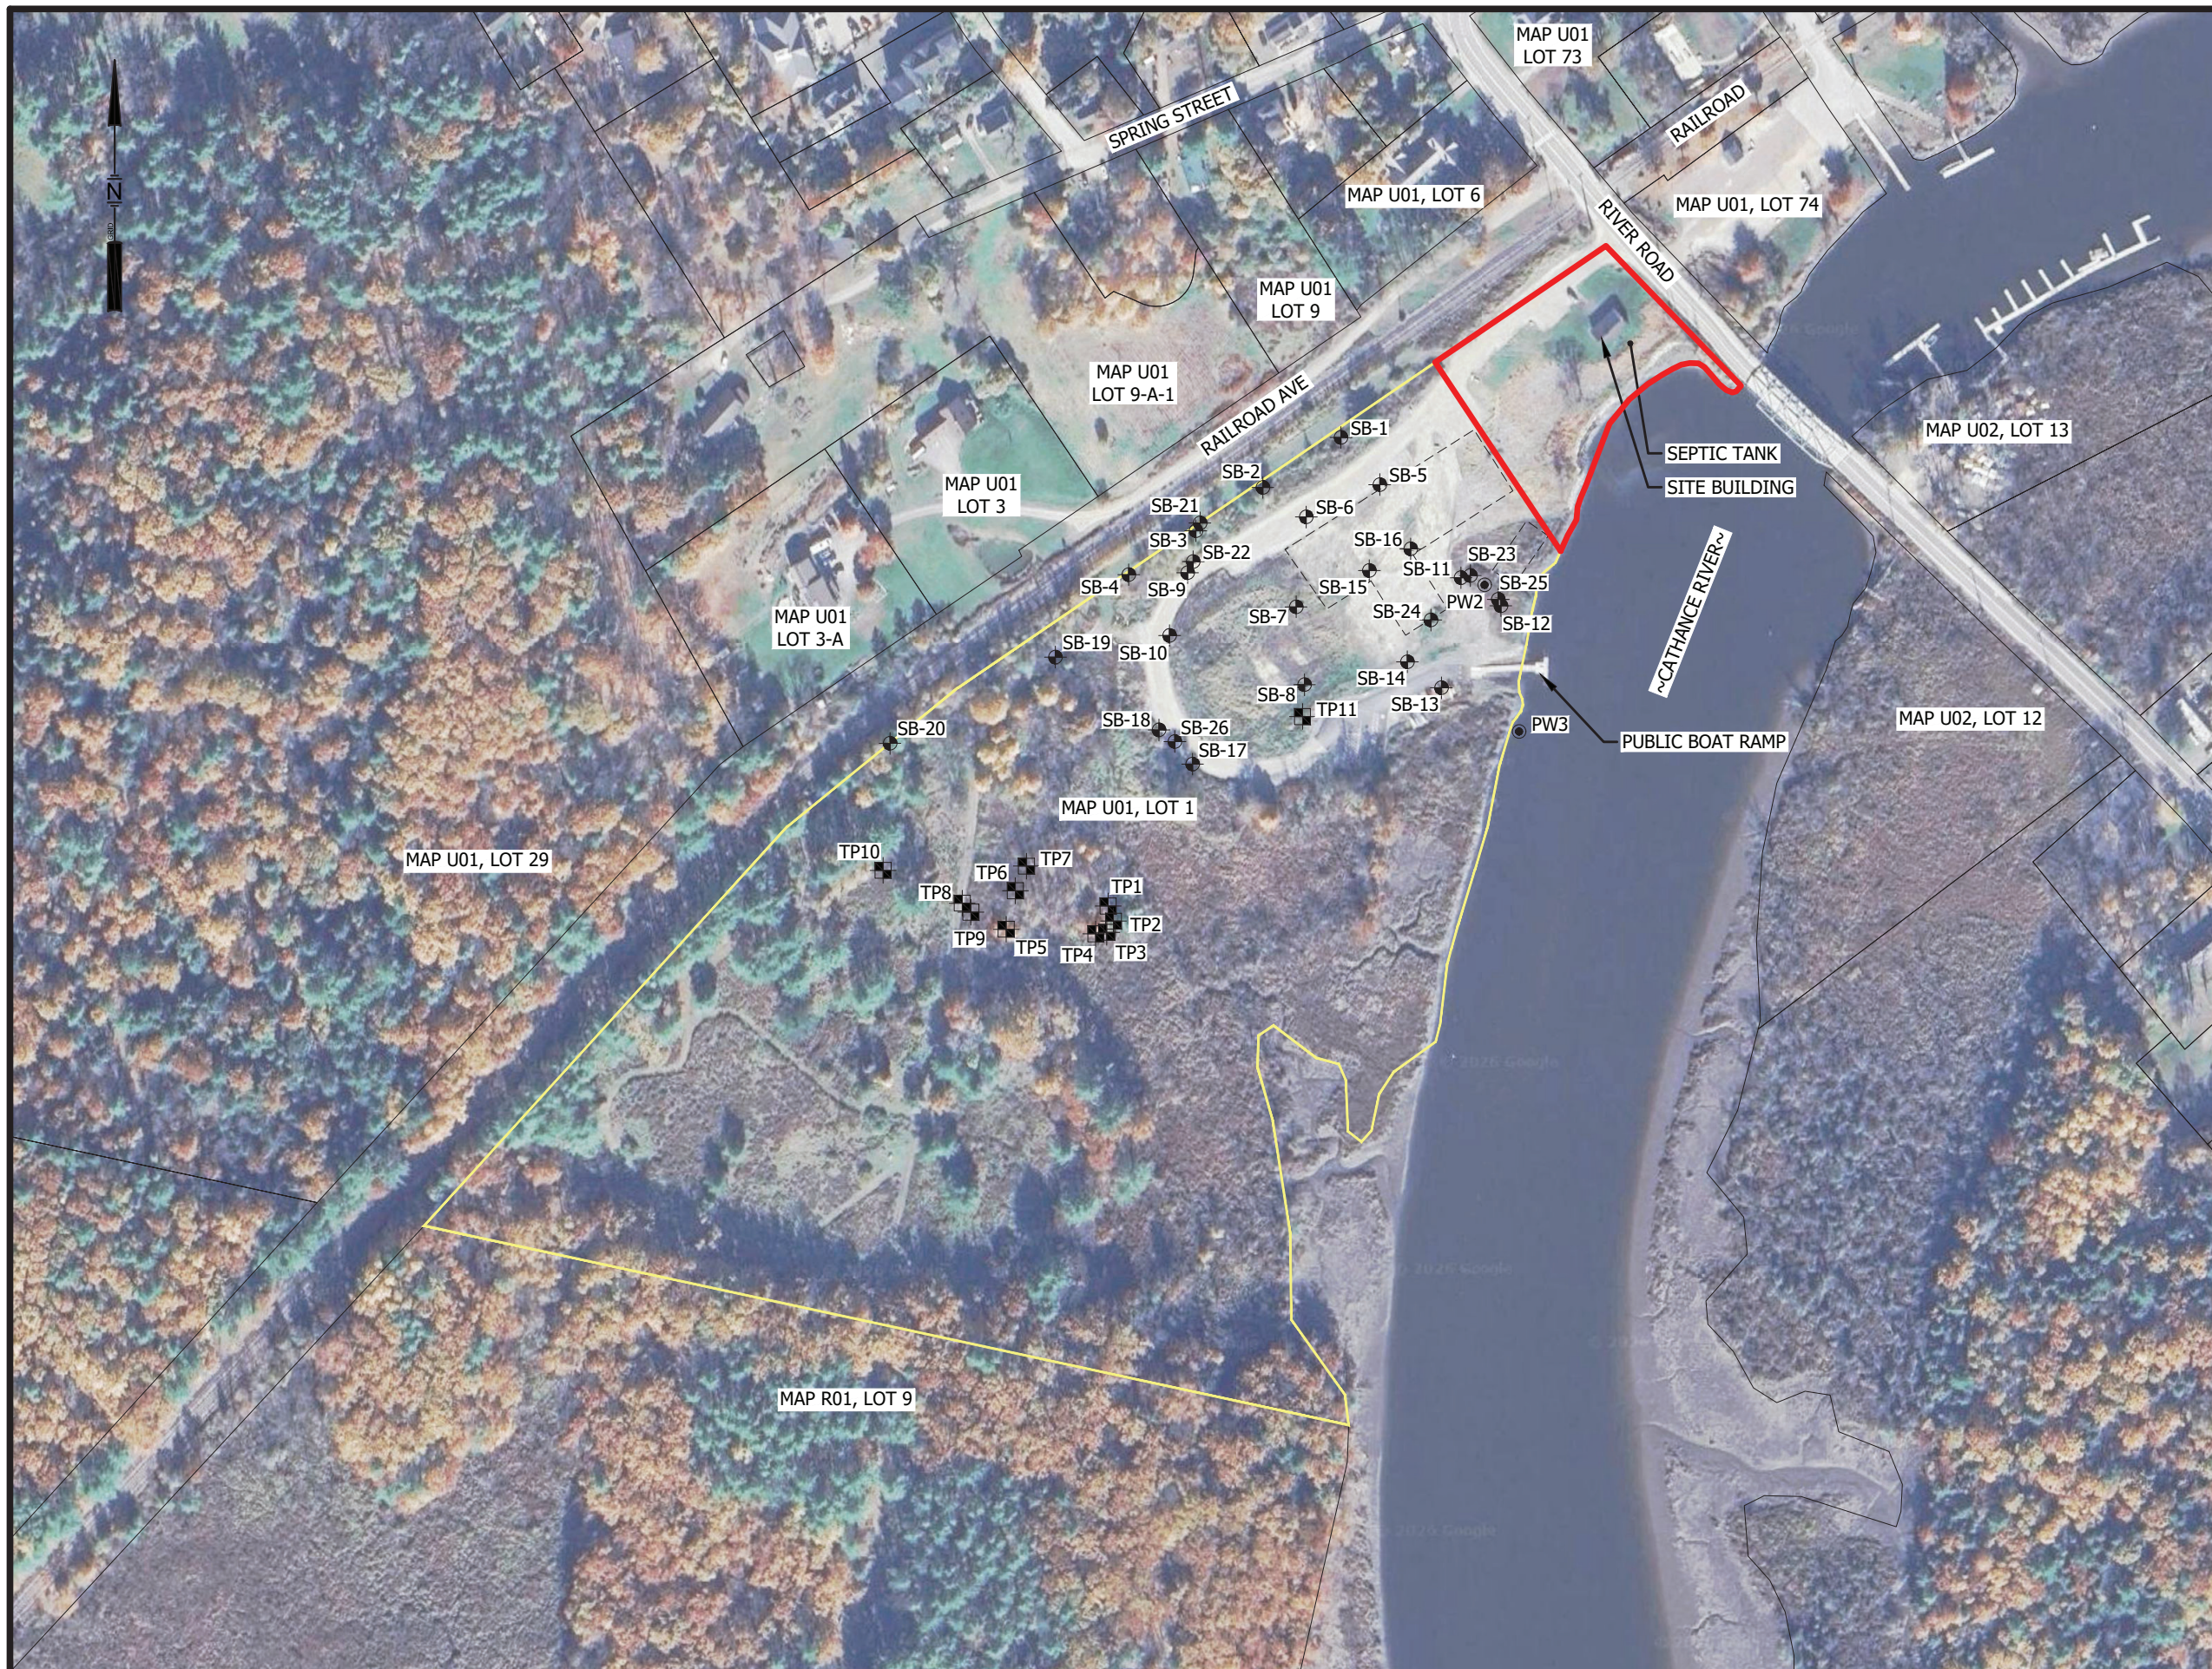
**FIGURE 2**  
**SITE PLAN**  
 RIVERVIEW HOUSE  
 8 RIVER ROAD  
 BOWDOINHAM, MAINE

- NOTES:**
1. AERIAL PHOTO FROM GOOGLE EARTH, DATED 10/21/2024.
  2. PARCELS FROM MAINE GIS DATA CATALOG.

- NOTES:**
- LOT 1 BOUNDARY
  - SITE BOUNDARY
  - - - - - FORMER BUILDINGS (APPROXIMATE)
  - ABUTTING PARCELS
  - ⊠ TEST PIT LOCATIONS (MEDEP, 2019)
  - PORE WATER SAMPLE LOCATIONS (MEDEP, 2019)
  - ⊕ SOIL BORING LOCATIONS (HALEY WARD, 2021)

A Site Plan is included as Figure 2.
