# **STRUCTURAL BARN EVALUATION**

**243 POST ROAD  
BOWDOINHAM, MAINE 04008**

Inspection Date: September 25, 2020

Project No. 20-0377-ME

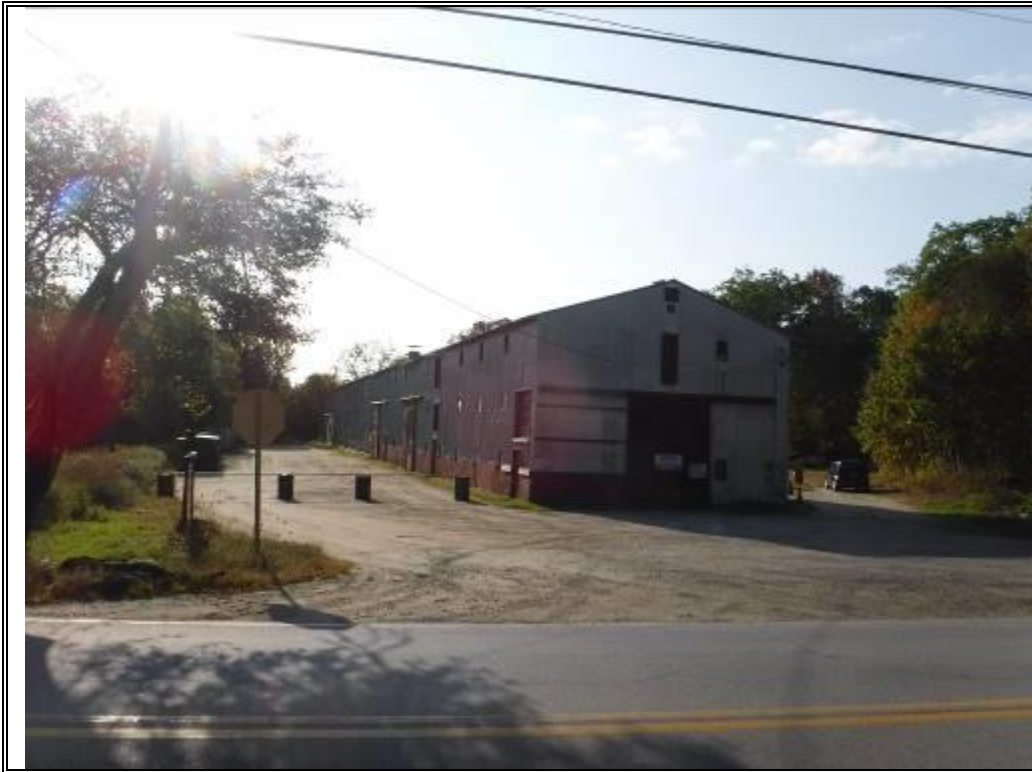
**Photo Number**  
**1**

**Description:**  
North and West  
Exterior

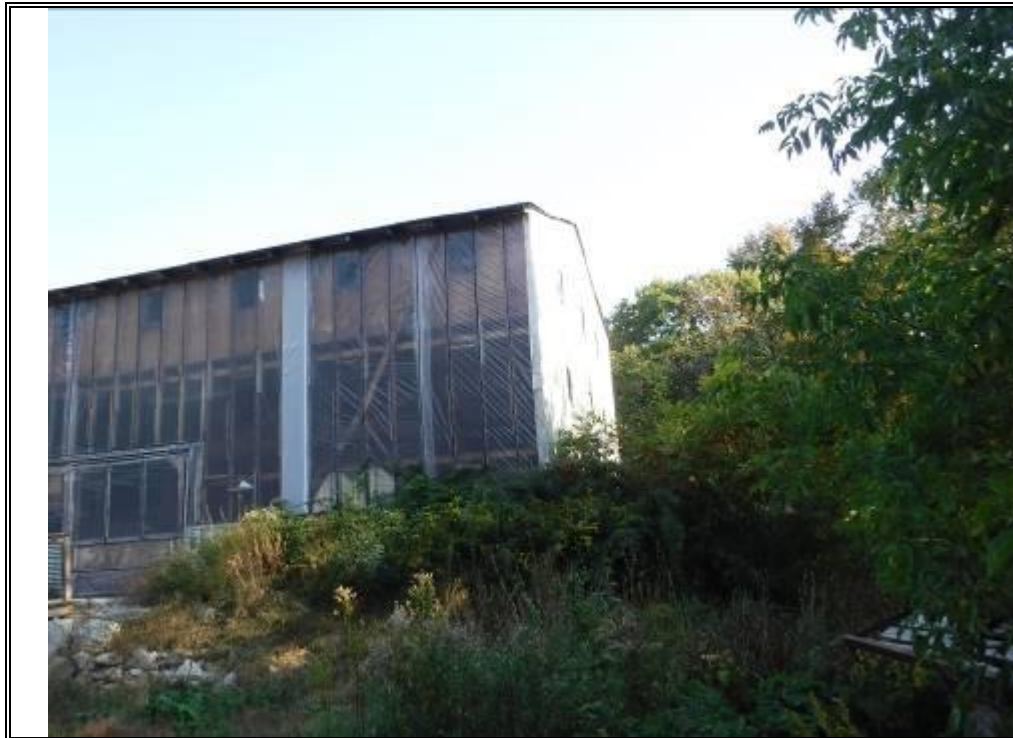
**Photo Number**  
**4**

**Description:**  
East end of South  
Wall, East Exterior

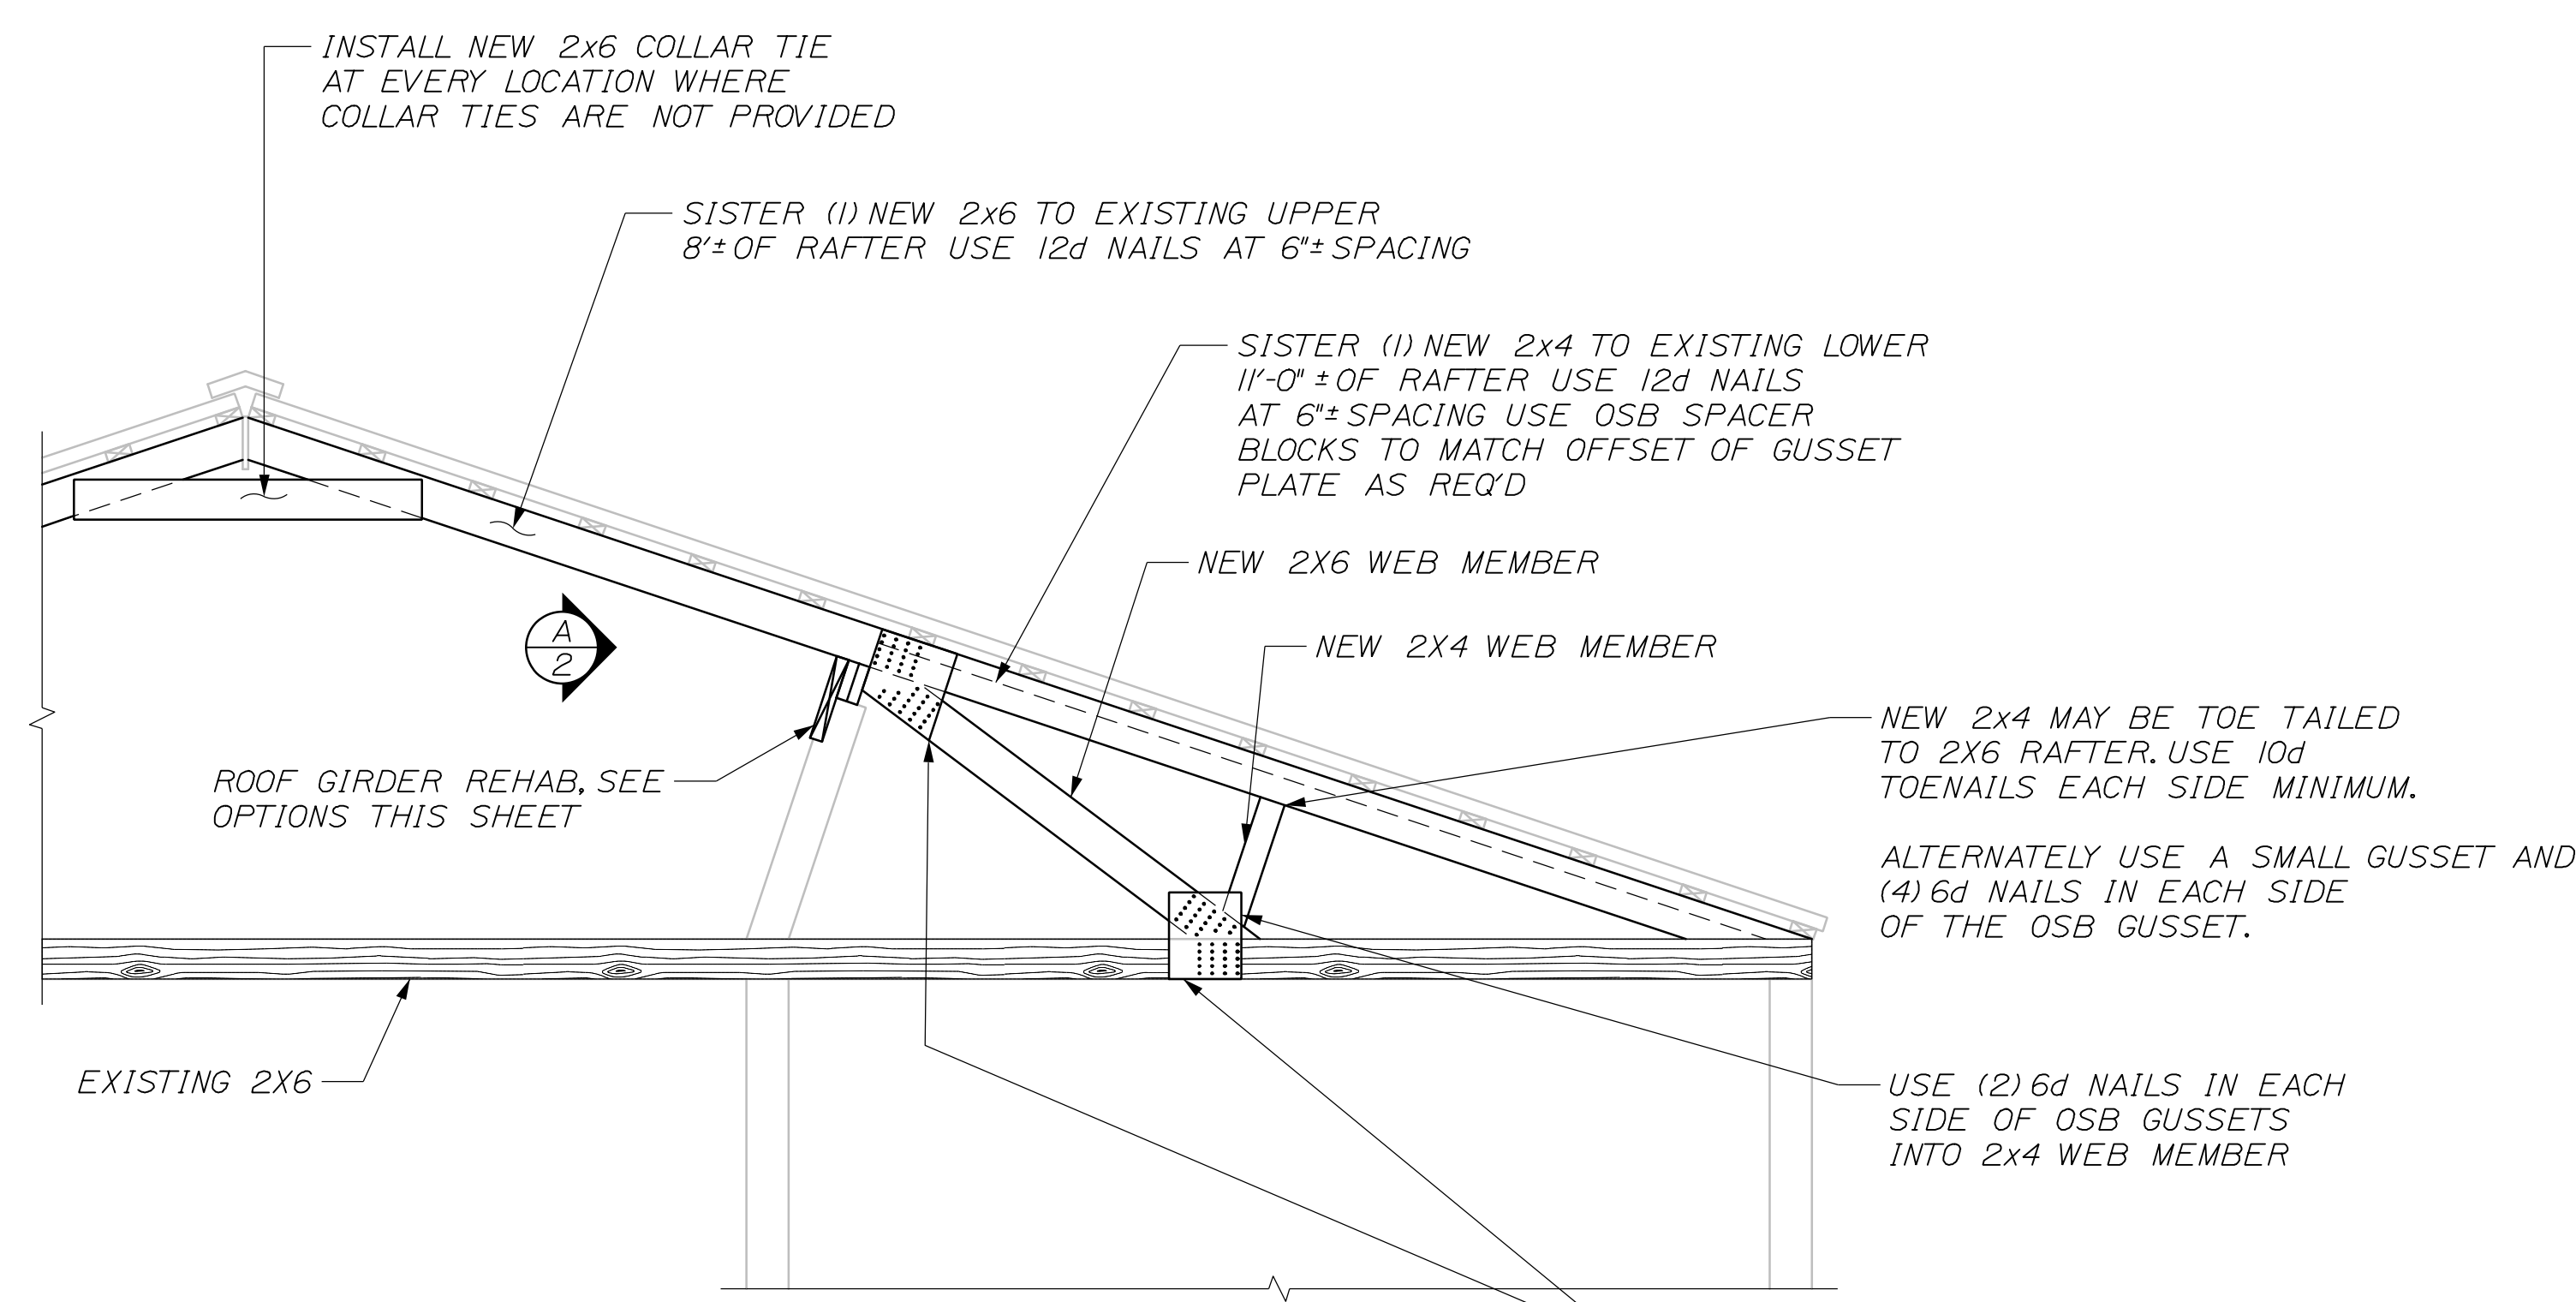
The recommended rehabilitation for the Upper section of the 2x6 rafter is to sister an additional 8'-0" +/- long 2x6 to the existing rafter.

There are (2) recommended rehabilitation options for the lower section of the 2x6 rafter. The first option is to add (1) 2x6 web member and (1) 2x4 web member to the lower section, converting this portion into a truss structure. These members would be fastened to the existing members with plywood or OSB gusset plates and nails. This option would also require (1) 2x4 to be sistered to the existing rafter. (Option 1)

**ROOF REHAB OPTION #1**  
 1/2" = 1'-0"  
 NOTE: OPTION A & B ARE BOTH ACCEPTABLE REPAIRS FOR THE EXISTING FOR GIRDER

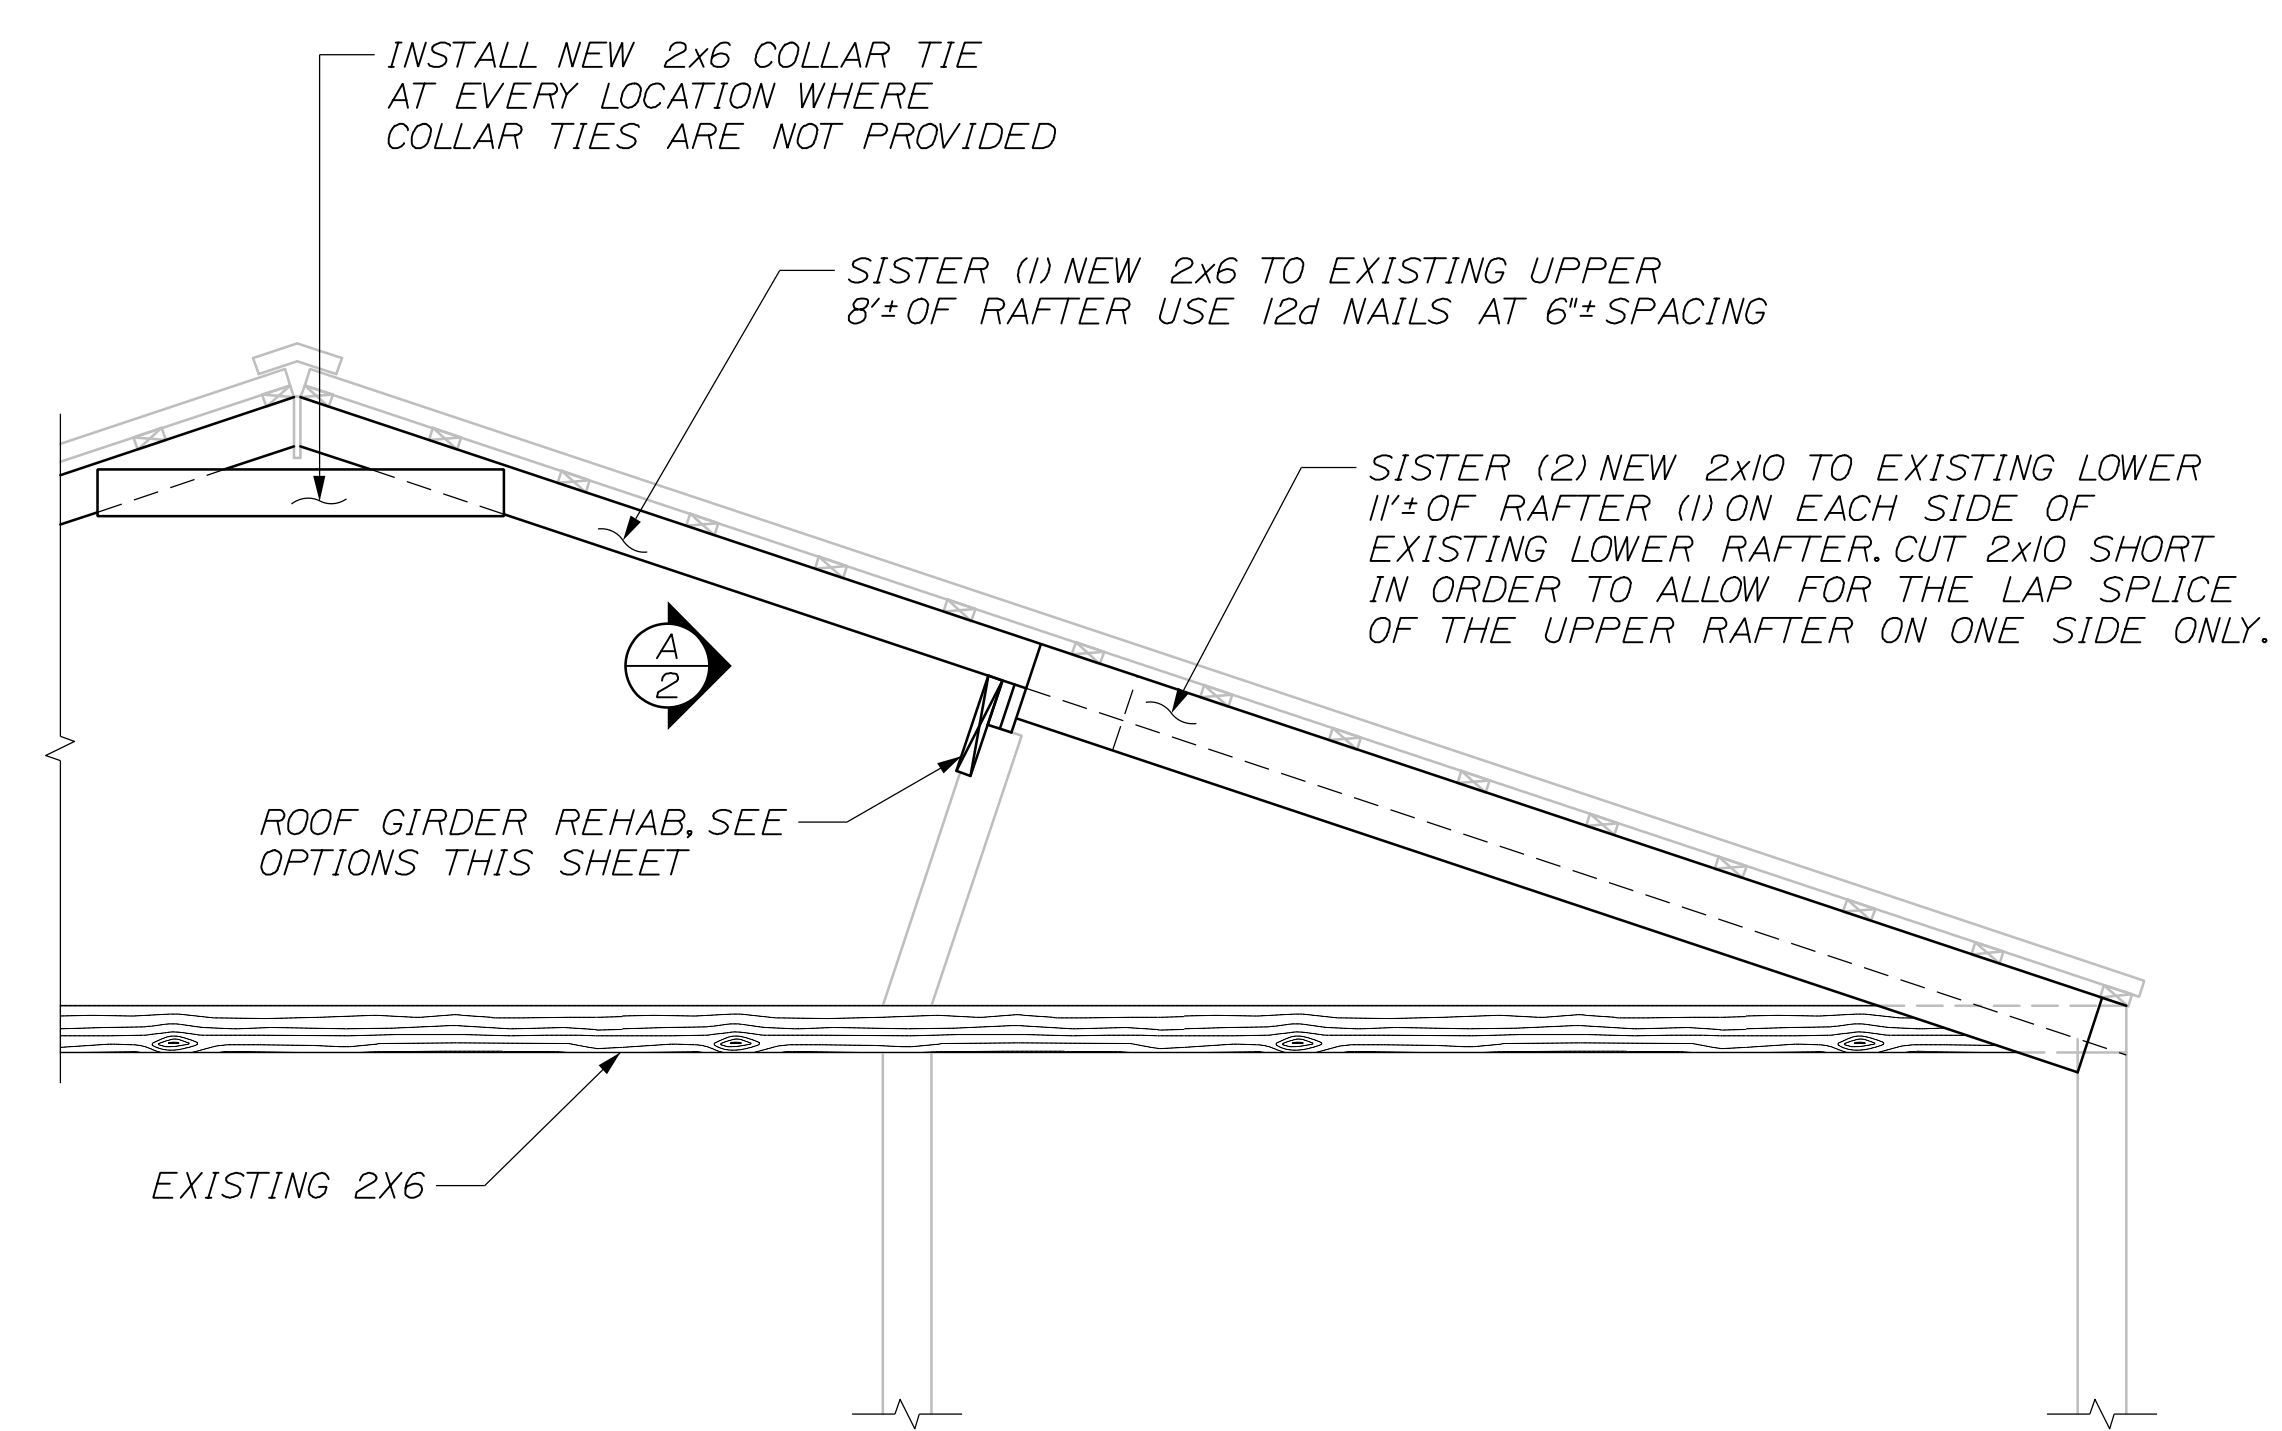
**ROOF REHAB OPTION #2**  
 1/2" = 1'-0"  
 NOTE: OPTION A & B ARE BOTH ACCEPTABLE REPAIRS FOR THE EXISTING FOR GIRDER

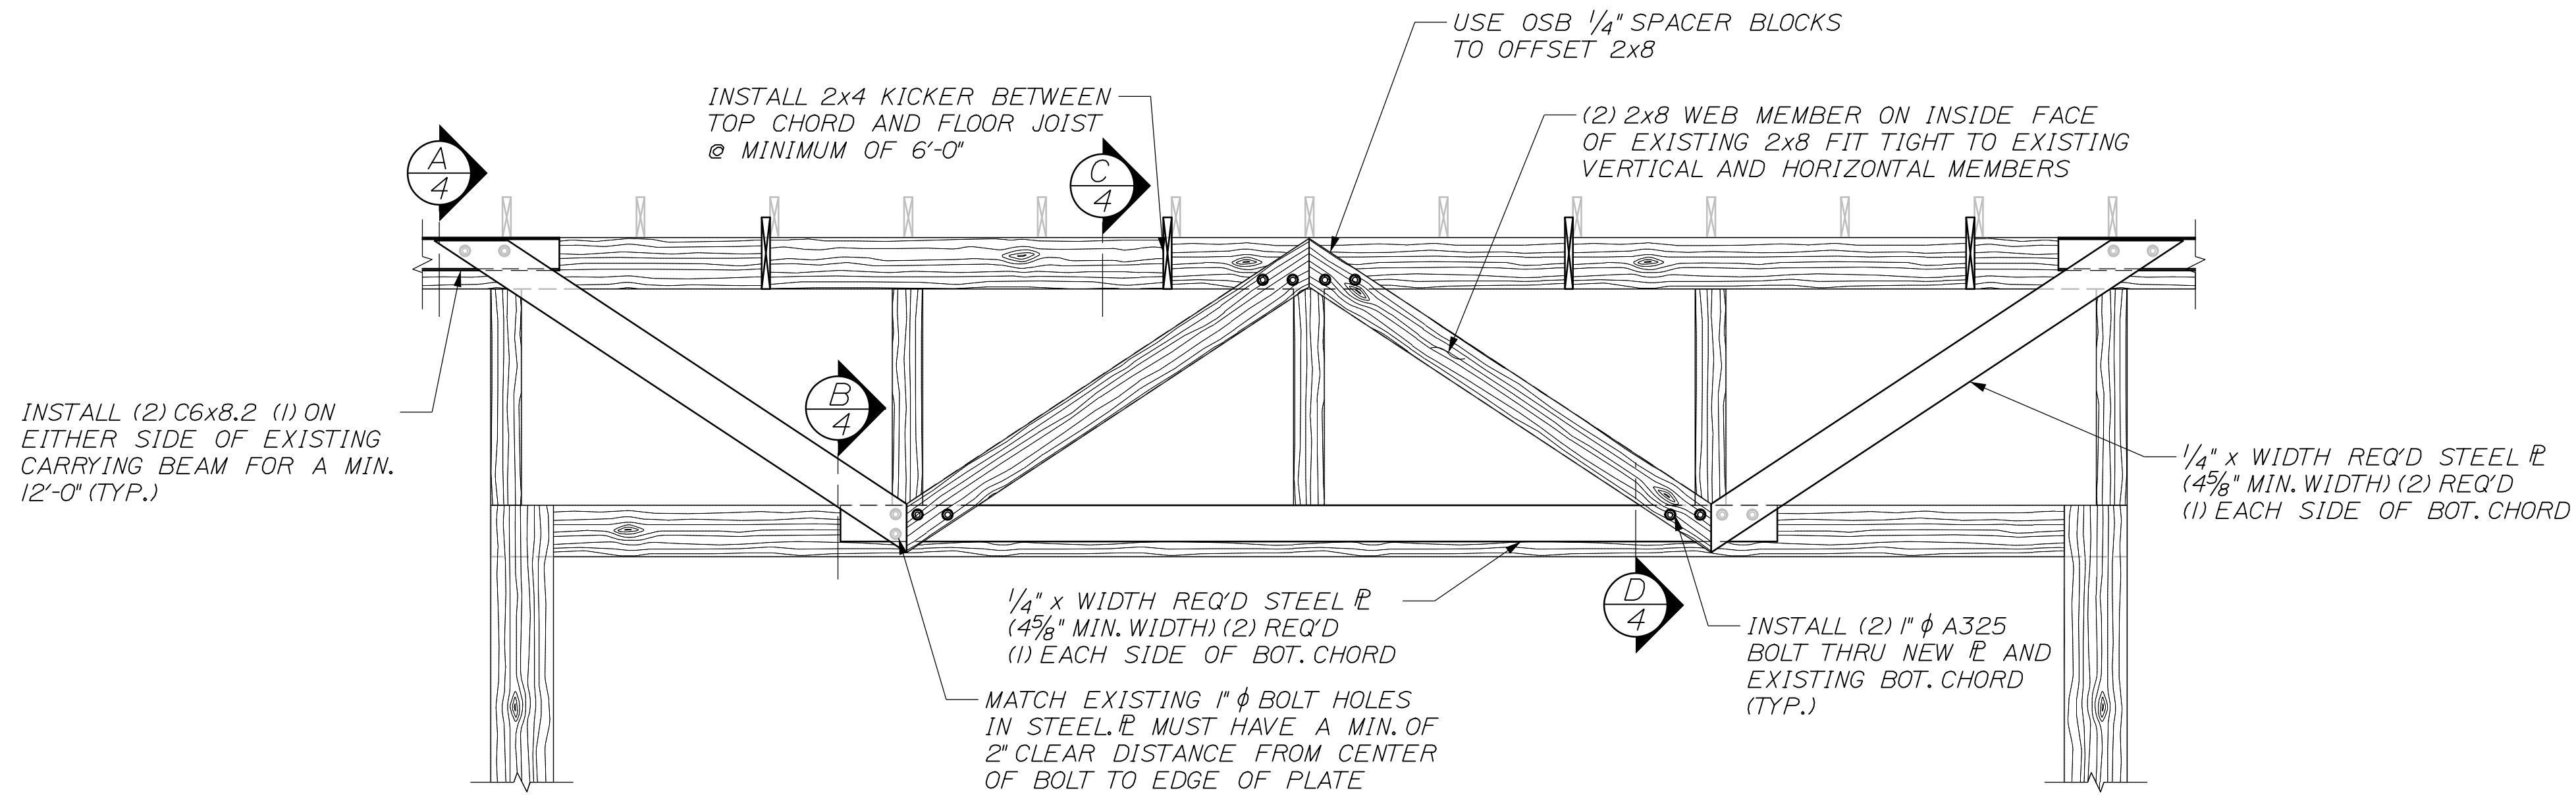
During inspection it was found that in the rear of the building there was a portion where the first floor is extended up to the floor joists of the 3rd floor. This sections is approximately 16' high and has (2) large trusses that span 24' each. The trusses have been modified with the addition of 1" diameter bolts to the connection of the tension diagonal web members. Calderwood Engineering performed an analysis of the existing truss and found that not all the existing members were adequate to carry the design loads. The following truss members were found to be undersized:

**CEILING TRUSS REHAB**  
 $\frac{1}{2}'' = 1'-0''$   
 NOTE: (2) 2x8 MAY BE SUBSTITUTED WITH (1) SOLID SAWN 6x6

The recommended option for the rehabilitation of the bottom chord is to add (2) 1/4" thick plates to the middle 14' +/- of the bottom chord. It was determined that the tension force in the bottom chord in the middle portion could be carried by adding (3) 2x10 to the existing (3) 2x10, but this did not seem feasible so the addition of a steel plate was inspected. The new steel plate should be connected with the existing 1" diameter through bolts located in the bottom chord. The minimum required width of the plate was found to be 4 5/8", but it is very likely that the location of the existing bolt holes will control the width.

The recommendation for the top chord is to add (2) 2x4 lateral braces at 6' centers. Each brace should be connected to the top chord and extend at a 45° +/- angle to the existing floor joists. There would be (1) brace required on each side of the top chord every 6'. This option is recommended because it requires the least amount of work and material added to the top chord.

The recommendation for the tension diagonals is to replace the (2) 2x8 members with (2) 1/4" thick steel plates. Wood was not an option for the tension diagonal because

it would require (5) additional 2x8 which did not seem feasible. The 1/4" would be connected to the bottom chord with the same bolts as the bottom chord steel plates and would be connected to the top chord with the existing through bolts. Since the capacity of the bolts in the wood in the top chord is not adequate to develop the tension in the diagonal members, the installation of (2) C6x8.2 channels as described in the repair of the triple 2x8's above would be required. These channels should extend (1) span on each side of the truss and would be enough to strengthen those spans. With the addition of the channels the bolt capacity is large enough to develop the tension required for the diagonal members.

The recommended solution for the compression diagonals is to add (2) 2x10 or (1) 6x6 solid sawn post to the diagonals. These members would be cut to be wedged tight between the existing vertical and horizontal members. Also (2) 1" diameter A325 bolts should also be installed through the existing 2x8 compression members and bottom/top chord in order to develop the compression members. Both the bolts and the direct compression of the additional members would be required to develop the compression force required.

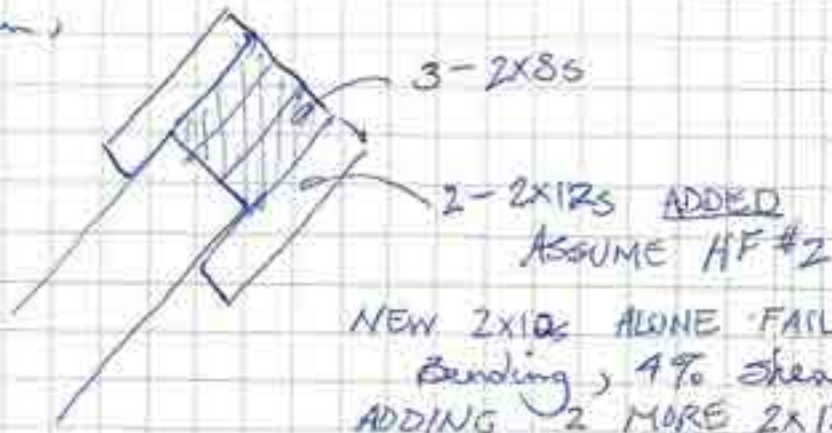
Rafter Beam,  
MODIFIED

NEW 2x12s ALONE FAIL BY 58%  
BENDING, 4% Shear  
ADDING 2 MORE 2x12s FAILS IN  
BENDING BY 16%

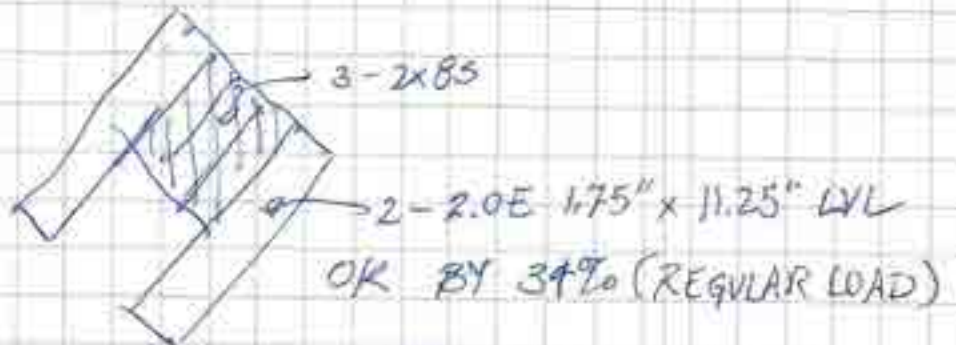
TRY ADDING LVLs

OK BY 34% (REGULAR LOAD)

RAFTERS @ 8' WORKS BY 25% (REGULAR LOAD)

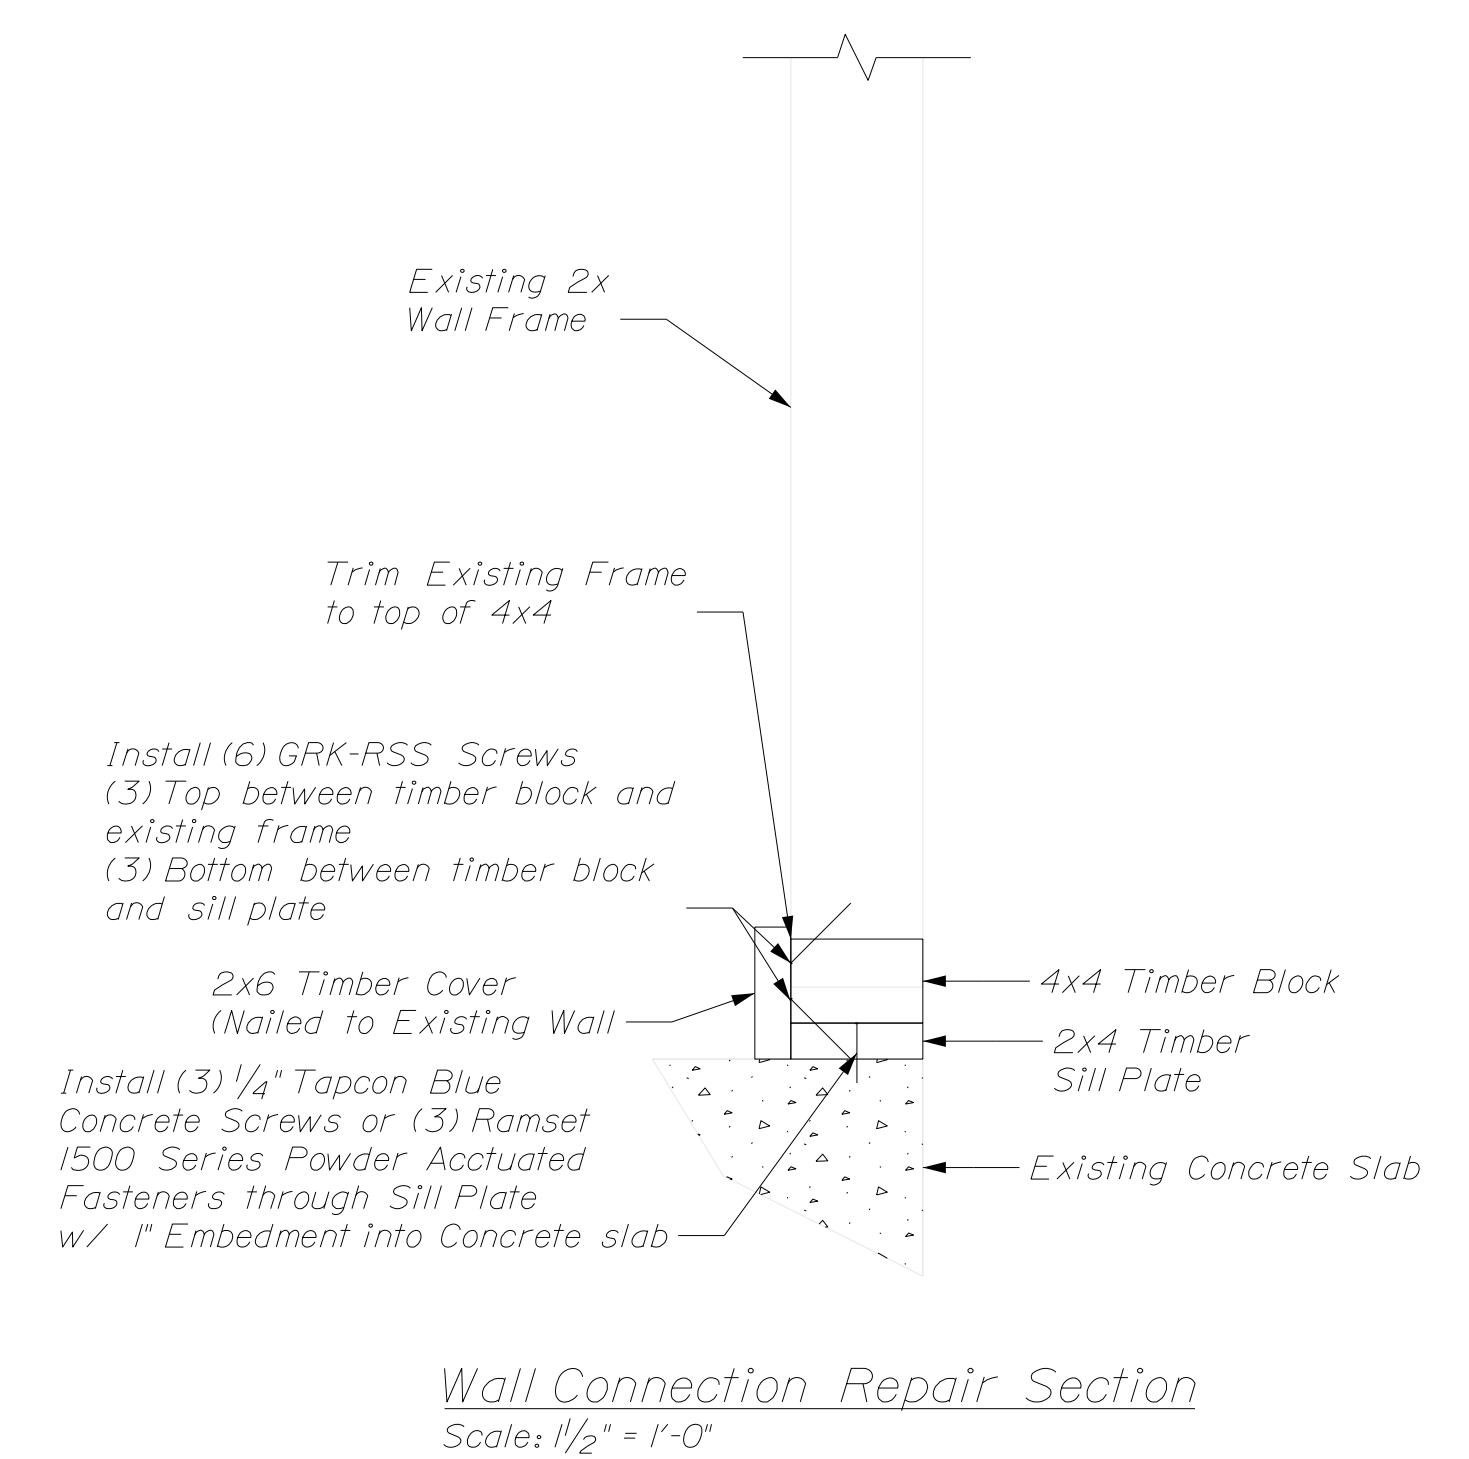
*Wall Connection Repair Section*  
Scale: 1/2" = 1'-0"

On the Northeast corner of the building, the wall next to existing door frame is not connected to the foundation. Calderwood Engineering has designed a connection between the existing timber wall frame to the concrete footing by installing a sill plate and connecting this to the existing door frame. See the attached details.

1. Concrete Screws to be Tapcon Blue with 1/4"φ and 1" Embedment into Concrete, or approved alternative.
2. Powder Actuated Nails to be Ramset 1500 Series with 1" Embedment into Concrete, or approved alternative.
3. Timber Screws to be GRK-RSS with a diameter of 1/4" and 1/2" Embedment into timber, or an approved alternative.
4. Timber cover to be measured in the field to cover the existing gap.
