# **STRUCTURAL BARN EVALUATION**

**243 POST ROAD  
BOWDOINHAM, MAINE 04008**

Inspection Date: September 25, 2020

Project No. 20-0377-ME

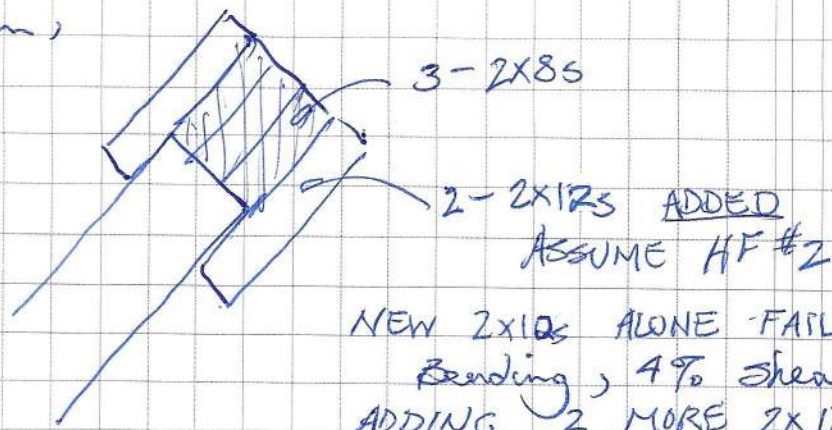
Rafter Beam,  
MODIFIED

NEW 2x12s ALONE FAIL BY 58%  
Bending, 4% Shear  
ADDING 2 MORE 2x12s FAILS IN  
BENDING BY 16%

RAFTER BEAM: ADD 1 LVL EA. SIDE OF BEAM - SIZE FOR  
ADDITIONAL LOAD OF UNBALANCED SNOW.

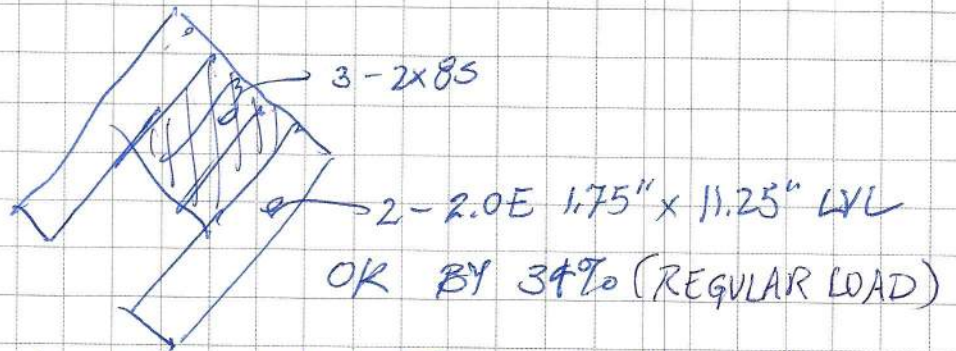
RAFTERS @ 8' WORKS BY 25% (REGULAR LOAD)  
RAFTERS @ 9' WORKS BY 6% ( " " )  
UPPER RAFTERS NEED TO BE SIZED FOR UNBALANCED LOAD.

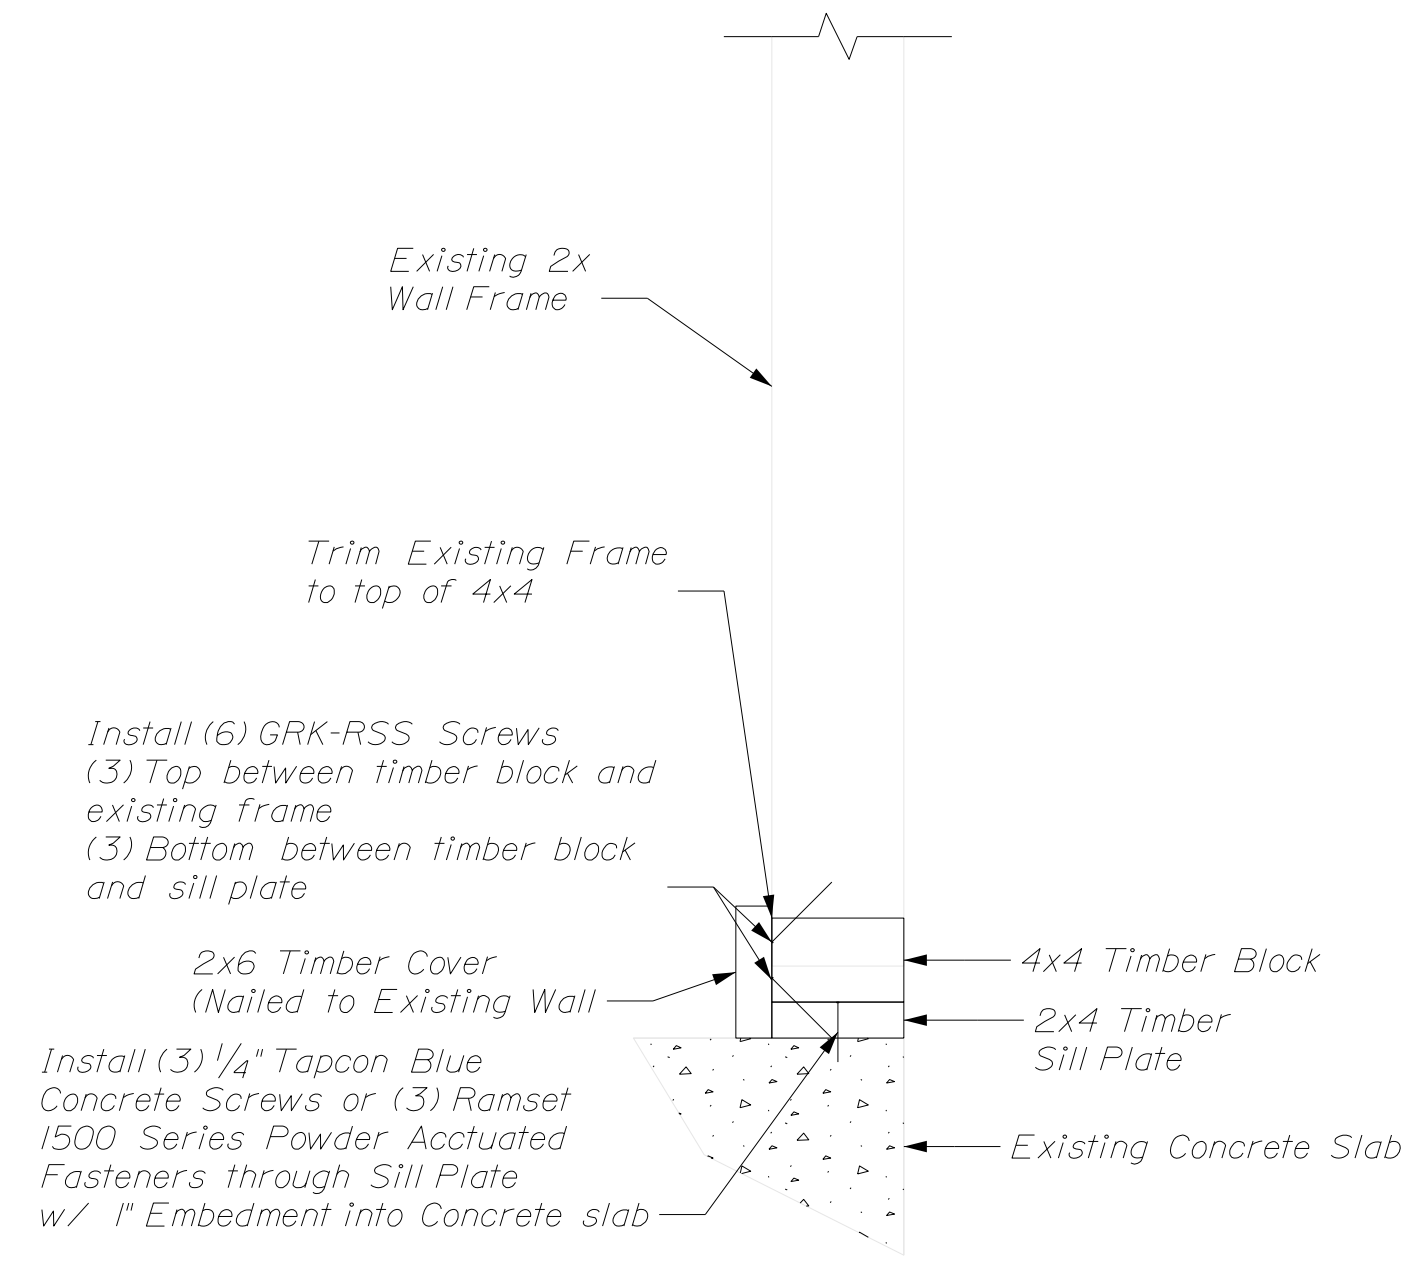
*Wall Connection Repair Section*  
Scale: 1/2" = 1'-0"

CE's inspection noted some damage to studs and lack of connection between the building and the foundation in one area. Repairs should be made per the Calderwood report.
