Preservation Timber Framing, Inc.

4/10/2023 | 101 Photos

Bowdoinham Old Town Hall Photo Report

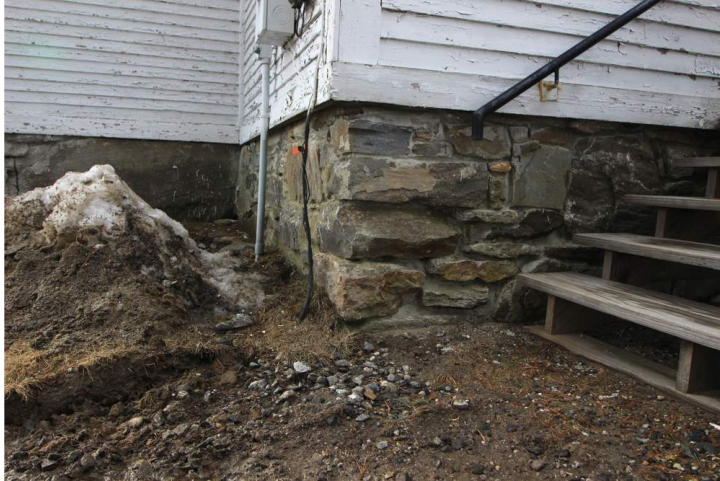
1

The foundation has received many generations of repair. Above ground, it is mortared, with stones of widely varying size.

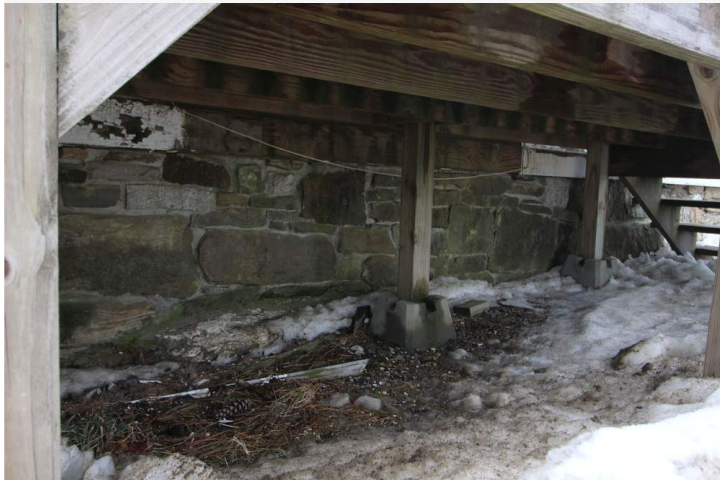
2

This stone wall is unusual for a building of this age. It is more typical for the foundation to have a fieldstone foundation below grade and capped with granite capstones. It is common for a dry-laid foundation to be infilled with mortar, but it is uncommon for the stones to vary so widely in size.

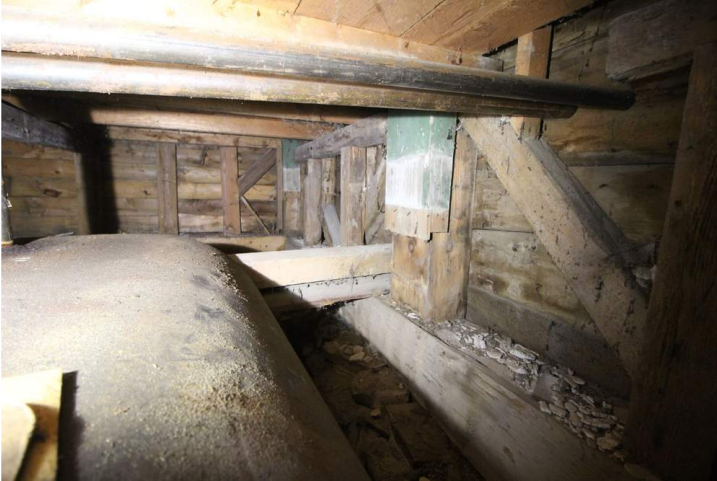
1

Entrance to the crawl space from the stage hatch shows wall framing below the stage. A mid-wall timber is wide and shallow, and shows the remains of former casing.

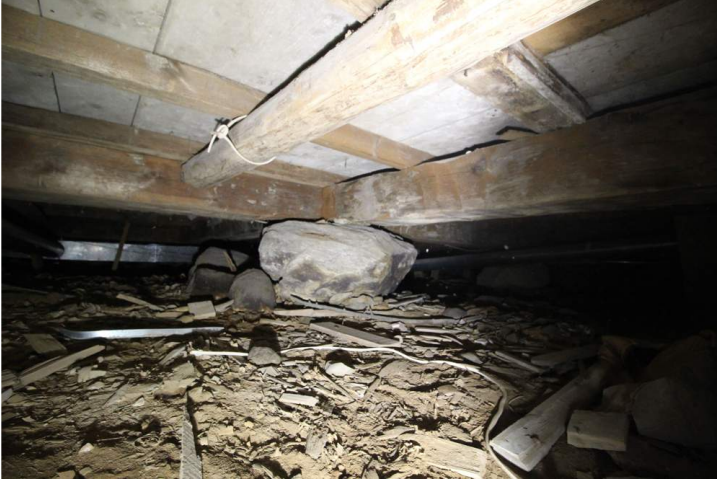
3

The floor is bisected longitudinally by two major summer beams. These are intersected by large floor girts aligned with the bents. Large log joists intersect the summer beams and eave sills, parallel with the floor girts. The major intersections are picked up on stone piers, which has significantly contributed to the longevity of this frame.

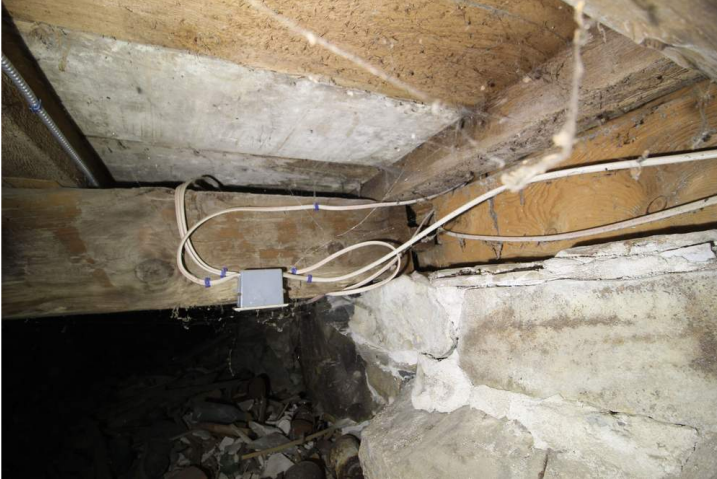
7

The large floor girts do not join to the new south eave sill. The sill is quite undersized and do not appear to have ever engaged the joinery.

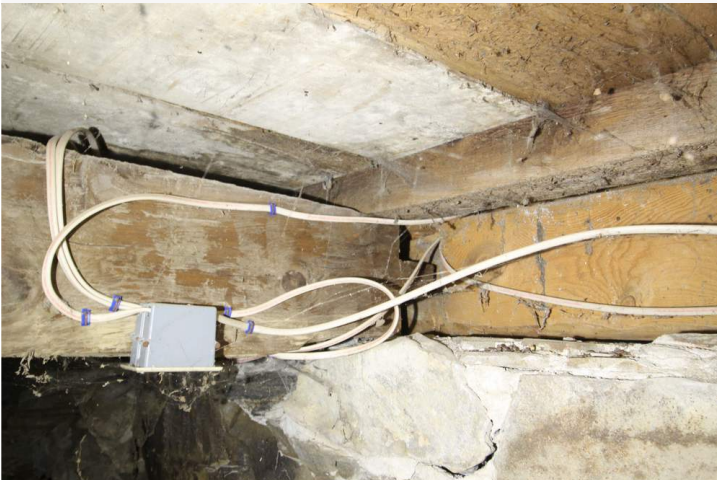
8

The floor girt tenons were left in place, and no joinery was cut into the sill.

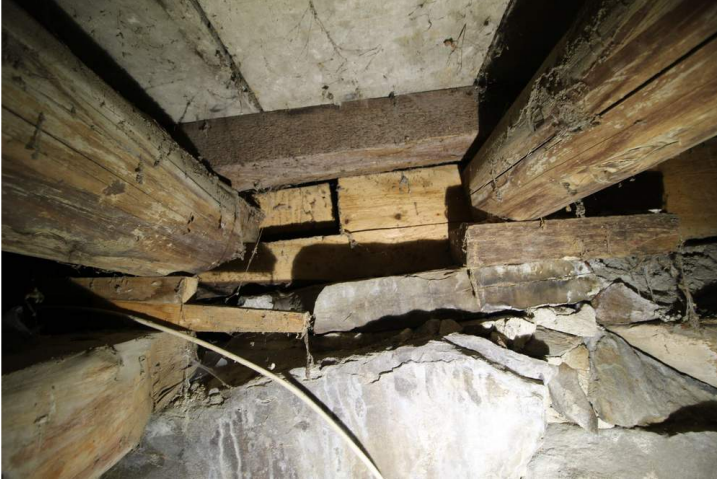
9

The new sills were joined to one another with short lap joints.

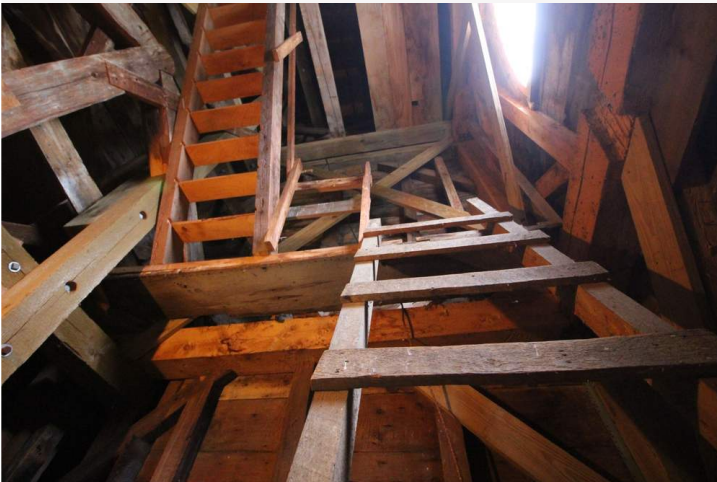
2

Looking north and up into the tower. The walls have been extensively braced with additional 2x8 kiln-dried lumber.

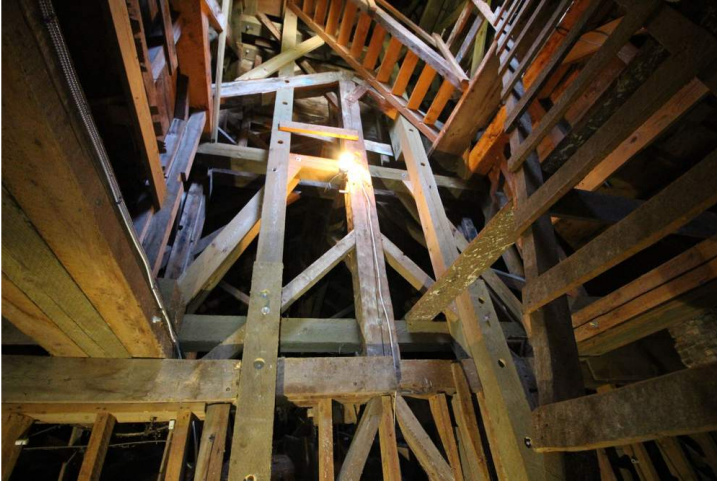
3

Looking west and up into the trusses. The hewn king post can be seen at the center of all this framing. A lot of framing has been added and primarily attached without joinery and with through bolts. It appears that the builder was attempting to load the tower onto the narthex wall, which isn't a bad idea.

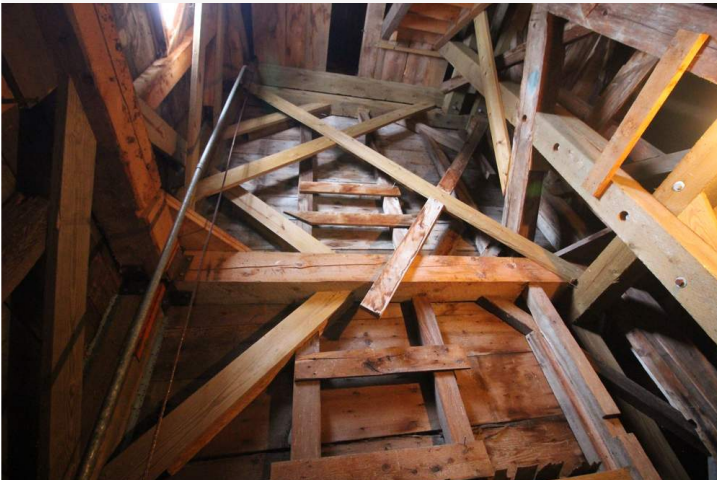
4

Looking south and up into the tower. The tower contains both original bracing and later stabilization bracing made from long pieces of dimensional kiln-dried lumber.

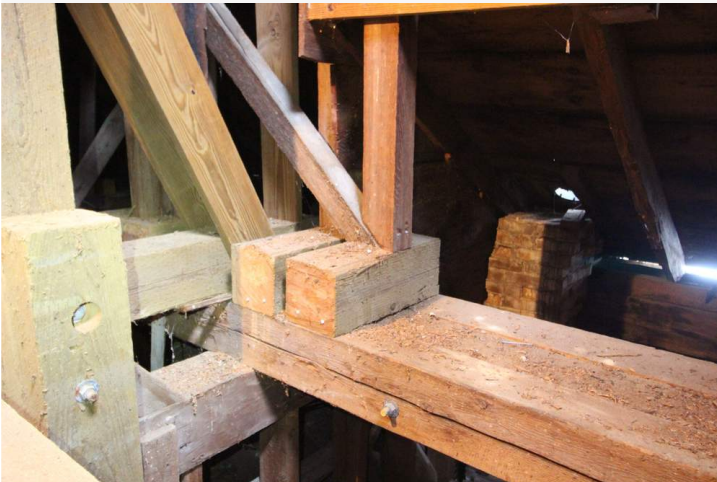
6

North tower bed timber and sisters. The tower beds cross from Bent 1 to bent 3 and pick up the tower posts, and other framing, like this stud and brace. The original bed timber was at 8x8 and is sandwiched between two new 8x8 sisters.

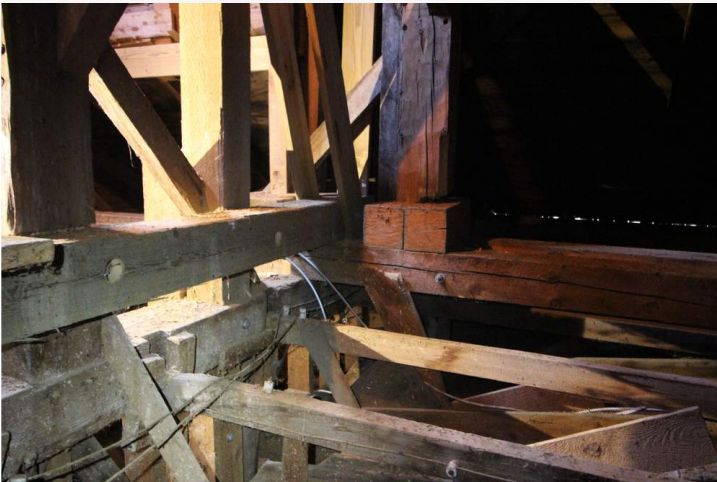
8

SW rear tower post, on short blocks, over replacement bed timbers.

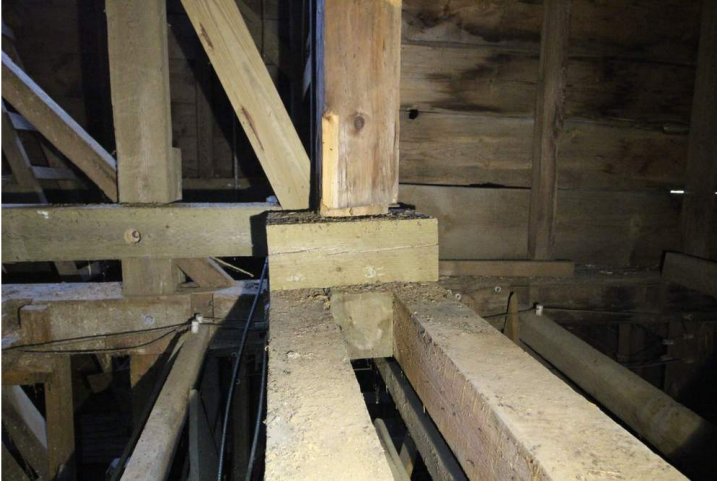
9

South bed timbers, blocks and SW tower post. These tripled bed timbers appear to be cut from completely new material. The center timber is not original.

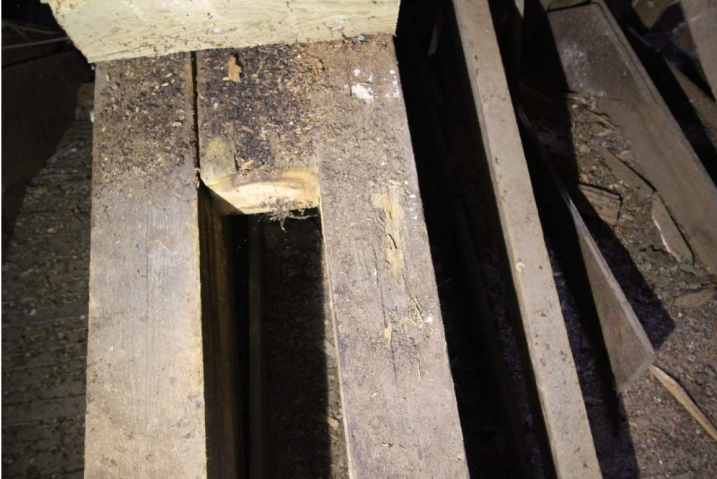
11

North bed timber and block. The center timber appears to be the original bed timber and has been severed and sistered.

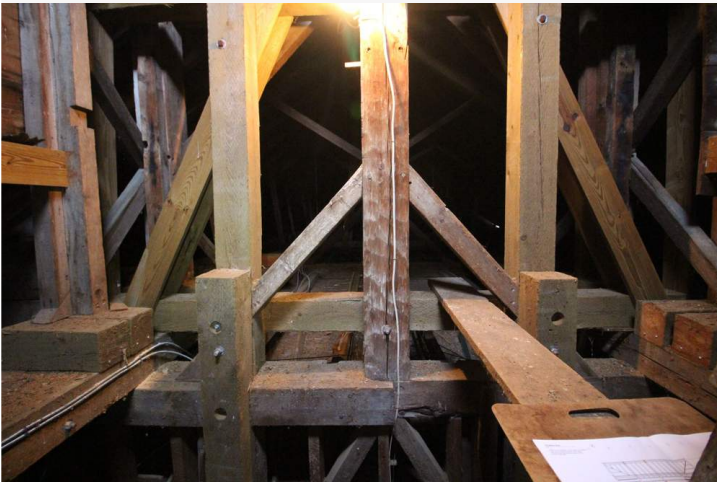
16

Bent 2, rear tower wall. Two additional 8x8 posts have been installed on either side of the king post.

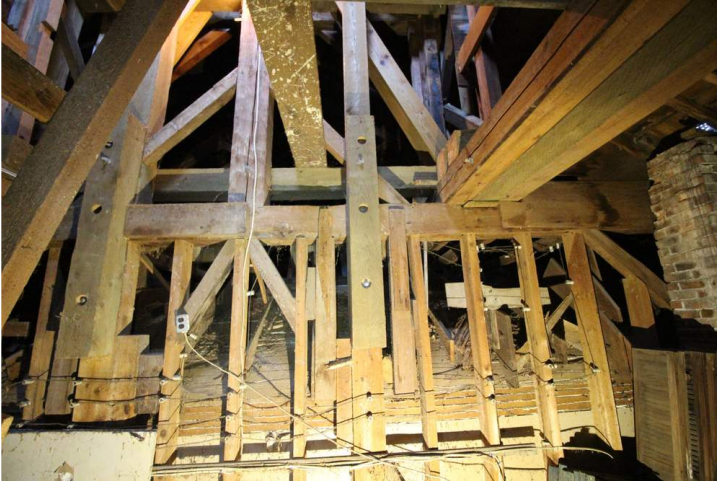
17

The posts land on the narthex wall. It would seem that the builder was attempting to transfer the belfry load to the narthex wall. It is unclear whether this was successful. Vertical bolsters reinforce the butt cut connections.

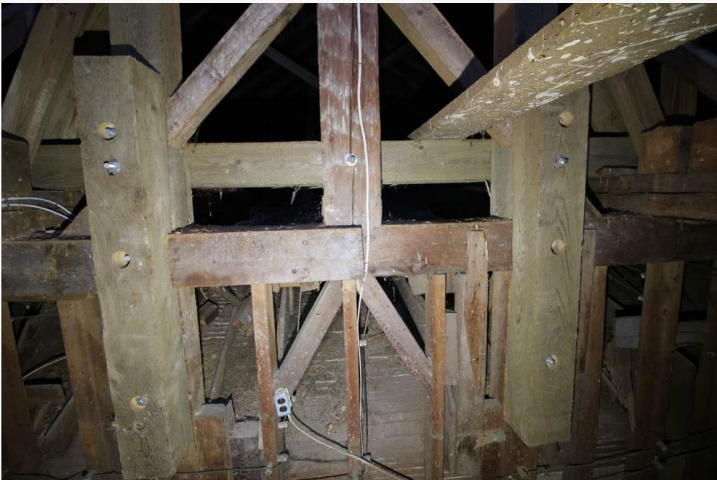
18

These large vertical bolsters and through bolts take the place of timber frame joinery. They are working for now. Through-bolts should be checked periodically for tightness.

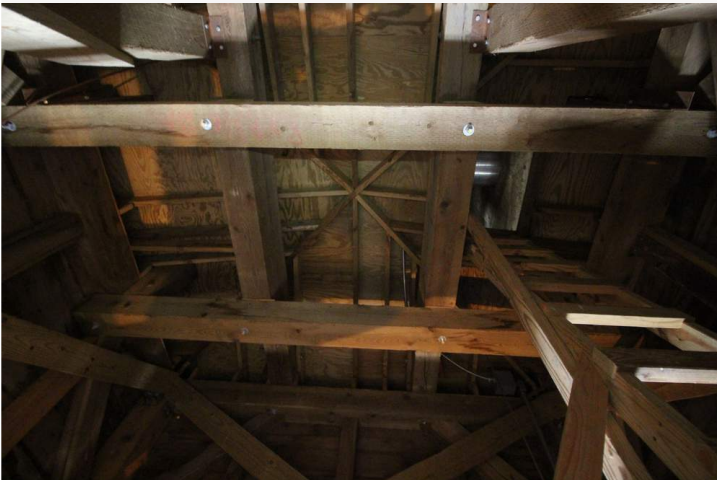
20

The belfry posts are supported on a stack of timbers that crisscross the tower plates. The long additional posts are visible at the very top of the frame, attached to two of the belfry bed timbers with angle iron

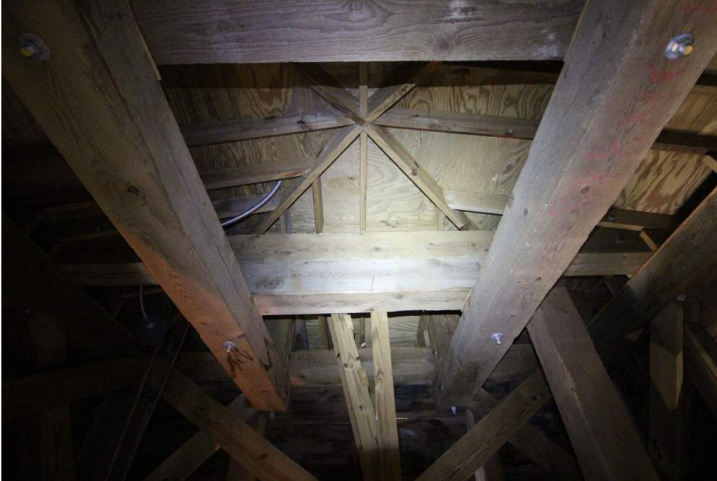
21

Belfry crab, looking south. The lower two belfry bed timbers cross beneath the plate, and the upper bed timbers criss above the plate. A bolster fills a void the thickness of the plate. The bed timbers are through-bolted together.

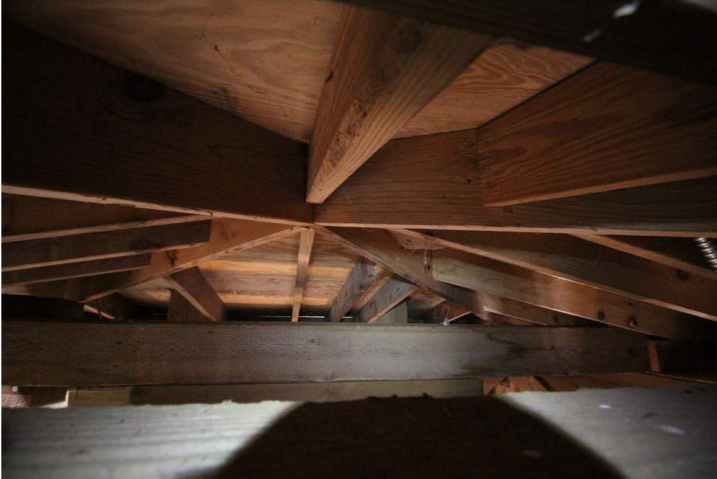
25

The tower roof is a new addition from the 1990s, and is a conventionally-framed hip roof.

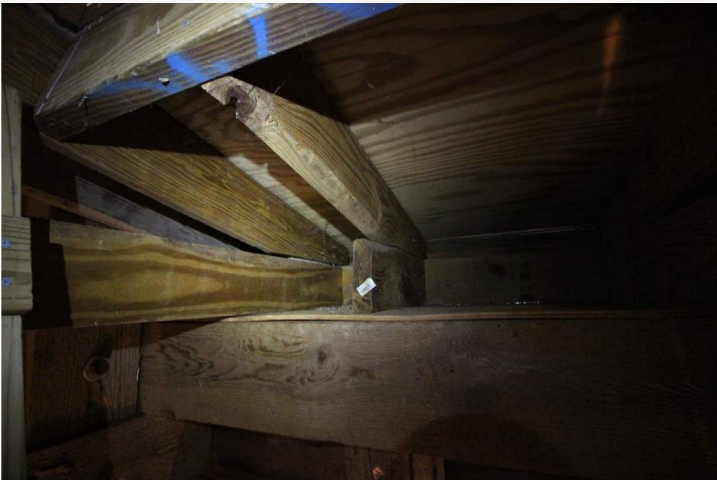
26

Detail of the tower roof cornice framing.

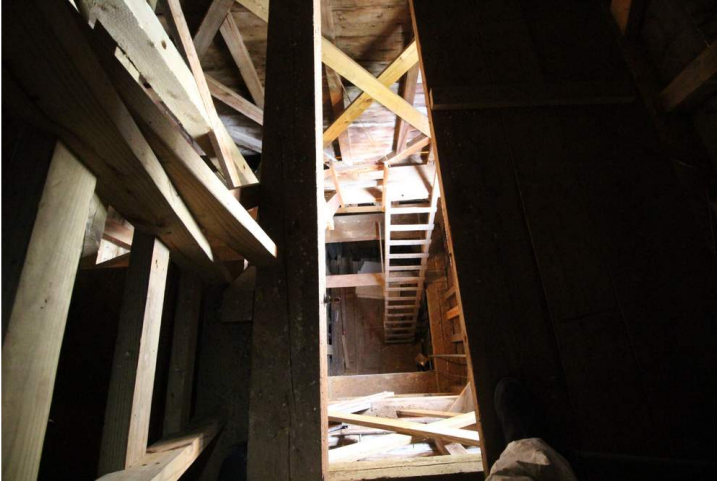
27

View from the first standing girt level, below the tower plate. This tower is tall.

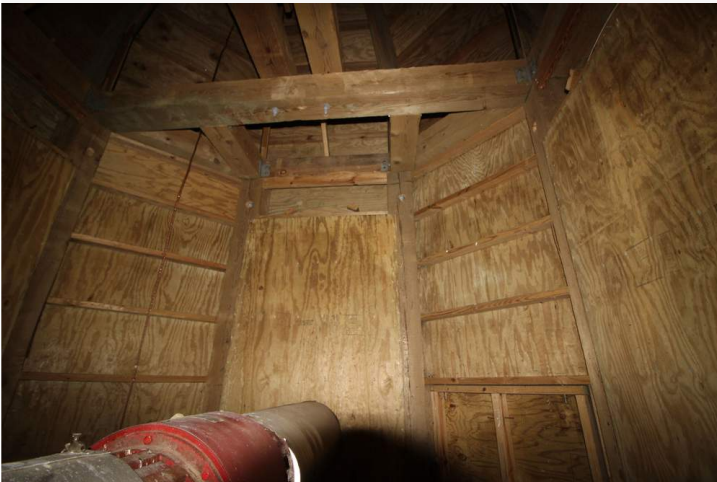
28

Belfry interior. The belfry walls are conventionally framed out of 2x4s and 2x6s, and sheathed in plywood.

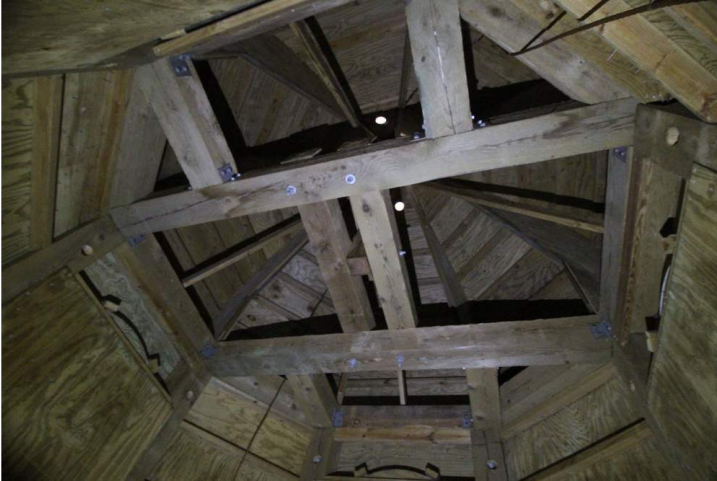
29

Belfry dome crab. The crab that supports the dome has been rebuilt out of new 8x8s, and bolted together. It is likely that this arrangement of timbers mimics the original timber-framed crab design.

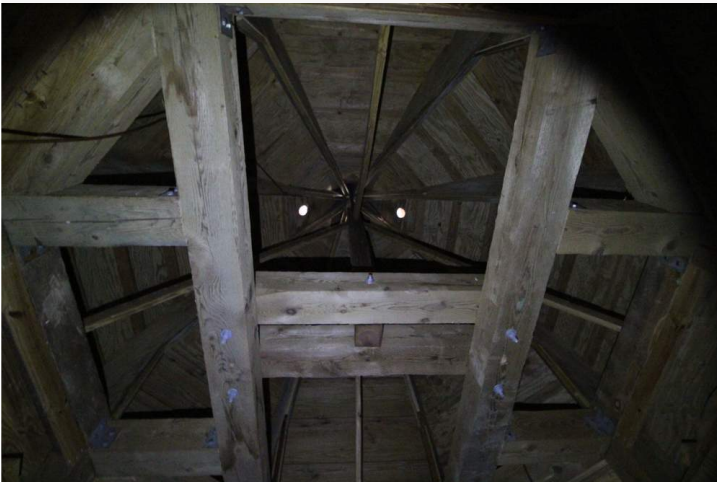
30

The center timbers in the crab clasp the dome's mast.

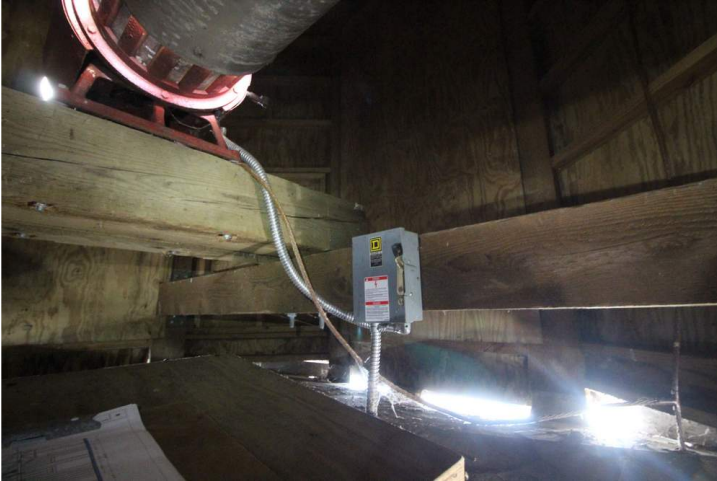
31

The siren is supported on bed timbers that span the belfry interior and are attached to the belfry posts.

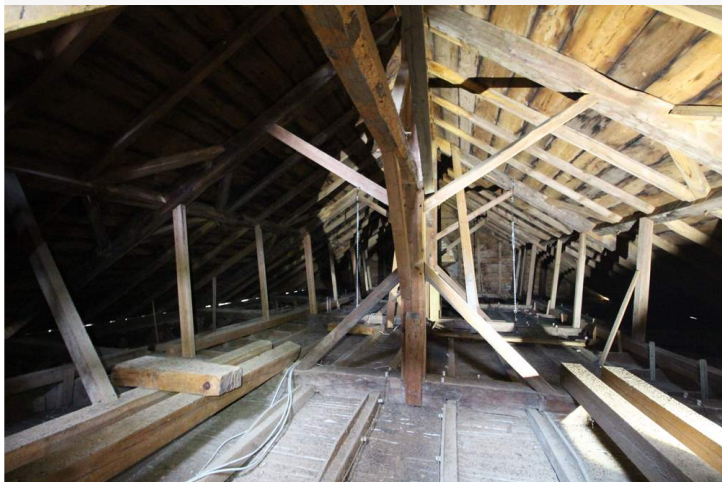
1

Bent 3 truss. The truss is composed of a king post (at the center of the triangle), two upper chords (or rafters), one bottom chord (or tie beam), two ascending braces (or struts), two descending braces and two additional struts farther out on the tie beam.

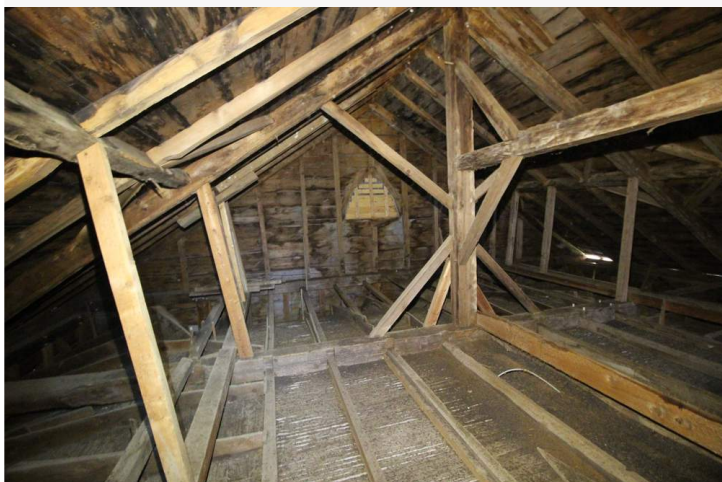
2

Bent 5 truss. The second set of struts is farther out on the tie beam, and meet the rafter under the intersection with the principal purlin. They do not appear to be original to the truss construction.

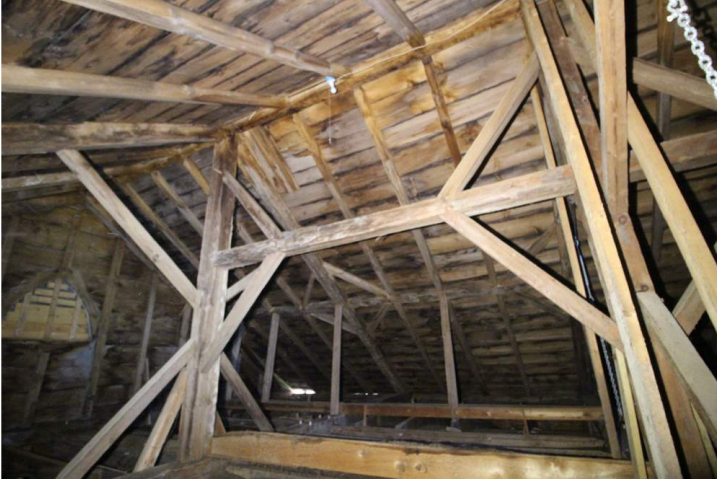
3

Bent 4 to Bent 5 trusses. The trusses are connected by a longitudinal girt, a pair of ascending braces and a pair of descending braces.

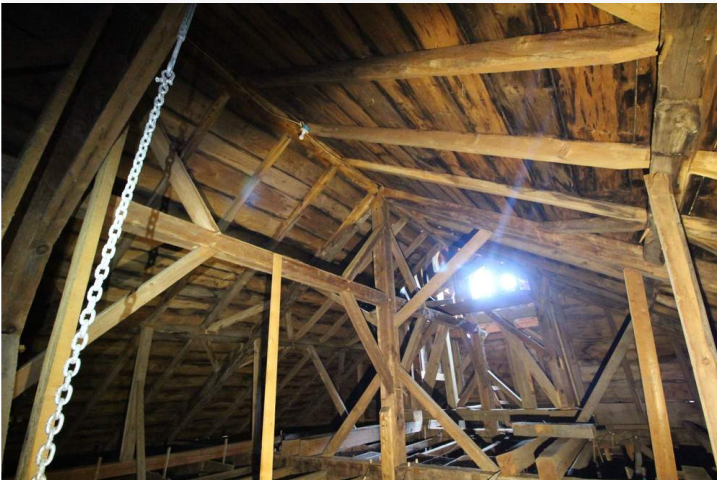
4

Bent 3 truss from behind, looking east. The trusses are well braced.

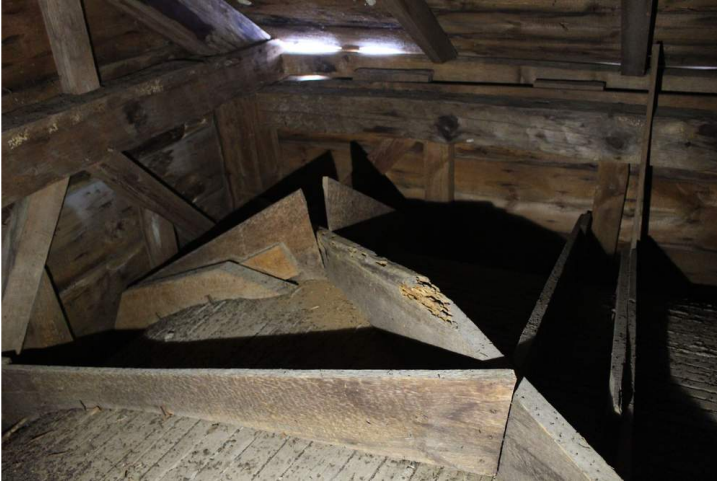
5

The ceiling cove is framed by 1x12 ribs with the profile of the cove cut into them.

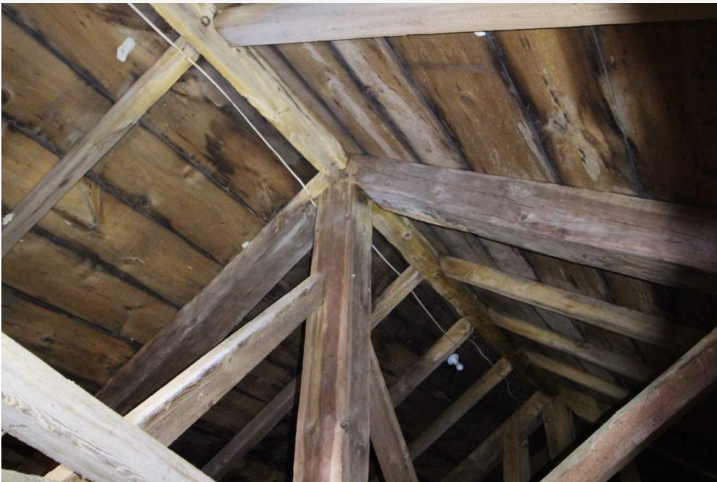
6

Bent 3 king post. The joinery between the principal rafters and the head of the king post is tight.

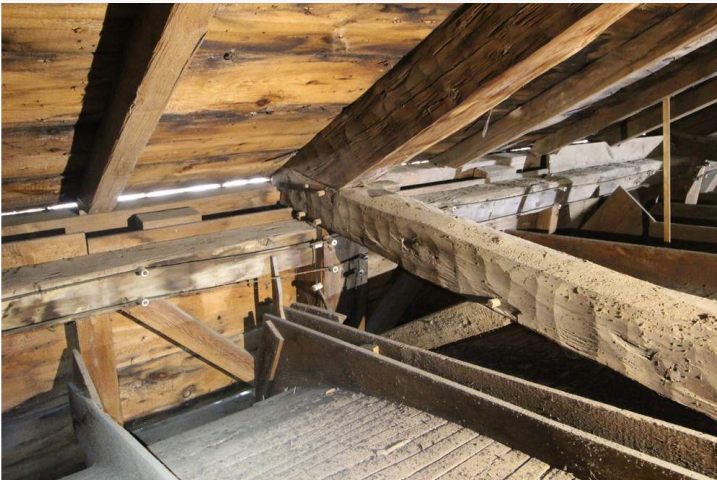
8

Bent 3, south end of truss. This bottom chord is beautifully hewn.

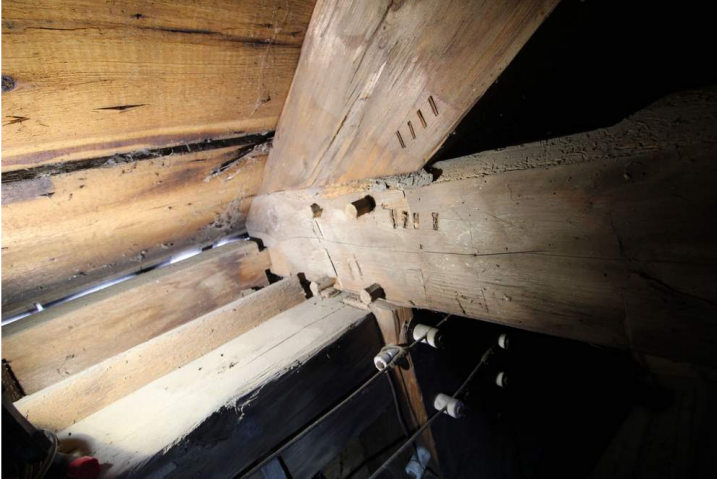
9

Bent 3, south end of bottom chord. The marriage marks on this and other trusses indicate that the bents were originally numbered from back to front.

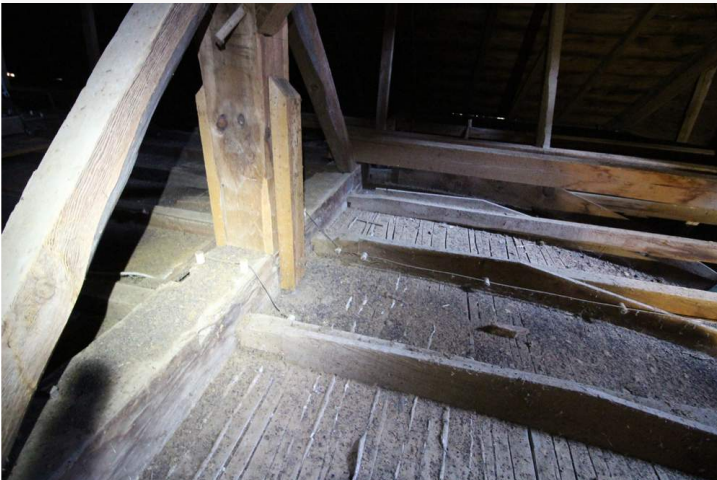
10

Bent 3, the bottom of the king post is gusseted on both faces at its intersection with the bottom chord.

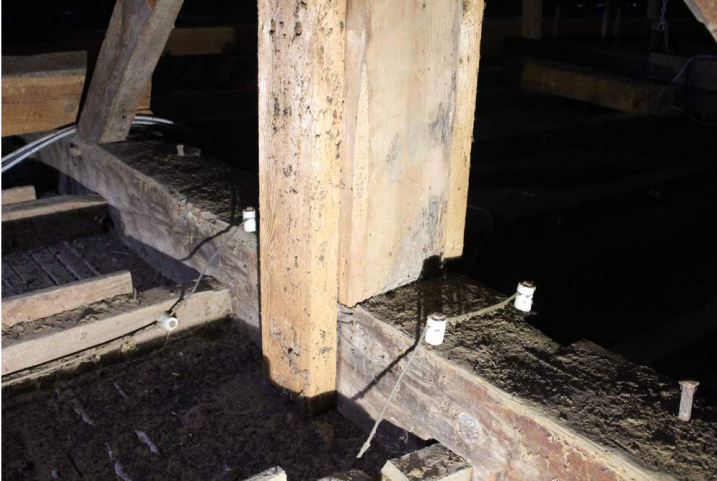
11

Bent 3, the bottom of the king post, where it intersects the bottom chord, is gusseted. A stirrup strap would provide more support.

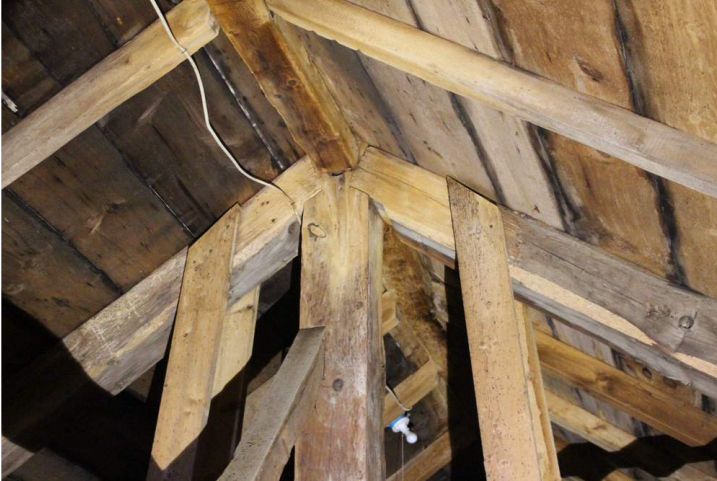
13

Bent 4 king post head. The joinery at the top of the king post is tight.

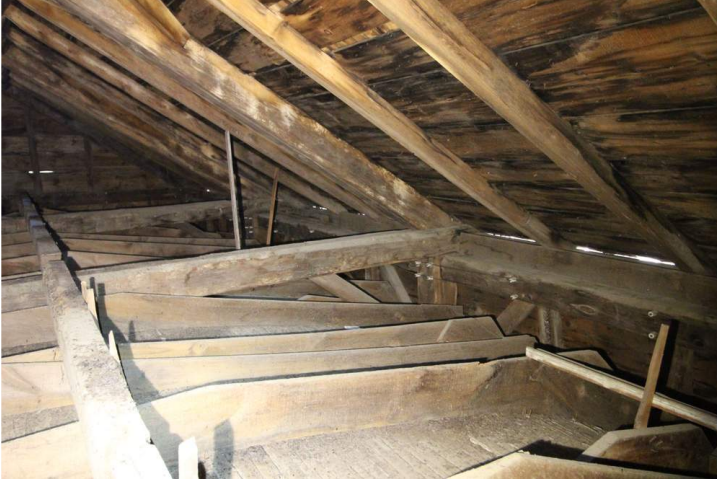
17

Bent 4 truss. Remarkably, the principal-rafter-bottom-chord connection looks stable.

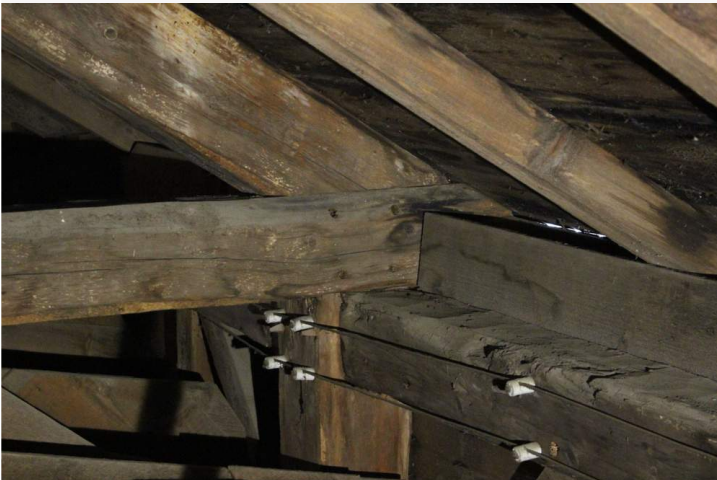
18

The principal rafter is connected to the bottom chord with a mortise and tenon, which is double-pinned.

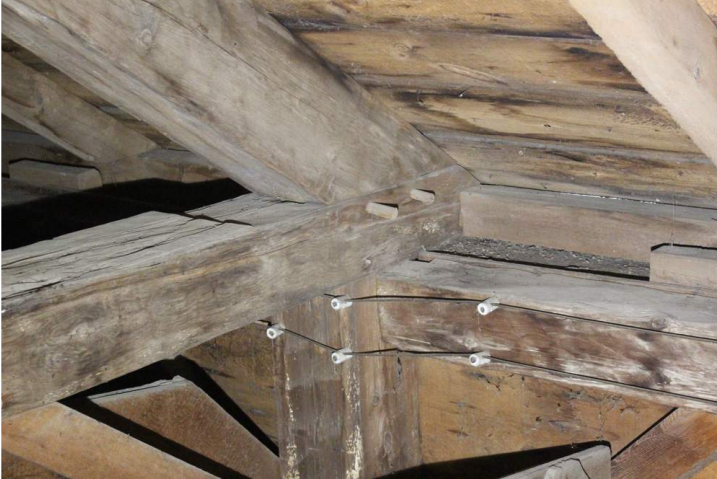
19

Bent 4 truss. South rafter heel is also tight. Bent 4 is referenced towards the rear.

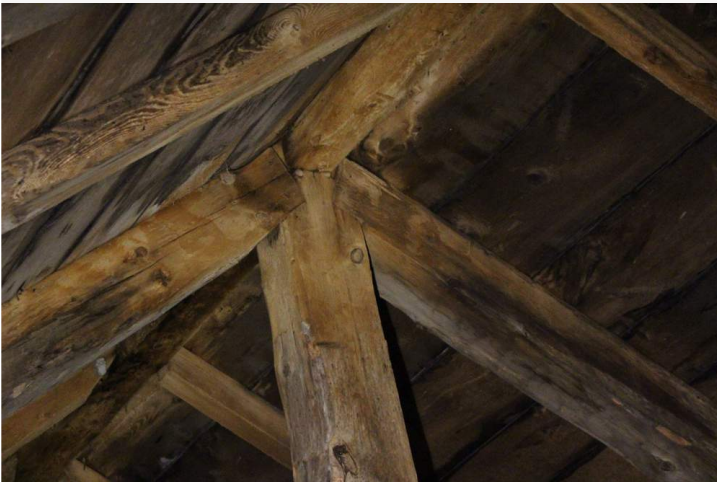
22

The joinery at the top of the bent 5 king post is tight.

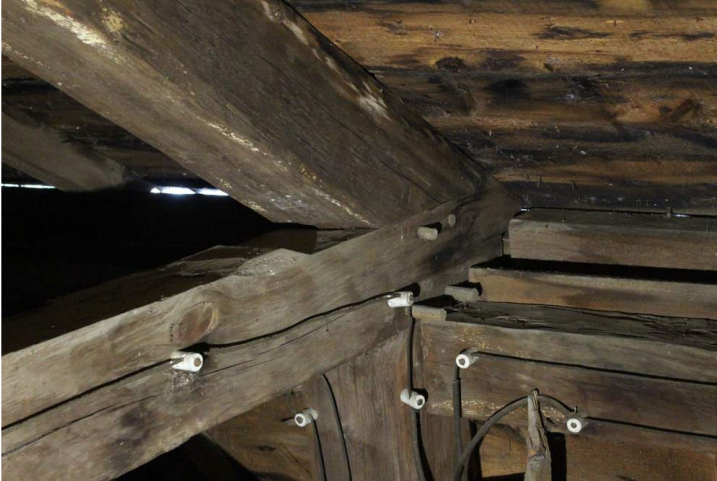
23

The joinery at the heel of the bent 5 principal rafter is also remarkably tight. However, the body of the rafter itself is showing signs of mold.

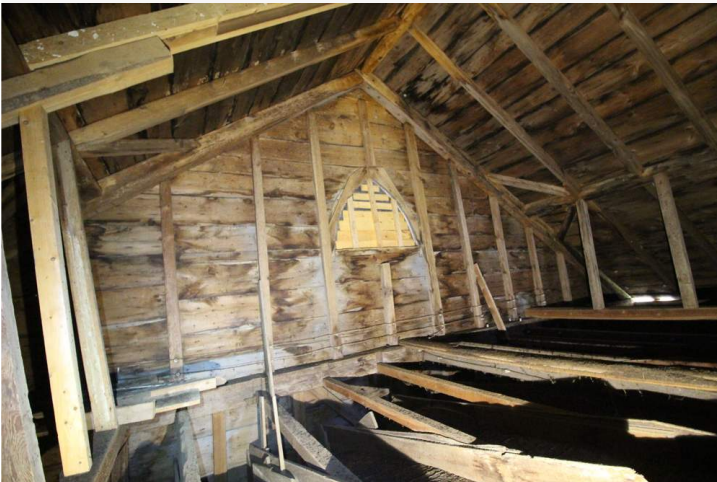
26

Bent 6 rear gable wall. Bent 6 is studded and contains the framing that once supported a triangular window similar to the one in the front wall of the tower.

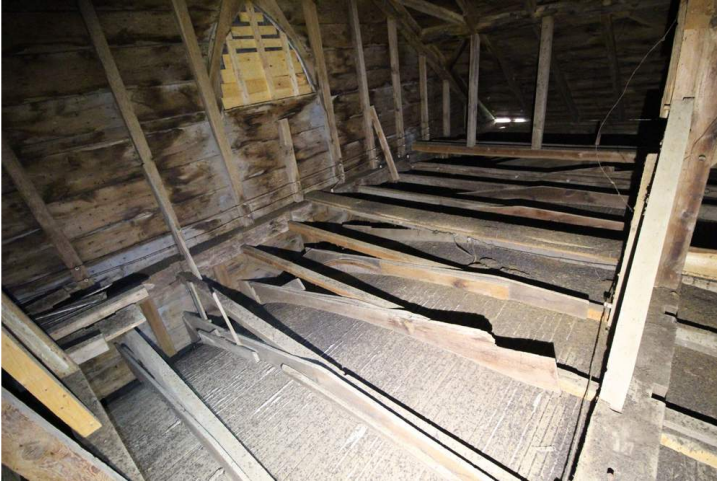
27

The bay in front of bent 6 gives a good view of the framing that supports the coved ceiling.

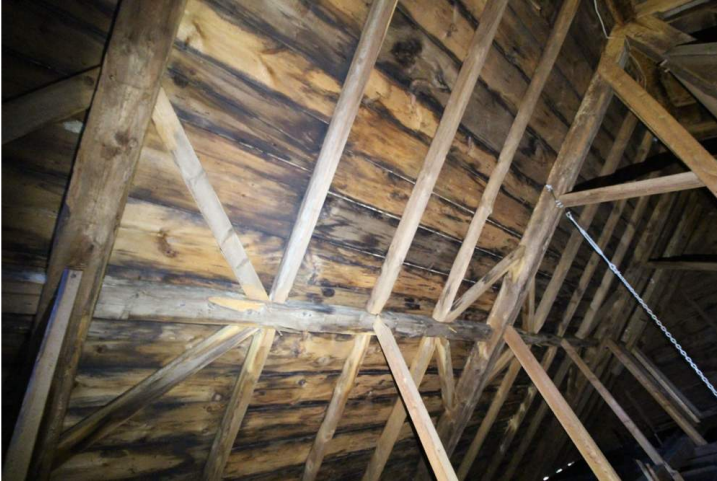
1

The Bowdoinham Town Hall has a very strong roof system. It is composed of principal rafters connected by horizontal principal purlins and braces. Common rafters support the roof between the bents; they start at a flying purlin in the eave cornice, cross the principal purlin, and meet at a ridge purlin in the peak.

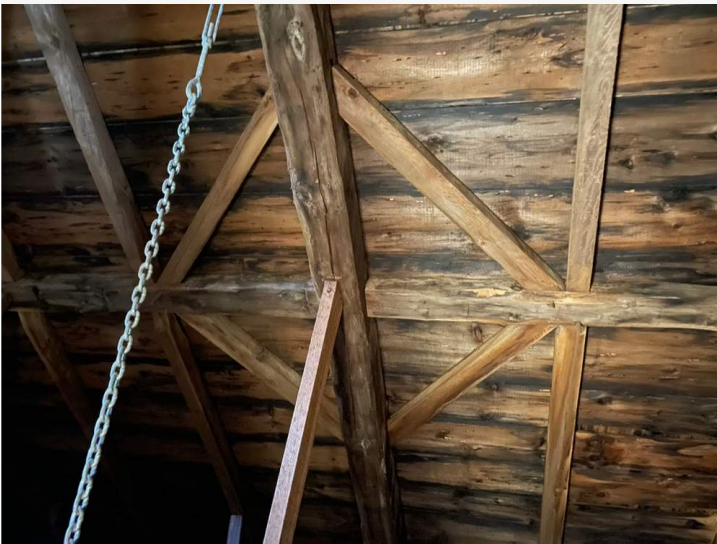
2

Ascending and descending wind braces in the roof plane lend the roof system extra stability.

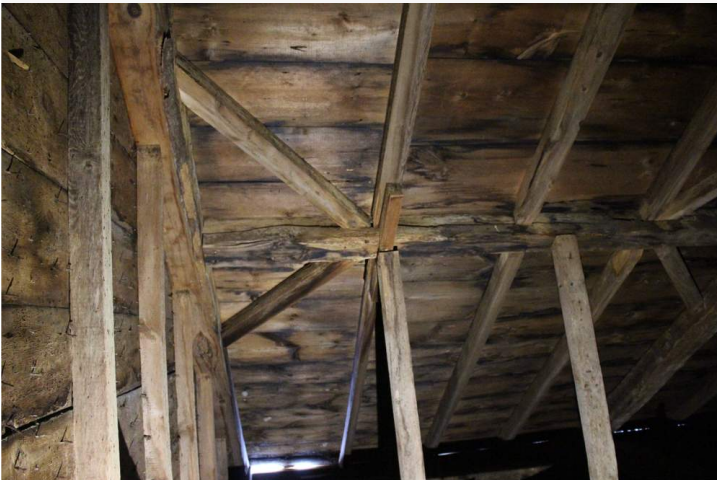
The principal purlin between bents 5 and 6 is badly rotted, and is being stabilized with a couple of struts.
